Living Shoreline Project Monitoring in Mississippi and Alabama

**Restore America's Estuaries/The Coastal Society Joint Summit
November 3, 2014 • National Harbor, Maryland**

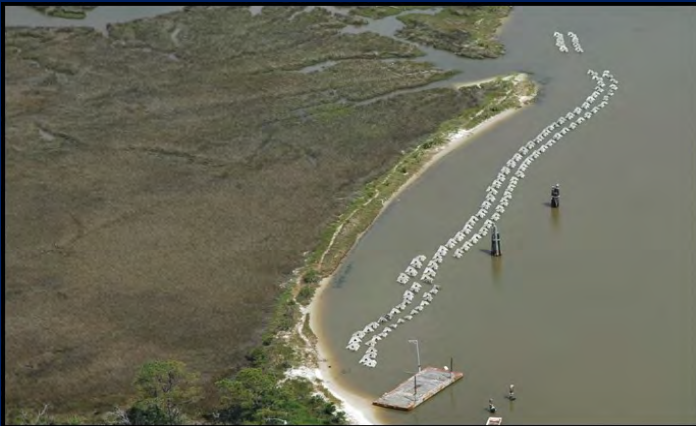
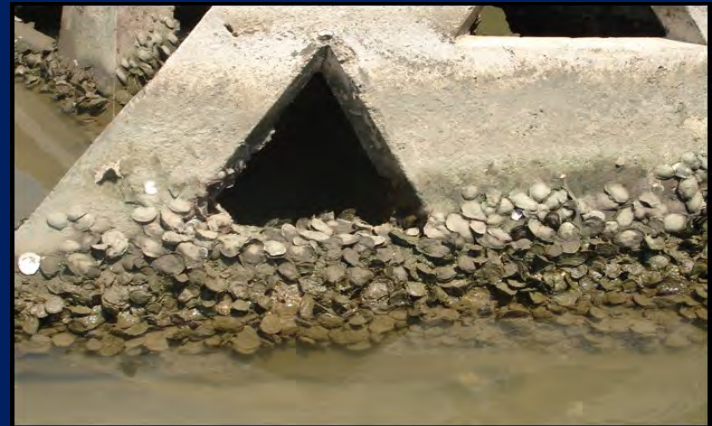
Alonzo Landing Wave Attenuation Devices Project, Dauphin Island, AL

Project Design: 182 precast concrete Coastal Haven breakwaters were installed in two interlocking rows parallel to the marsh in water approximately 1.3 m deep.

Project success: Good. Reduced erosion rate, oyster recruitment (205 oysters/m²), and healthy marsh vegetation.

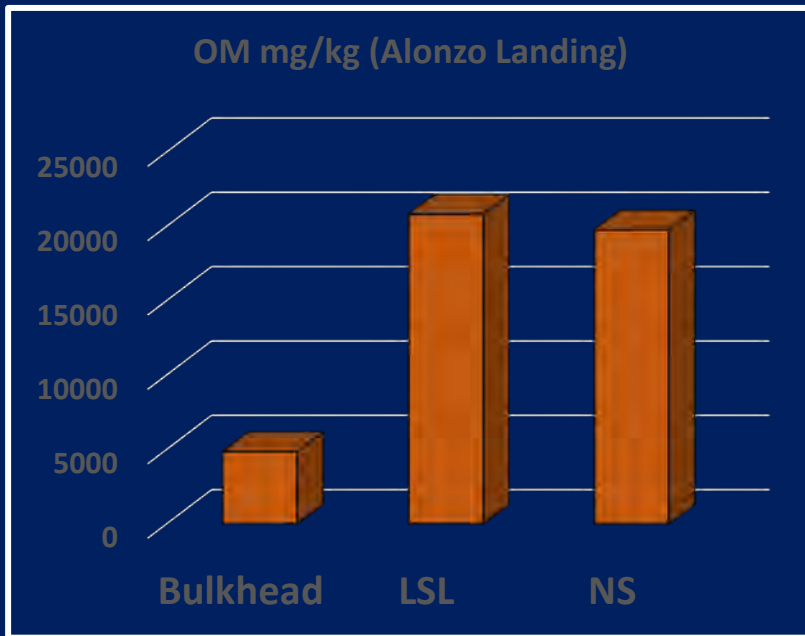
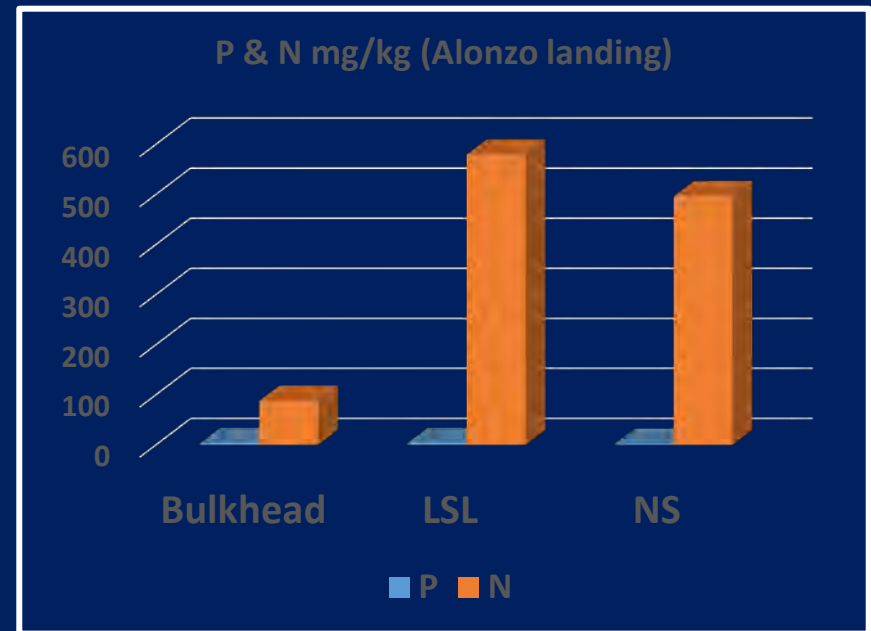
Alonzo Landing, Dauphin Island (continued)

Soil Samples were collected to compare if the wave attenuation devices have increased organic matter and nutrients to promote marsh growth and increase ecosystem services in 2012.

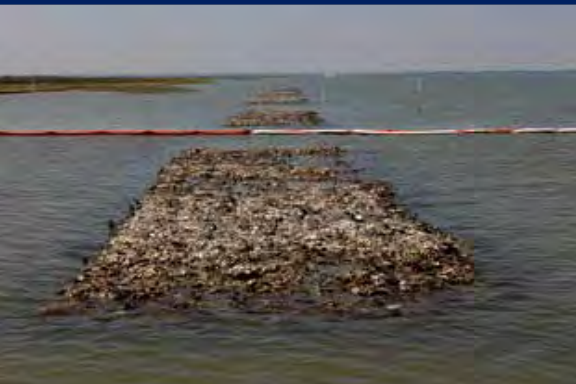
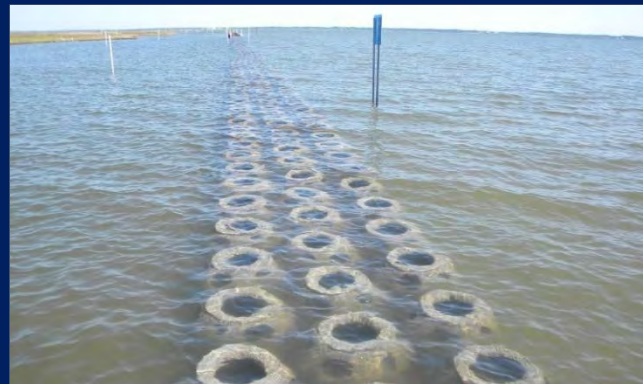
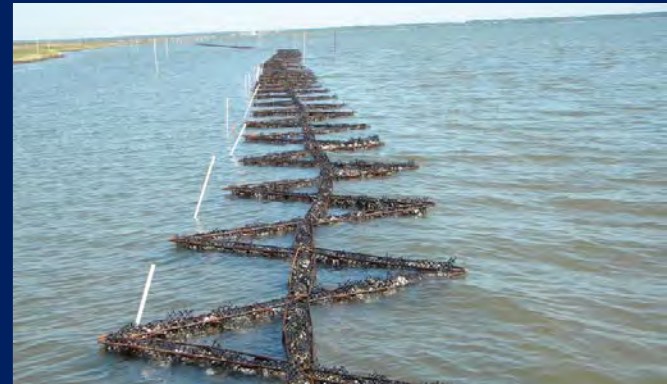
Alabama Port, Coden, AL

Project Design: Three types of breakwaters were used, bagged oyster shell, Reef Balls, and ReefBlk cages.

Project success: Marshes are still eroding but structures are providing good fisheries benefits.

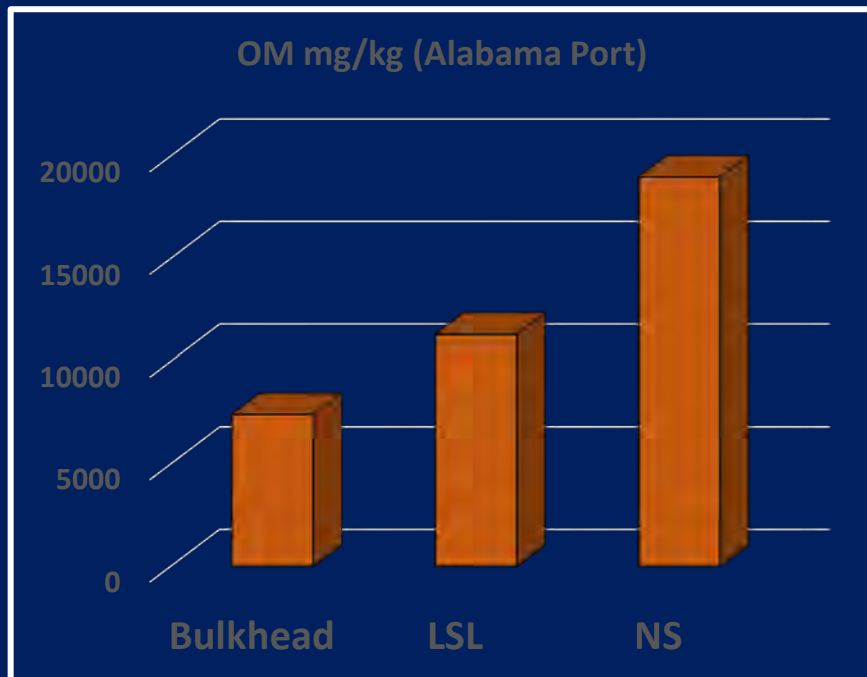
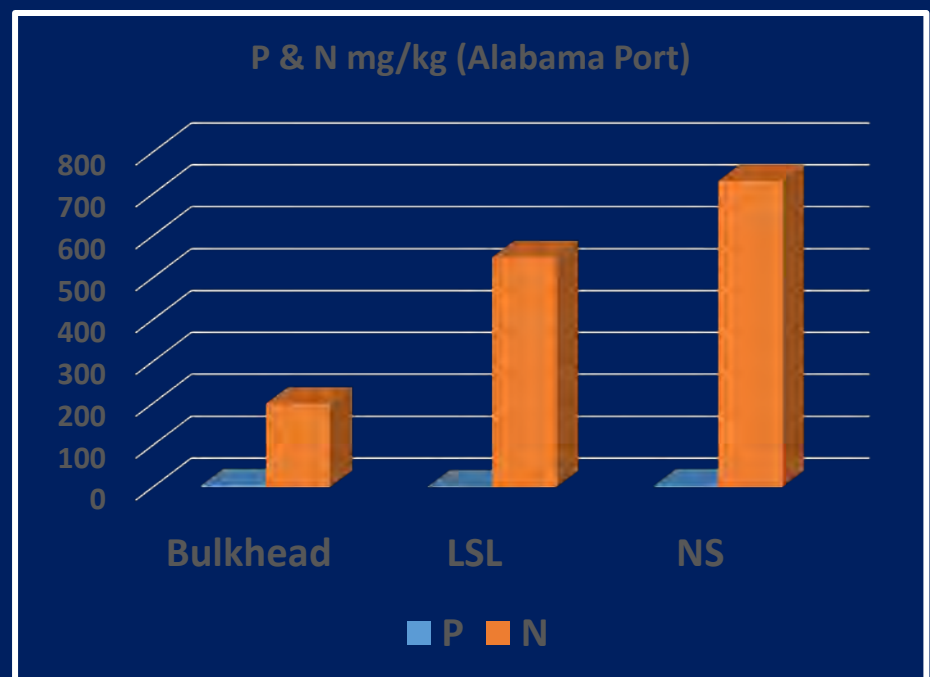
Alabama Port, Coden, AL (continued)

Soil Samples were collected to compare if the living shoreline treatments have increased organic matter and nutrients to promote marsh growth and increase ecosystem services in 2012.

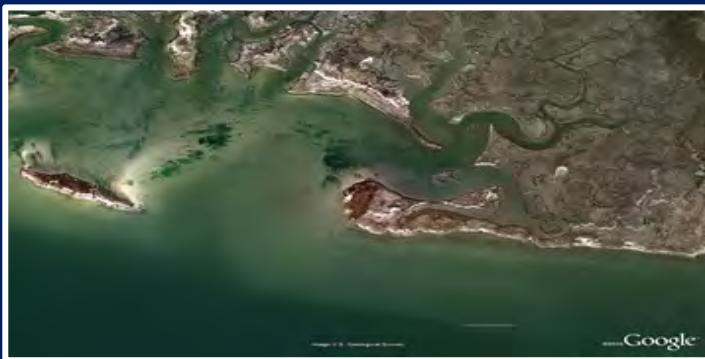
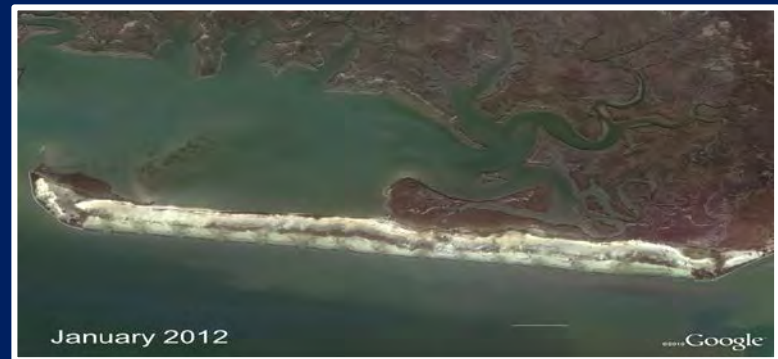
Little Bay Coastal Marsh Creation and Protection Project, Bayou La Batre, AL

Project Design: Installed 5,200 feet of segmented breakwater using wave attenuation devices or WADs[®] and riprap to restore 30 acres of salt marsh.

Project success: Good. Sediment is compacting, erosion gaps between WADs stabilizing, marsh plants are expanding, large amount of nekton, oysters are settling on WADs.

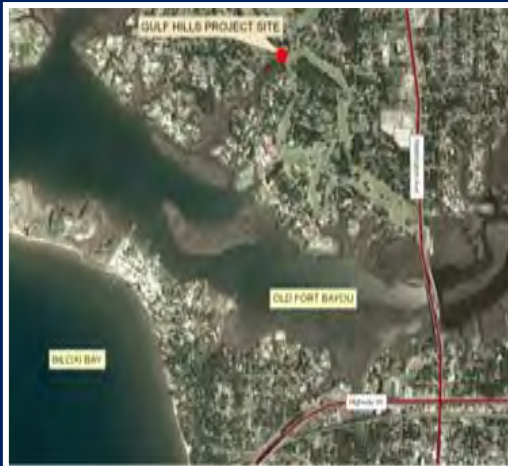
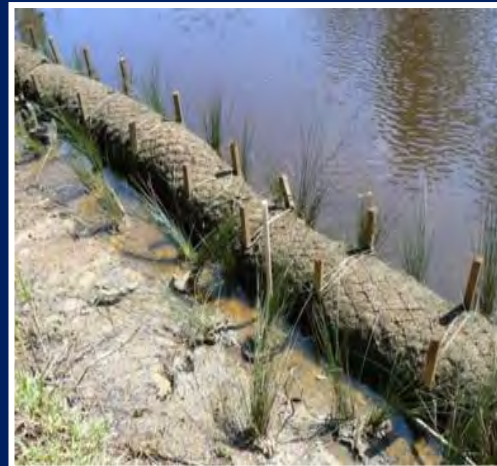
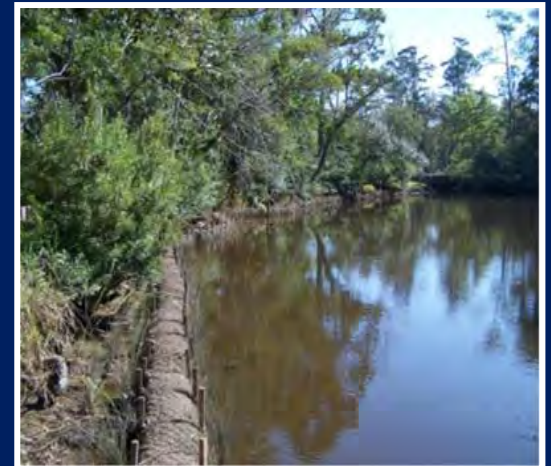
Gulf Hills Coir Log Project, Ocean Springs, MS

- **Location:** Old Fort Bayou, Ocean Springs, MS
- **Erosion Rate:** Low
- **Project Size:** 270 feet
- **Project Design:** 200 feet of Coir Logs staked at the MLWL and planted Black Needlerush
- **Installation Date:** September 2009
- **Monitoring Parameters:** Erosion, Accretion, and Survival and Growth of Vegetation
- **Project Status:** Good Condition

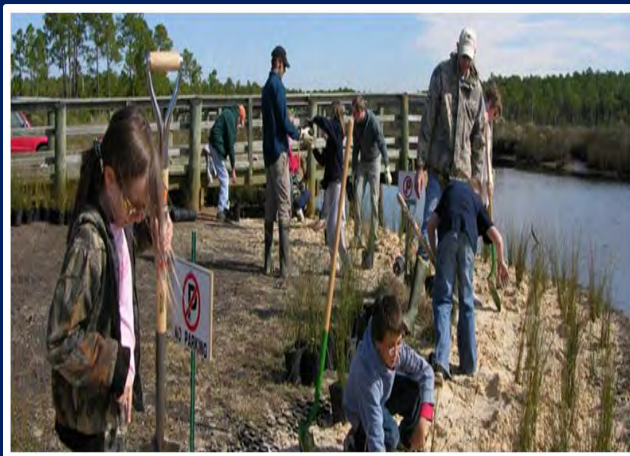
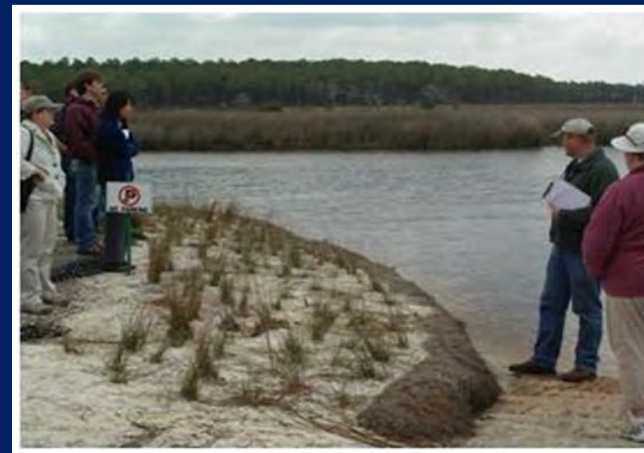
Bayou Heron Boat Ramp at Grand Bay NERR

- Project Location: Moss Point
- Project Size: 170 feet
- Project Design: used coconut fiber logs, backfilled with sand, and planted native black needle rush (*Juncus roemerianus*) to protect boat ramp from erosion
- Installation Date: Late Fall 2009
- Monitoring: Erosion, Accretion, and Plant Survival
- Project Status: very successful, planning to potentially do some site maintenance in near future

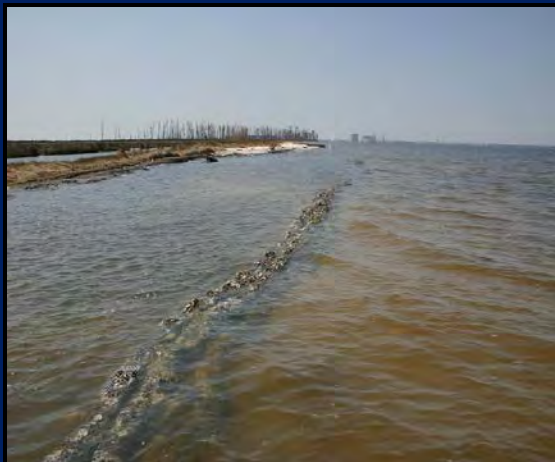
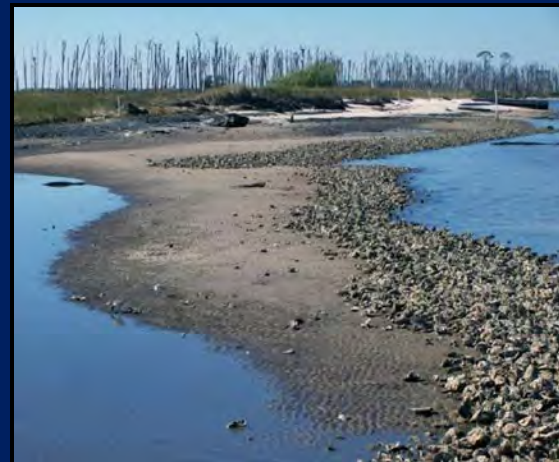
2010 Deer Island Restoration Project, Biloxi, MS

- **Location:** Northeast corner of Deer Island
- **Erosion rate:** High
- **Project Size:** 800 linear feet
- **Project Design:** Breakwater berm built using recycled oyster shell bags composed of wire mesh (chicken wire). The breakwater was designed to be covered slightly at high tide and exposed during low tide
- **Monitoring Parameters:** oyster spat recruitment, water quality (temperature, salinity, dissolved oxygen), and erosion rates (using rulers and photographs at low tide).
- **Project Success:** Moderately successful

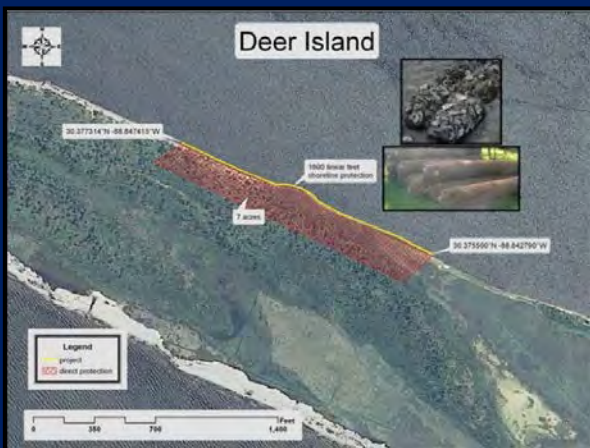
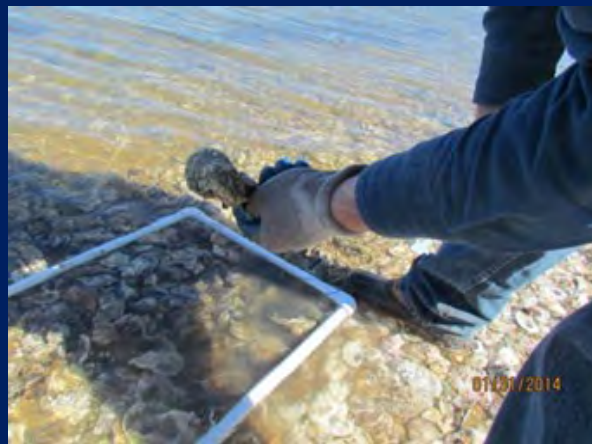
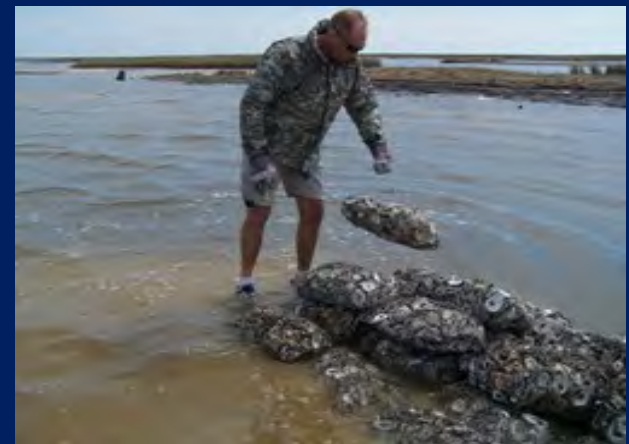
2013 Deer Island Restoration Project, Biloxi, MS

- Erosion rate: High
- Project Size: 1,600 linear feet
- Project Design: 160 coconut fiber coir logs (20 in. diameter X 10 long) were staked and placed along shoreline and 8,000 oyster shell bags (poultry netting) were installed 10 feet off shore to create a breakwater
- Monitoring: 10 half meter oyster quadrats sampled (180 oysters and spat/m²) and coir logs are monitored.
