Micro-siting and Nitrogen Removal Efficiency of a Liquid Injection Permeable Reactive Barrier (PRB)

Residential Area: Lagoon Pond Rd

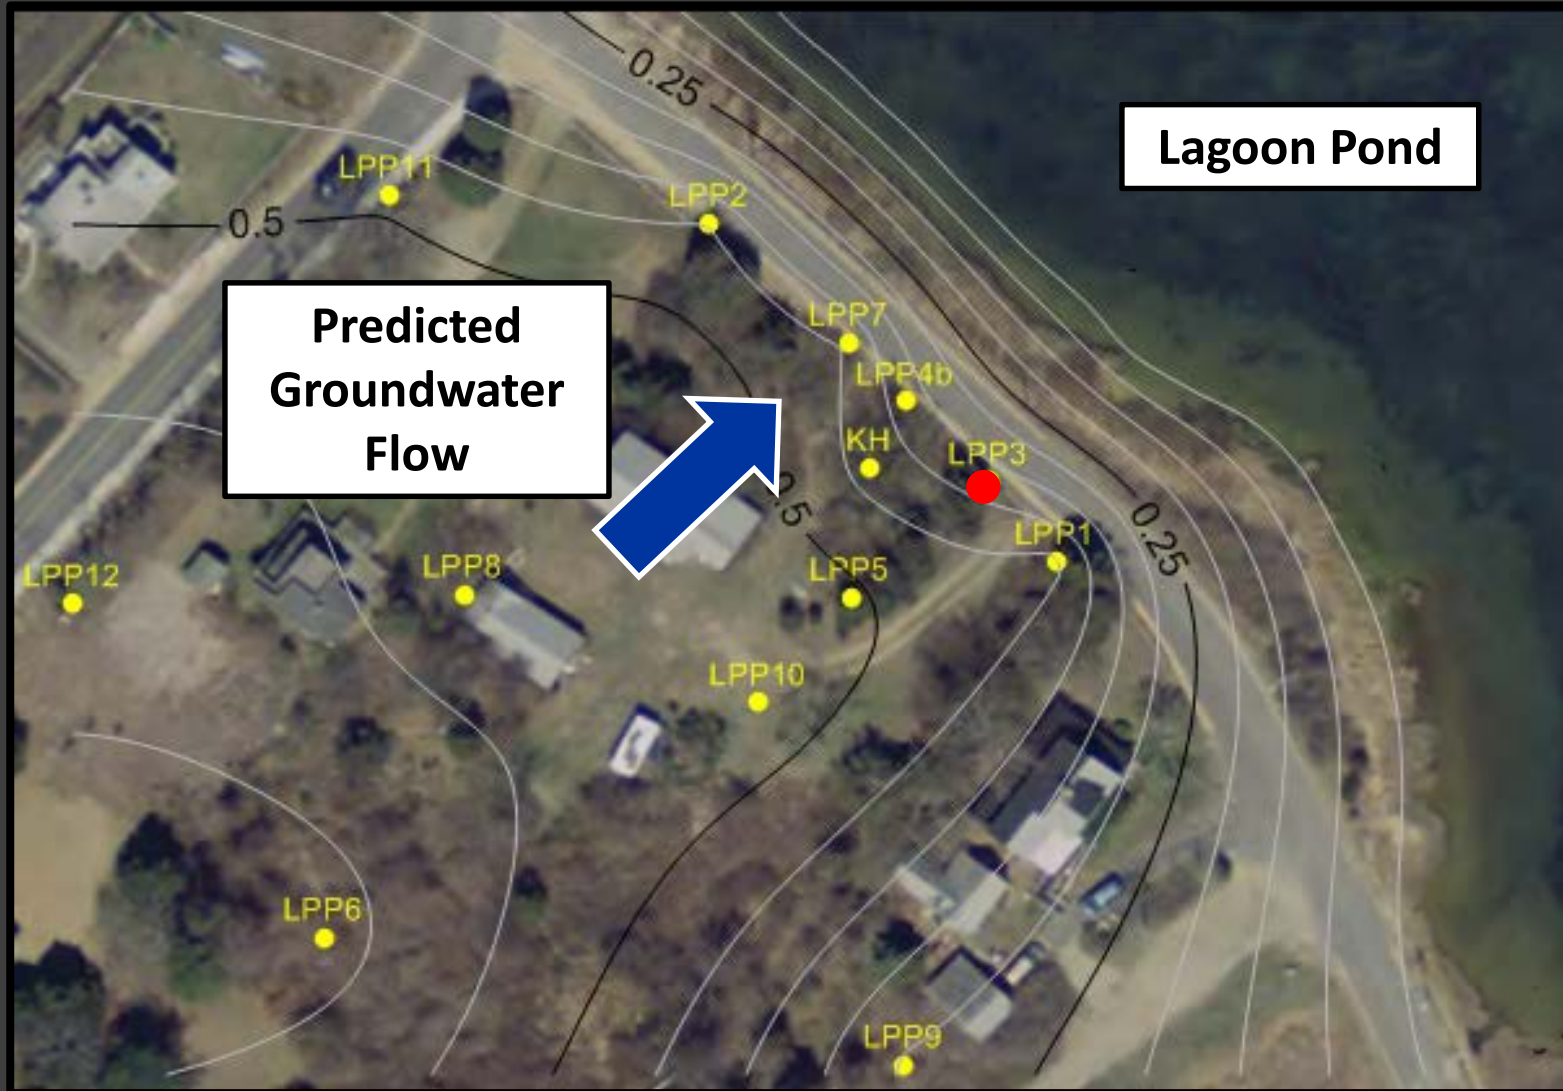
Case Study

Pre-Injection Findings

- Groundwater only 0.5 – 2.5 m below ground surface
- Soils are coarse to fine sand with some silty/clay
- Nitrate is the dominant form of nitrogen and corresponds with average residential levels
 - Total Dissolved Nitrogen: Average 2.7 mg/L (0-13 mg/L)
 - Nitrate + Nitrite: Average 2.0 mg/L (0-12 mg/L)
 - Ammonium: Average 0.3 mg/L (0-0.68 mg/L)

- Freshwater (Salinity <0.2 PSU)
- High nitrate levels - oxygenated groundwater
- Hydraulic Conductivity: 20 ft/day (15-25 ft/day)
- Groundwater velocity: Average 0.6 ft/day (0.41-0.75 ft/day)
- Tracer tests indicate groundwater flow towards Lagoon Pond and perpendicular to the PRB location
- Elevated levels of Mn, Fe, and As were observed in the *Phragmites* root zone at the edge of Lagoon Pond

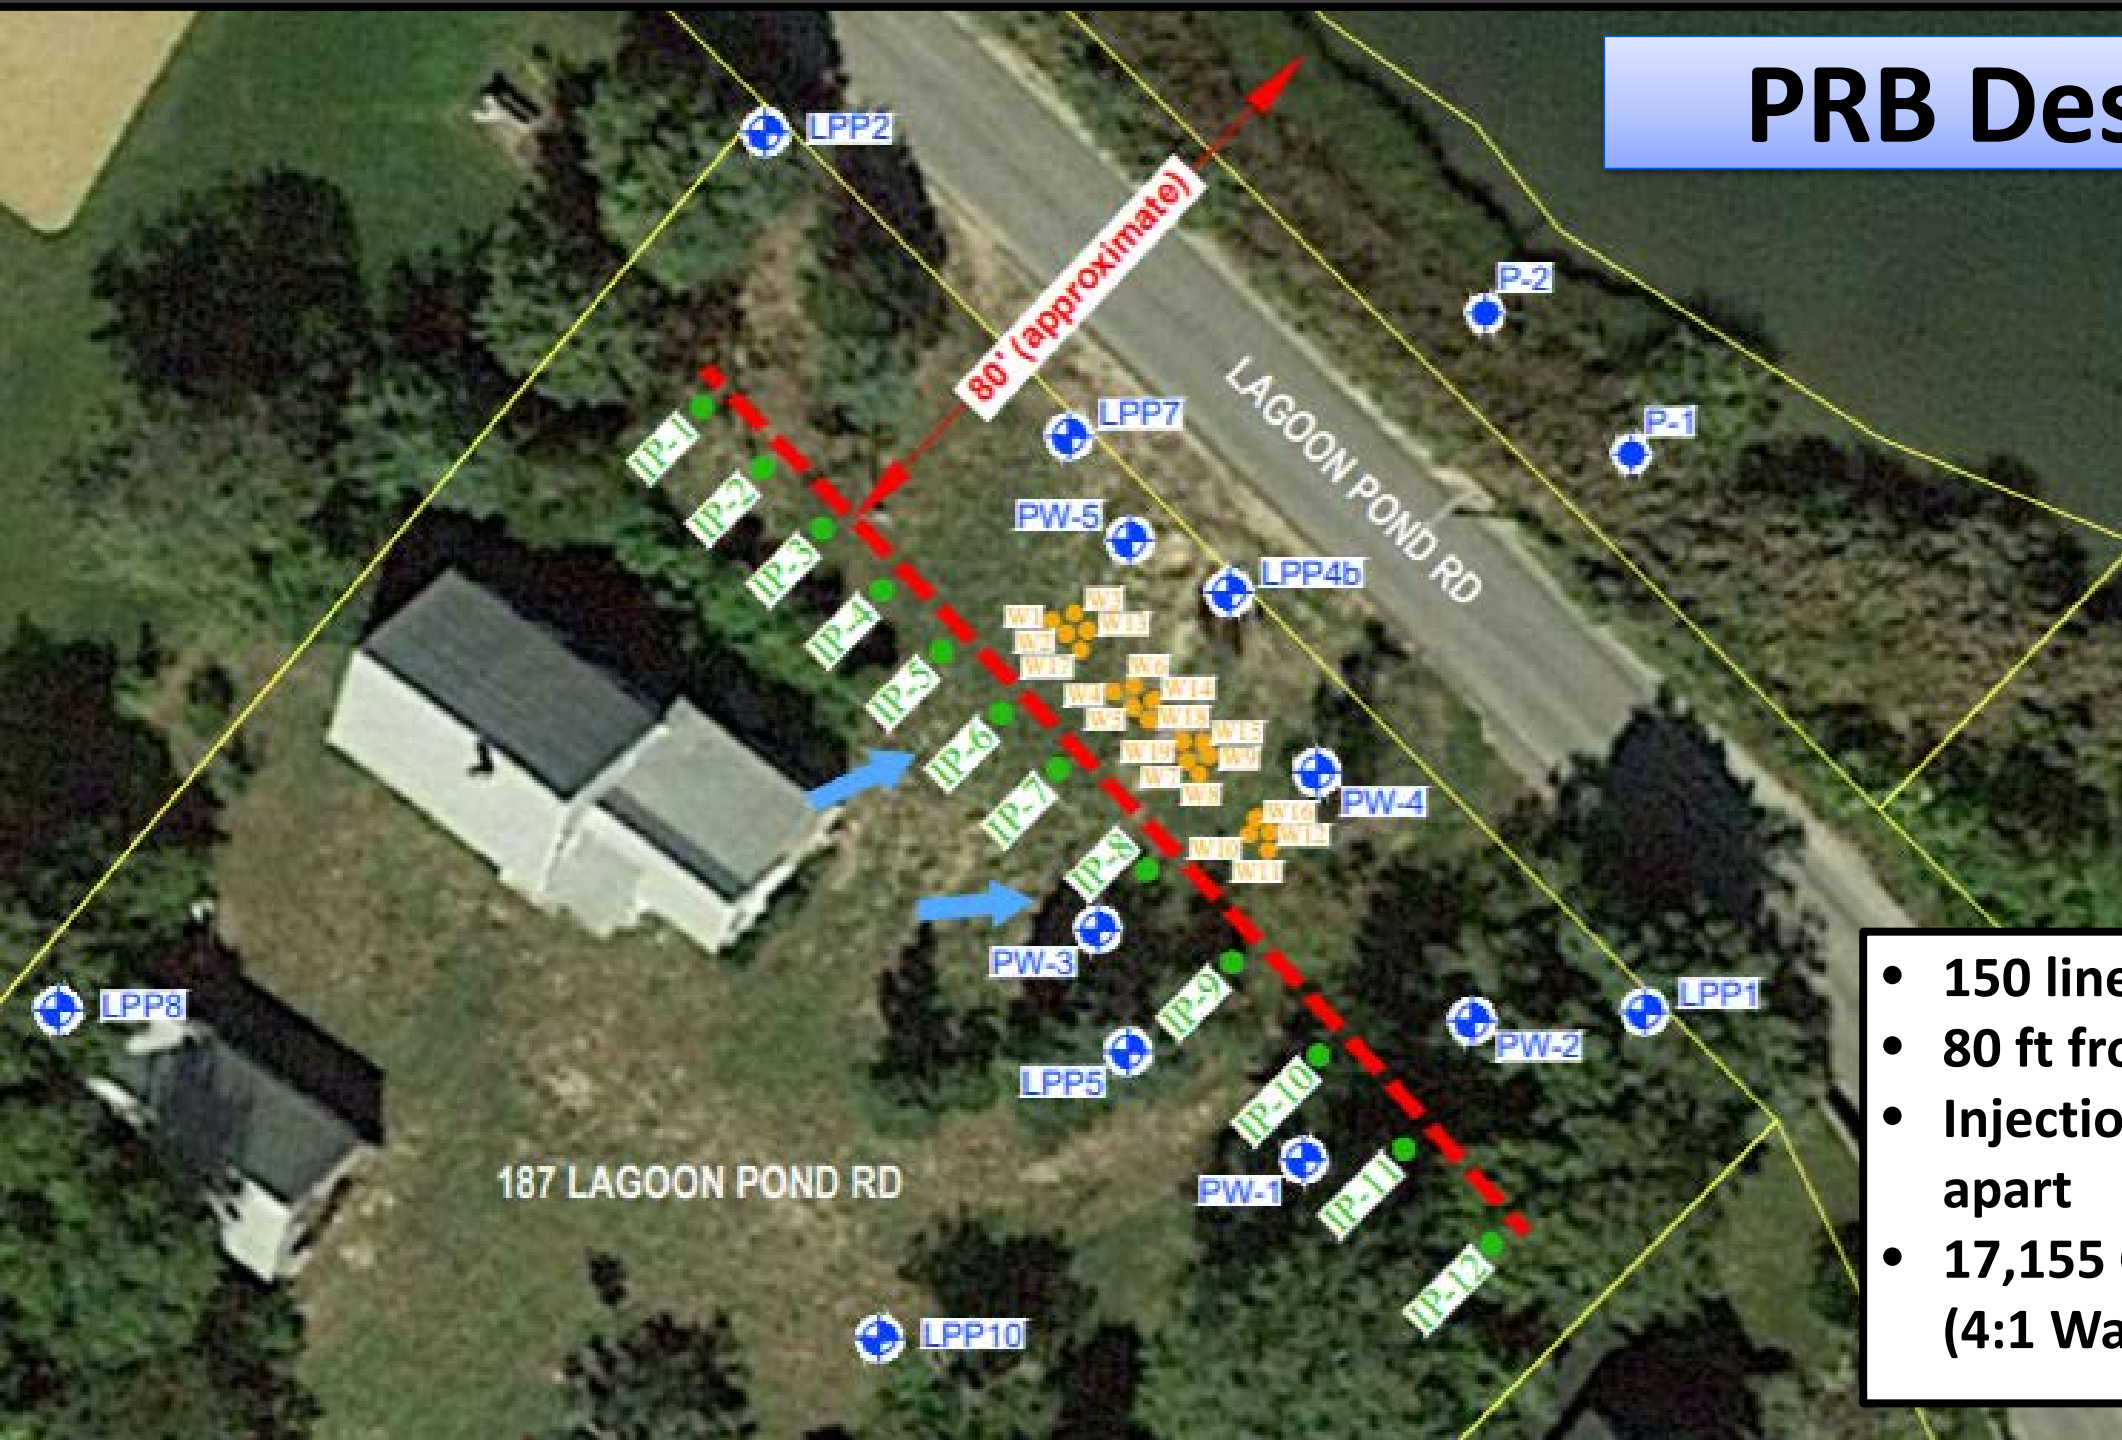
PRB Design

- 150 linear ft
- 80 ft from Pond
- Injections 10 ft & 15 ft apart
- 17,155 Gal Total (4:1 Water:EVO)
