Shoreline Change and Reef Development Analysis of a Restored Oyster Reef in Biloxi Marsh, Louisiana

Oyster Shell Recycling Program Coordinator, Coalition to Restore Coastal Louisiana (CRCL)

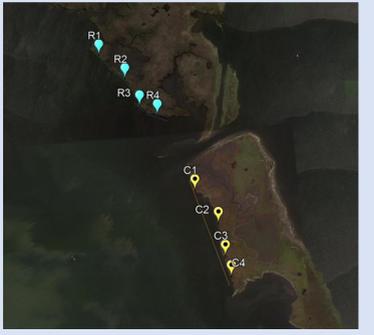
Reef (1-4) and control (5-8) sampling sites

- Sampling annually, during a low tide event (Dec. – Feb.)
- 8 sampling sites (4 reef, 4 control) marked by 5f PVC poles
- 12in diameter bucket filled to 10cm (7306.17 mL) with randomly collected reef substrate
- All live and dead organisms measured (mm), returned to reef
- Water quality measured 5m from the marsh edge
 - Temperature
 - Salinity (YSI)
 - Turbidity (Secchi disk)
- Analysis of reef development data in R Studio and Excel
