#### **City of Pawtucket**

# Green Infrastructure Installation in Transit-Oriented Development (TOD) District to Incentivize Economic Development and Assess Long-Term Maintenance

#### **SNEP Watershed Grants Final Progress Report**

# Green Infrastructure Maintenance QUICK REFERENCE GUIDE

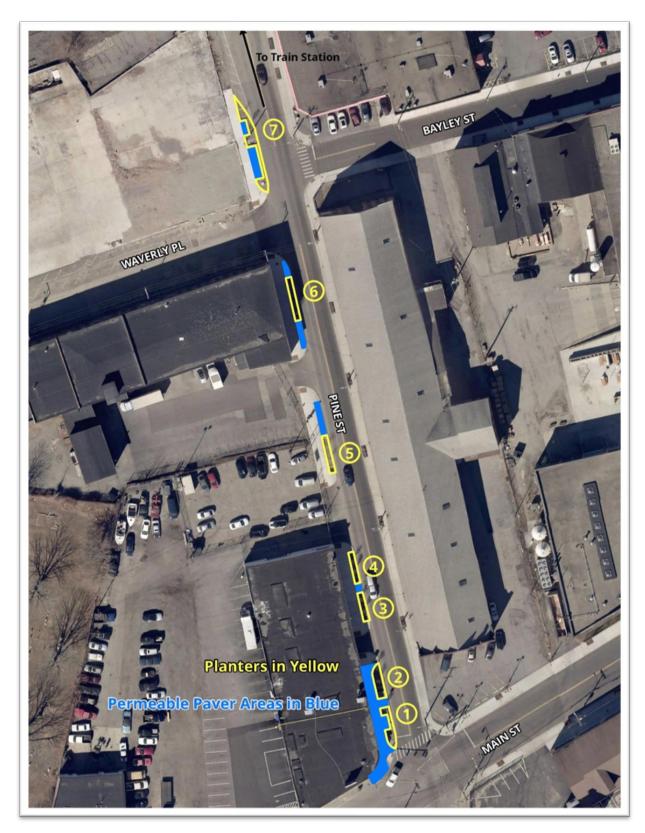
Figure 2: Locations of planters and permeable pavers along Pine Street.

The Pine Street GSI treatment system is composed of three key elements

- Pretreatment structures
- Planter beds and overflow structures
- Pervious pavers

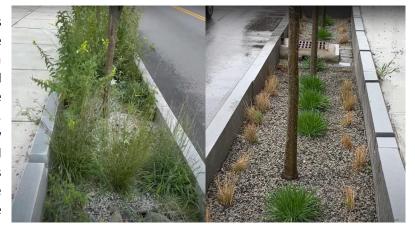
Figure 4. Overgrown planter bed (left) and freshly weeded planter bed (right).

Here, water infiltrates into a specially designed, high-performance soil media designed to filter bacteria and nutrients like nitrogen and phosphorus. Trash and sediment can clog the soil media and cause the beds to fail, so it's important to maintain these. Specially selected plants and trees provide both aesthetic quality and pollutant removal. These are plants were selected based on the light conditions on Pine Street, and on their ability to withstand the wet and dry conditions in the planter bed. These plants are hardy and native to New England but can get overgrown by weeds. Weedy beds have generated some public complaints, so maintaining a schedule for removal is key.

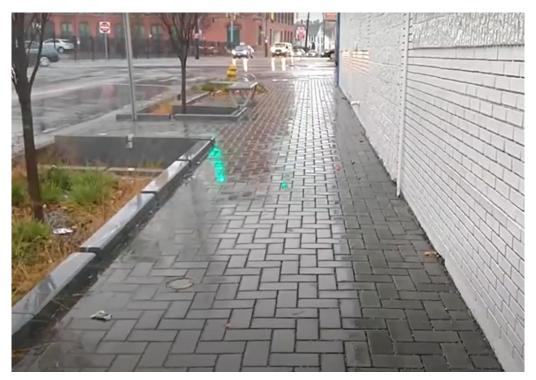
Figure 5. Pervious paver sidewalk

The third stormwater treatment element is the <u>pervious paver system</u>. In a few locations along Pine Street, the typical concrete sidewalk was replaced with pavers to allow stormwater to flow in between the stones and infiltrate into the ground. There's a reservoir of gravel under the pavers to store stormwater that would otherwise go into the planters or into the storm drains.

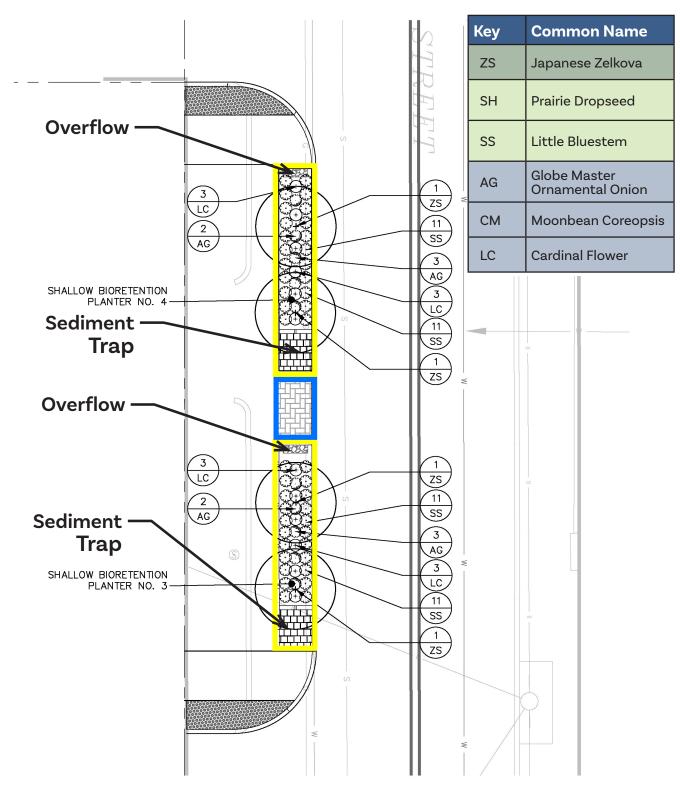
#### **PLANTING PLAN 5**

BIORETENTION PLANTER NO. 3 & 4

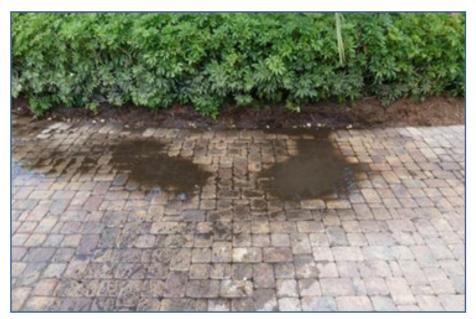
Ponding (more than an hour after rain) - Restore infiltration

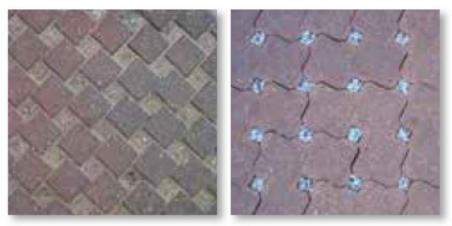
Covered joint material - Normal maintenance and replenish joint material
