**SNEP Watershed Grants
Final Report
February 28, 2022**

Project Name: Upper Bass River Restoration Project
Contract Number: #SNEPWG-20-8-FOBR

Evaluation of alternatives for replacement of the North Dennis Road Culvert and causeway over Bass River in Yarmouth, Massachusetts

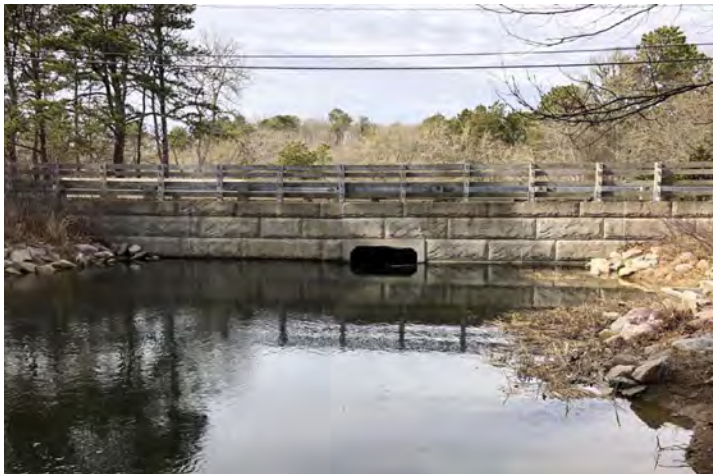
North Dennis Road currently

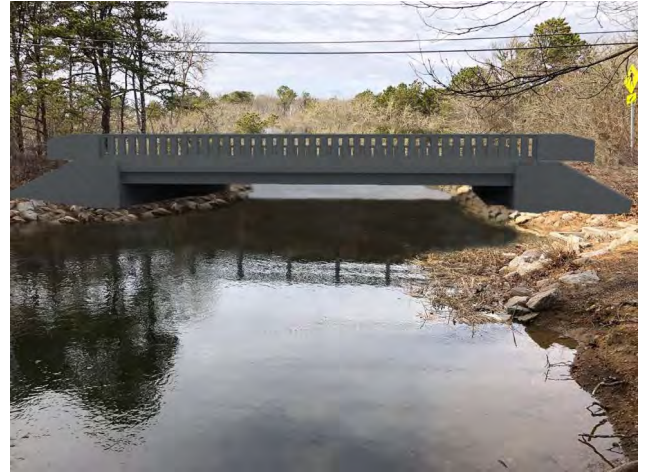
Photo Rendering of 60-foot span alternative

- Alternative 1: Replacement with a single span bridge to clear the banks of the river – estimated cost is \$3,260,000
- Alternative 2: Replacement with multiple culvert spans – estimated cost \$3,400,000

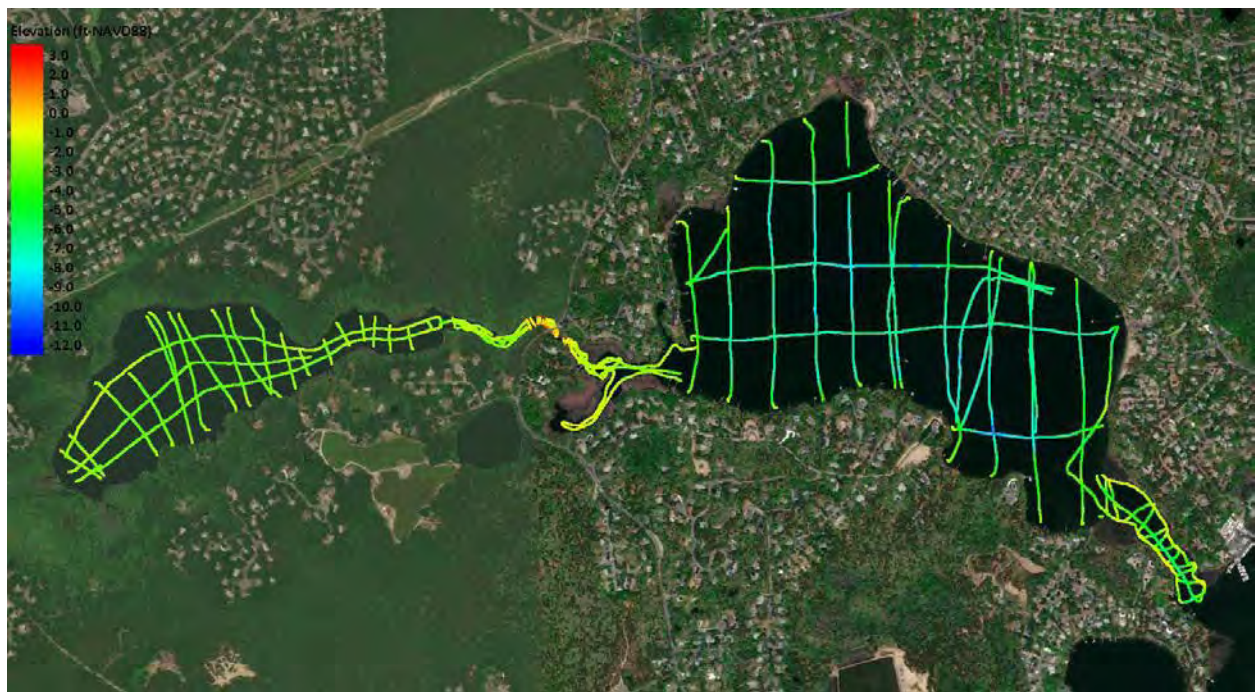
Figure 8. Hydrographic survey conducted on October 1, 2020.

The echosounder sends an acoustic beam that bounces off the river bottom to calculate the distance between the sensor and the channel bottom. The distance between the sensor and the riverbed was converted in elevations in ft- NAVD88 using the RTK GPS and correcting for the distance between the GPS and the EU D24 transducer. Additional bathymetric data in the section of Crab Creek downstream of the culvert was collected on October 21, 2020, using a pole mounted RTK GPS unit to get elevations in the shallower sections of Crab Creek and immediately upstream of the culvert as heavy fish shoals interfered with the echosounder.

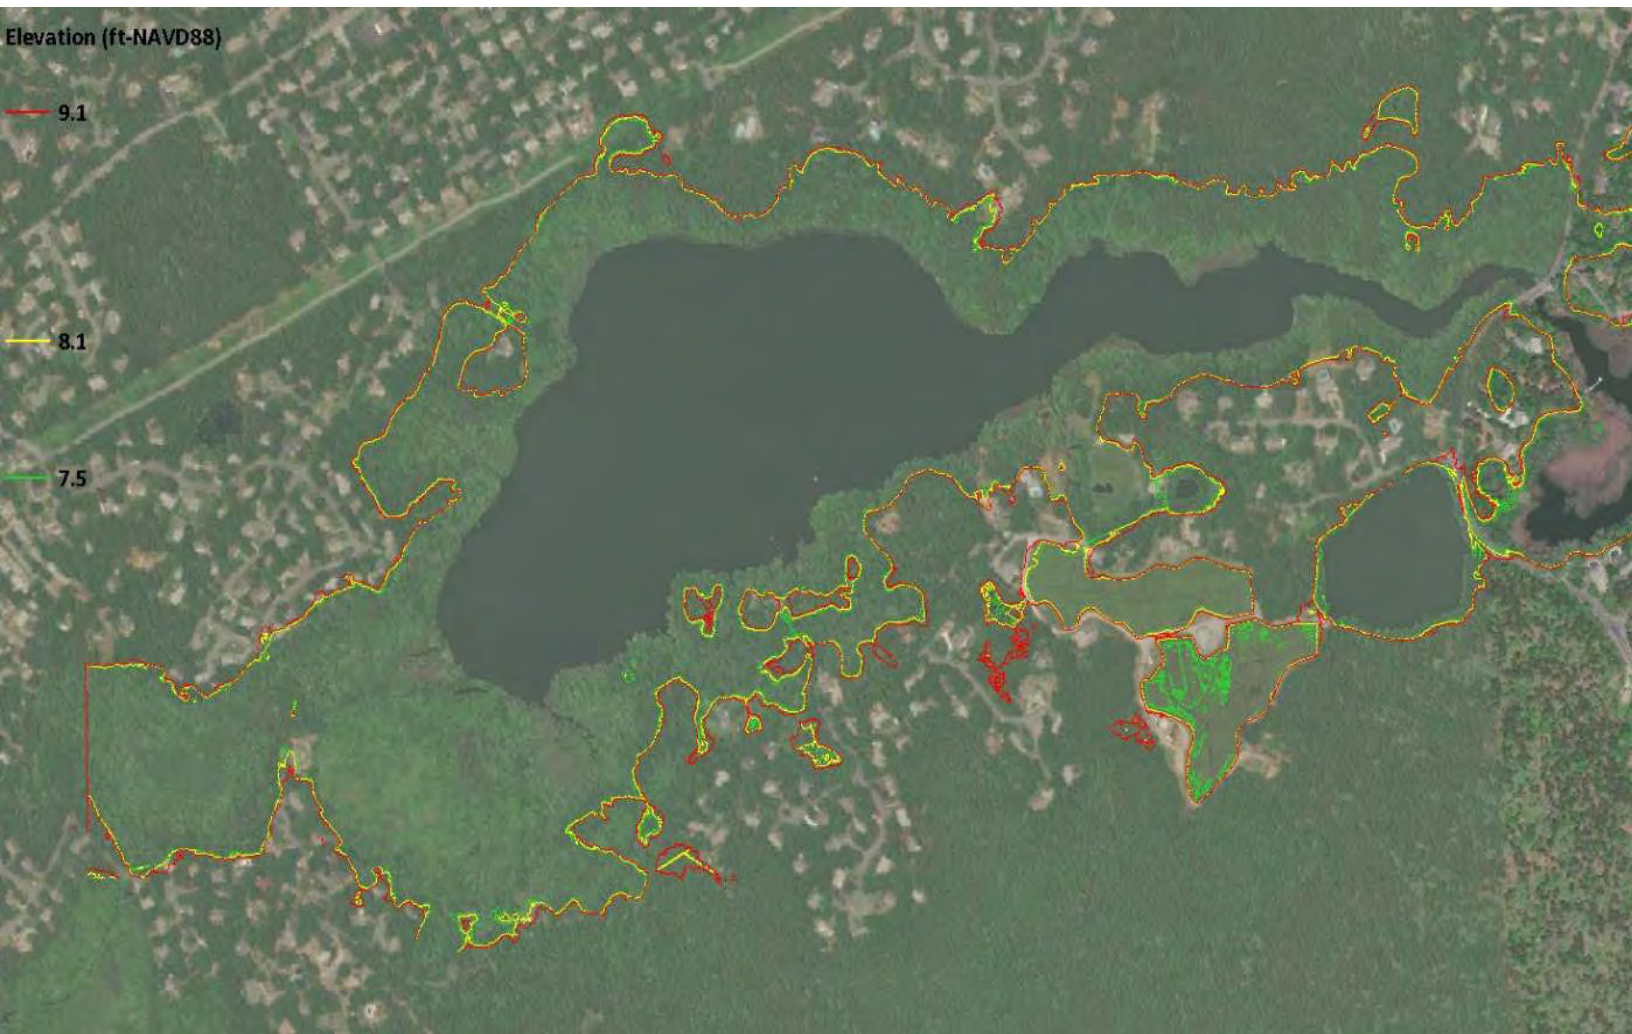
Figure 32. Contours of the 1% Annual Exceedance Probability (AEP) storm event. Red shows the FEMA flood elevation, yellow shows the modeled peak elevation with seiche, and the green line is the elevation from the Massachusetts Coastal Flood Risk Model (MCFRM).

- The 1% Annual Exceedance Probability (AEP) storm event, also referred to as the 100-year return storm, the bridge option did not change the flood risk to properties adjacent to Mill Pond as the current stream crossing at N. Dennis Road is expected to be overtopped with weir flow over the roadway.
- Contours of peak water levels are shown in Figure 32. The highest potential 1% AEP water level as specified by FEMA at 9.1 ft-NAVD88 are shown in red, the modeled 1% AEP for both existing and bridge alternatives at 8.1 ft-NAVD88 are shown in yellow, and the 7.5 ft-NAVD88 water surface elevation from the Massachusetts Coastal Flood Risk Model (MCFRM) are shown in green.

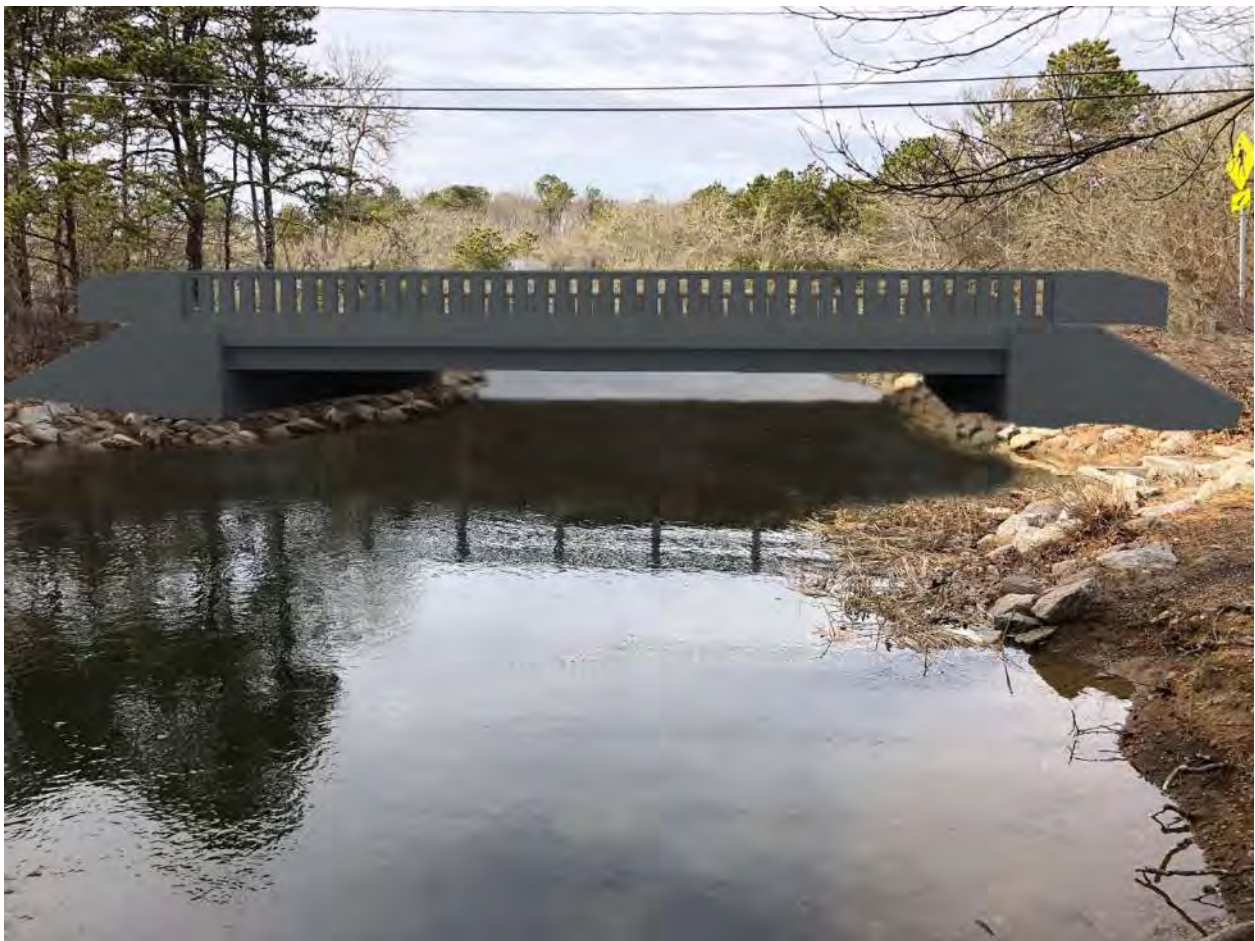
Photo Rendering of 60-foot span alternative

Deep foundations would be required due to the poor soil conditions and the history of scour erosion at the site. For the 60-foot span alternative, an advantage is that the piles and pile caps would be placed outside the footprint of the river. This would result in substantially less dewatering than constructing foundations in the stream, and would likely simplify the permitting process. While a detour is assumed for the purposes of this study, piles could be driven using lane shifts and buried below the roadway to maintain traffic through the site prior to replacement. Accelerated Bridge Construction could be implemented depending on traffic needs using precast prestressed NEXT beams and closure pours.

Considering biologic performance of the River, a 60-foot span bridge is preferred over a multi-span structure to satisfy the desired nutrient flushing of the upstream Mill Pond. Additionally, MARSCS would be satisfied with this alternative.

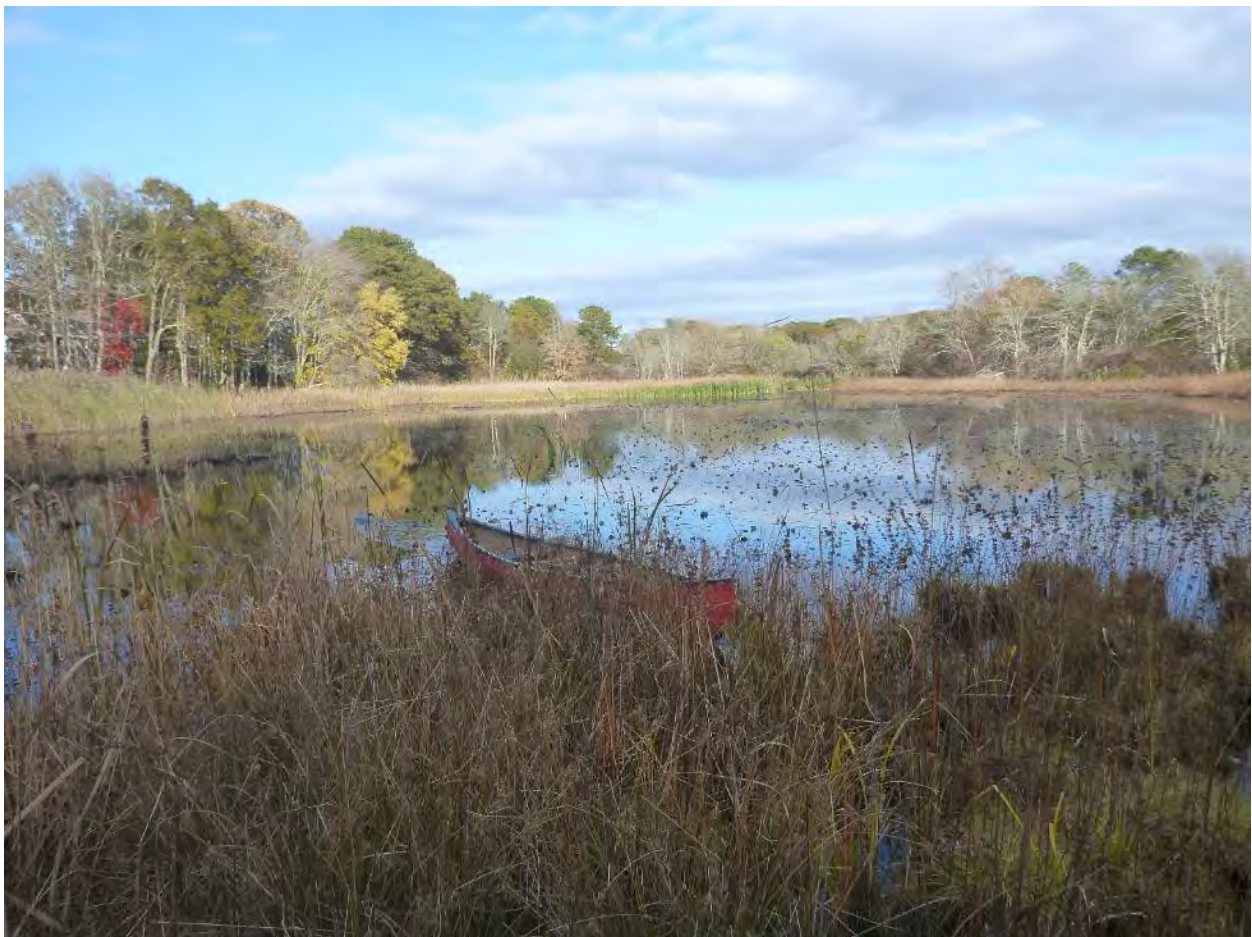
Figure 2. Miss Thatcher's Pond

Miss Thatcher’s Pond is the upstream extent of the Project Site, with a surface area of approximately 0.8 acre (Figure 2). According to historical records, farmers excavated the wetlands to create a pond they could use as an irrigation source for their cranberry bogs. The pond has a maximum depth of 4 feet and the average depth is approximately 2.5 feet.

Miss Thatcher’s Pond is divided into two main components. The southern portion is larger and deeper and was the primary water source for farming. The northern portion was a cranberry bog before being converted to a pond between the 1930s and 1970s. Historical topographic maps from the U.S. Geological Survey show the pond having two outlets: one flows north very close to the location where Hamblin’s Brook enters Miss Thatcher’s Pond and one flows into the project area to the east (Figure 3). The outlet to the north has been abandoned, and we were unable to locate the ditch during the site assessment. Portions of the ditch have been filled in, and houses have been built on top of the fill along Seminole Drive and Starbuck Lane. North of Starbuck Lane, we were able to identify the ditch, but the culvert under the road was not present or likely filled in through road reconstruction and housing development. The fish ladder at the eastern outlet of the northern portion now controls water levels of the pond (Figure 4). The fish

Many areas of Miss Thatcher's Pond have filled in with organic material and aquatic vegetation, resulting in low levels of dissolved oxygen and elevated water temperatures. Water warmed in Miss Thatcher's Pond flows downstream, degrading water quality through the rest of the Bass River watershed. While conducting our survey and site assessment, we observed ducks, geese, and swans in Miss Thatcher's Pond. One resident spoke about large snapping turtles that he observed in the pond. Though no records are available, we assume that warm-water fish species currently live within the pond.

Along the northern and eastern edges of Miss Thatcher's Pond, an earthen berm was created to maintain water levels and separate the pond from Cells 2 and 4. This earthen berm remains intact, though portions of the berm are showing signs of deterioration with erosion around disused flow control structures. Two flow control structures had historically carried water from the pond to the cranberry bogs to the north, but these culverts have filled in and no longer support flow. A former pump house was located on the earthen berm with only a portion of its concrete walls now remaining.

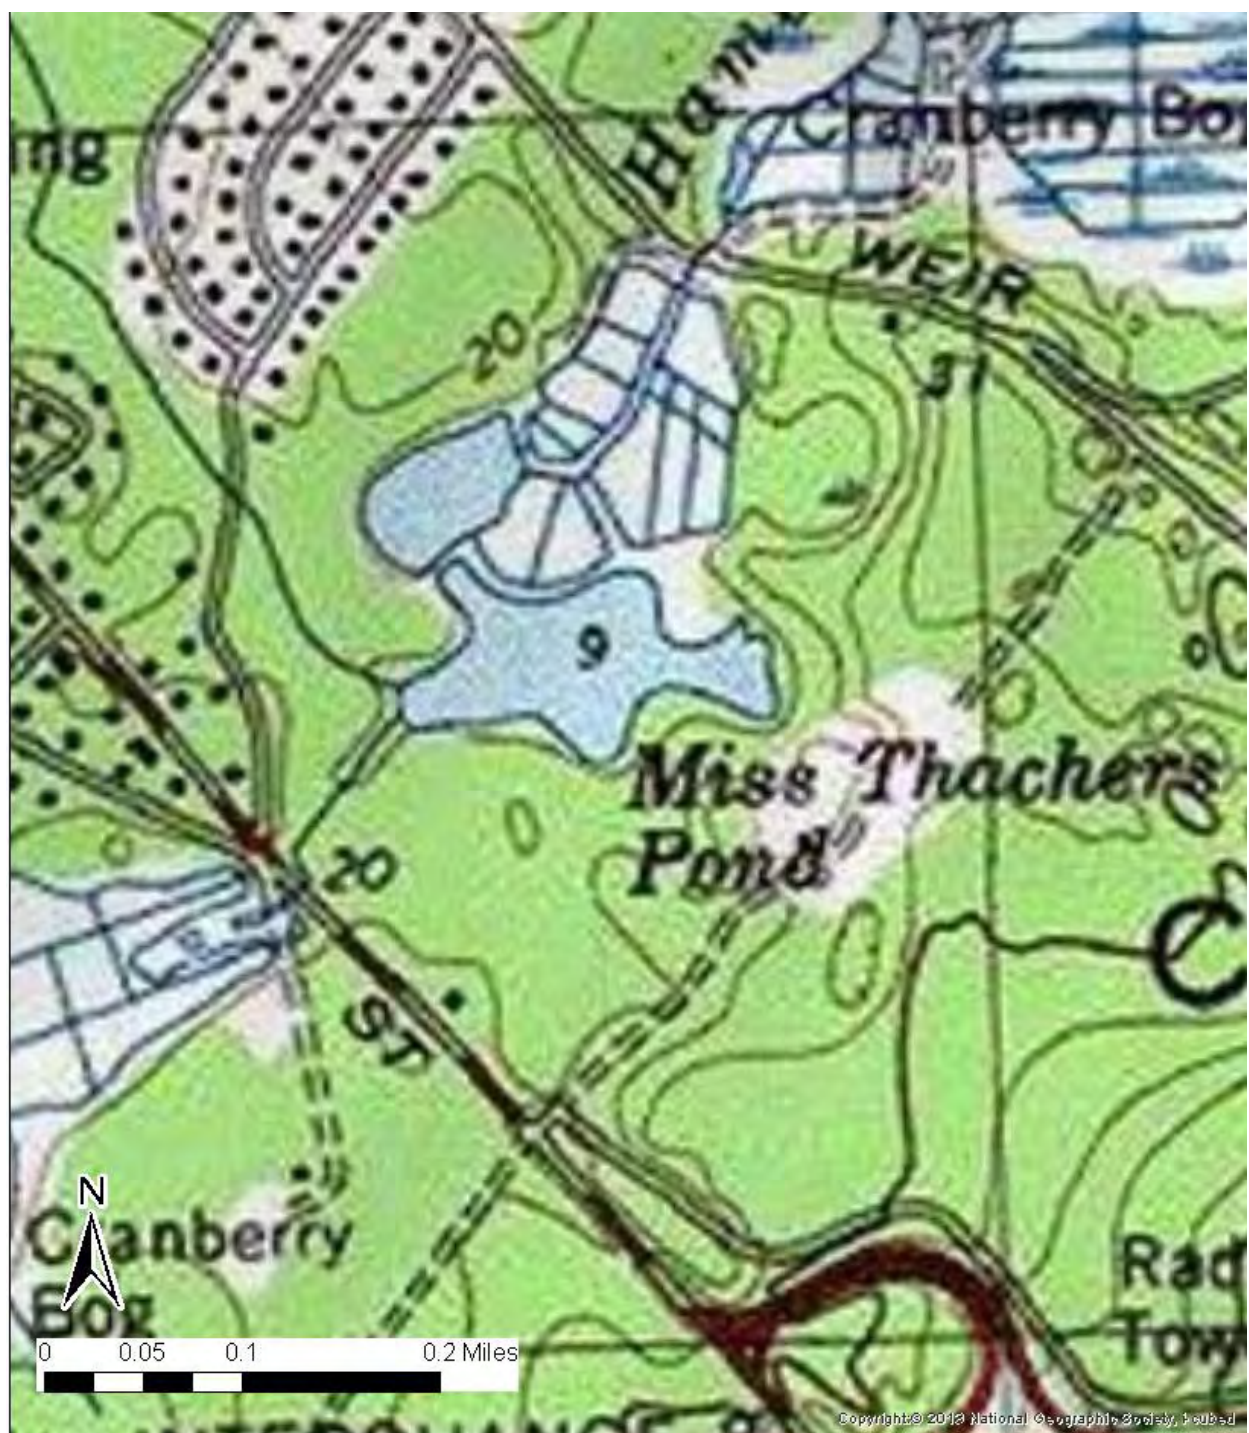
Figure 3. U.S. Geological Survey topo map of Miss Thatcher's Pond, 1940s.

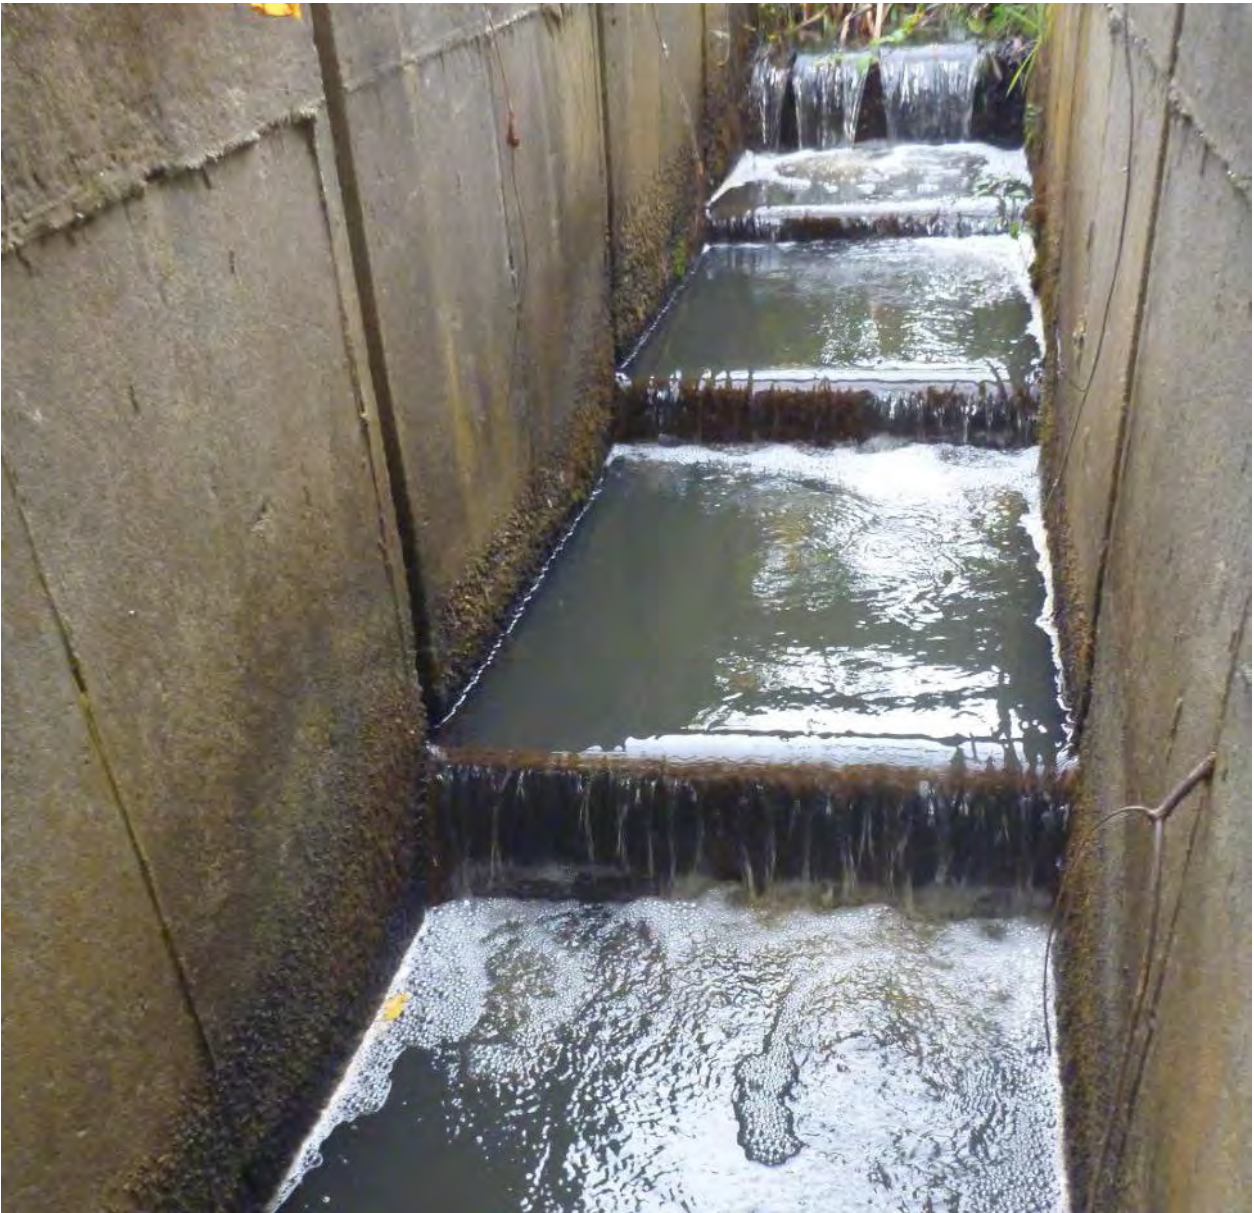
Figure 4. Miss Thatcher's Pond outlet and fish ladder

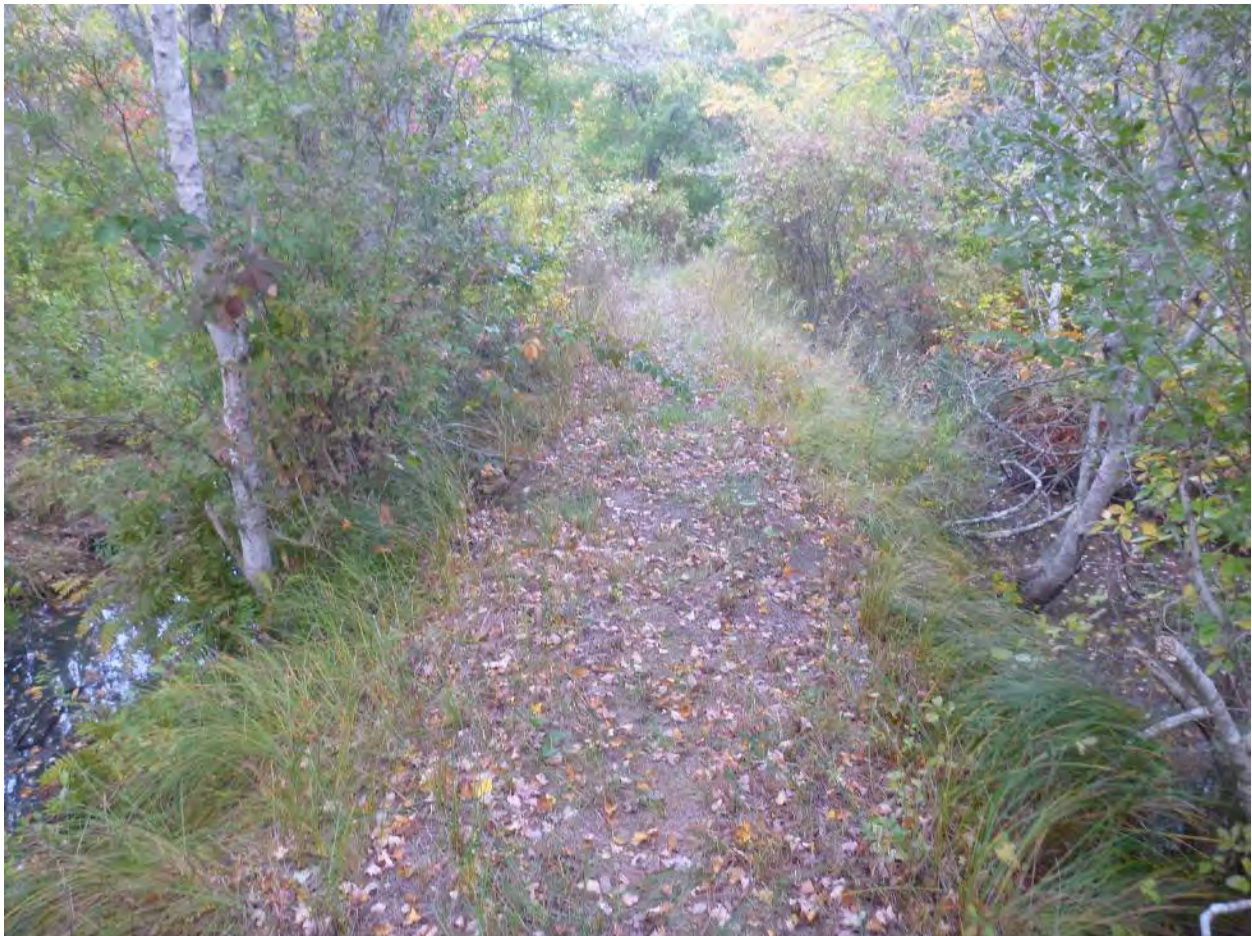
Figure 5. Looking downstream along the top of a levee separating Cells 1 & 3 from Cells 2 & 4. The main channel within the Project Site runs along the left toe of the levee in Cell 3.

Much of the cranberry bog landscape is now a mix of hummocks of vegetation and deep pockets of water. The vegetation in Cells 1 & 3 is a mix of sphagnum moss, shrubs, and red maple saplings over 20 feet in height. In Cells 2 & 4, higher water levels limit woody growth and vegetation is mainly herbaceous, primarily grasses, rushes, sedges, and sphagnum moss.

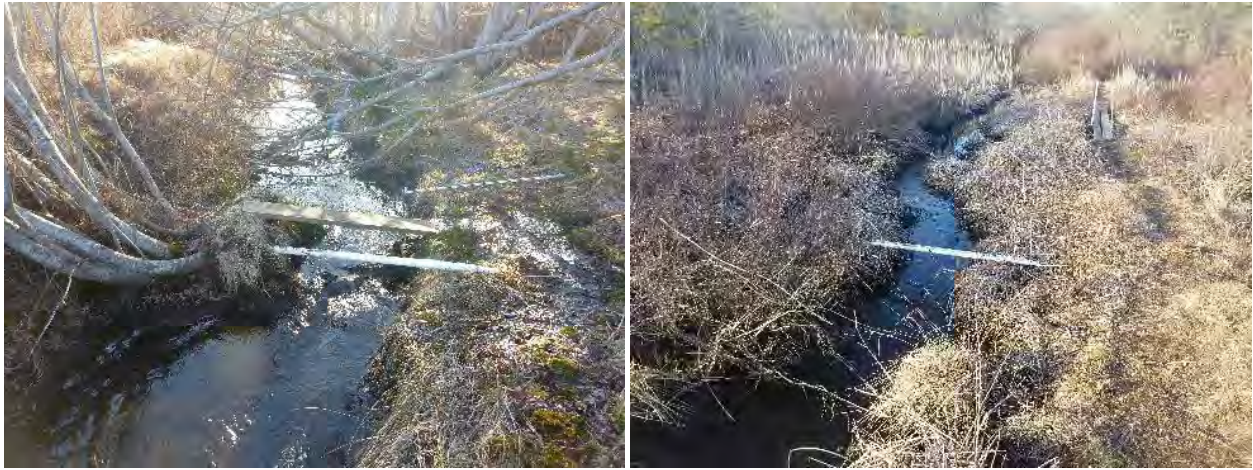
Figure 6. Approximately 75 feet downstream of the fish ladder at Miss Thatcher's Pond, vegetation and roots have constrained the channel to be approximately 4 feet wide at the top of bank (left). Further downstream, the effective flow through the hummocky vegetation is approximately 4 feet wide at the top of bank (right).

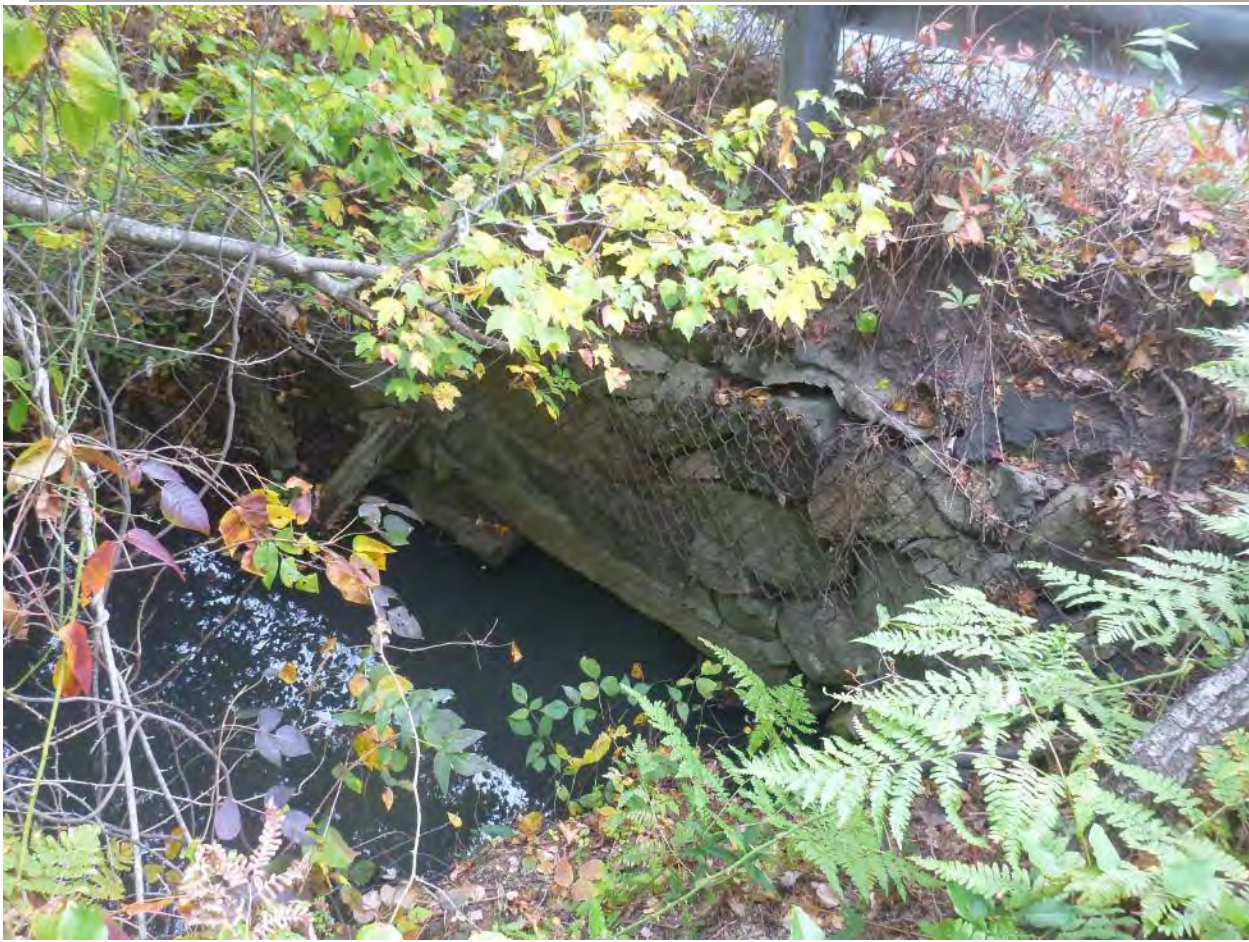
Figure 7. Culvert at Weir Road

The Weir Road culvert, a stone masonry box culvert, has partially collapsed. On the downstream side of the road, the existing opening is 3.2 feet wide and 2.5 feet tall. On the upstream side of the road, the existing opening is 1.8 feet wide and 2 feet tall. The weir road crest elevation is 10.7 feet. In addition to its poor physical condition, the culvert restricts flood flows and elevates water levels upstream. Weir Road is classed as an Urban Local Road/ Rural Minor Collector. It mostly serves the residential areas that surround it.

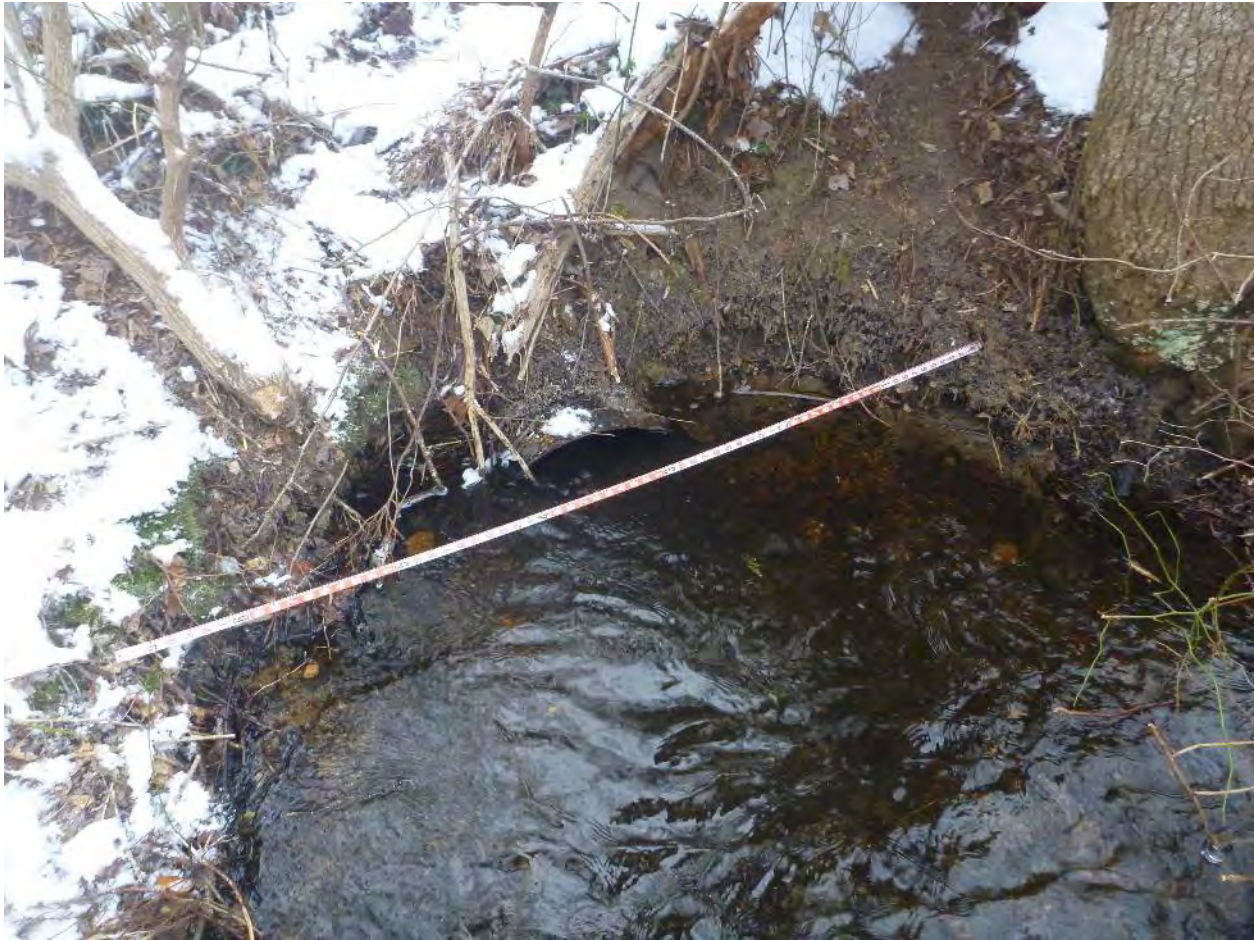
Figure 8. Looking upstream at the 18-inch corrugated metal pipe under the earthen berm and walkway between Cheyenne Lane and Knollwood Drive

At the downstream end of Cell 5, the channel flows through an undersized, 18-inch corrugated metal culvert beneath the earthen berm and walkway between Cheyenne Lane and Knollwood Drive (Figure 8). The culvert is partially filled and restricts flows, increasing the water elevations upstream of the crossing.

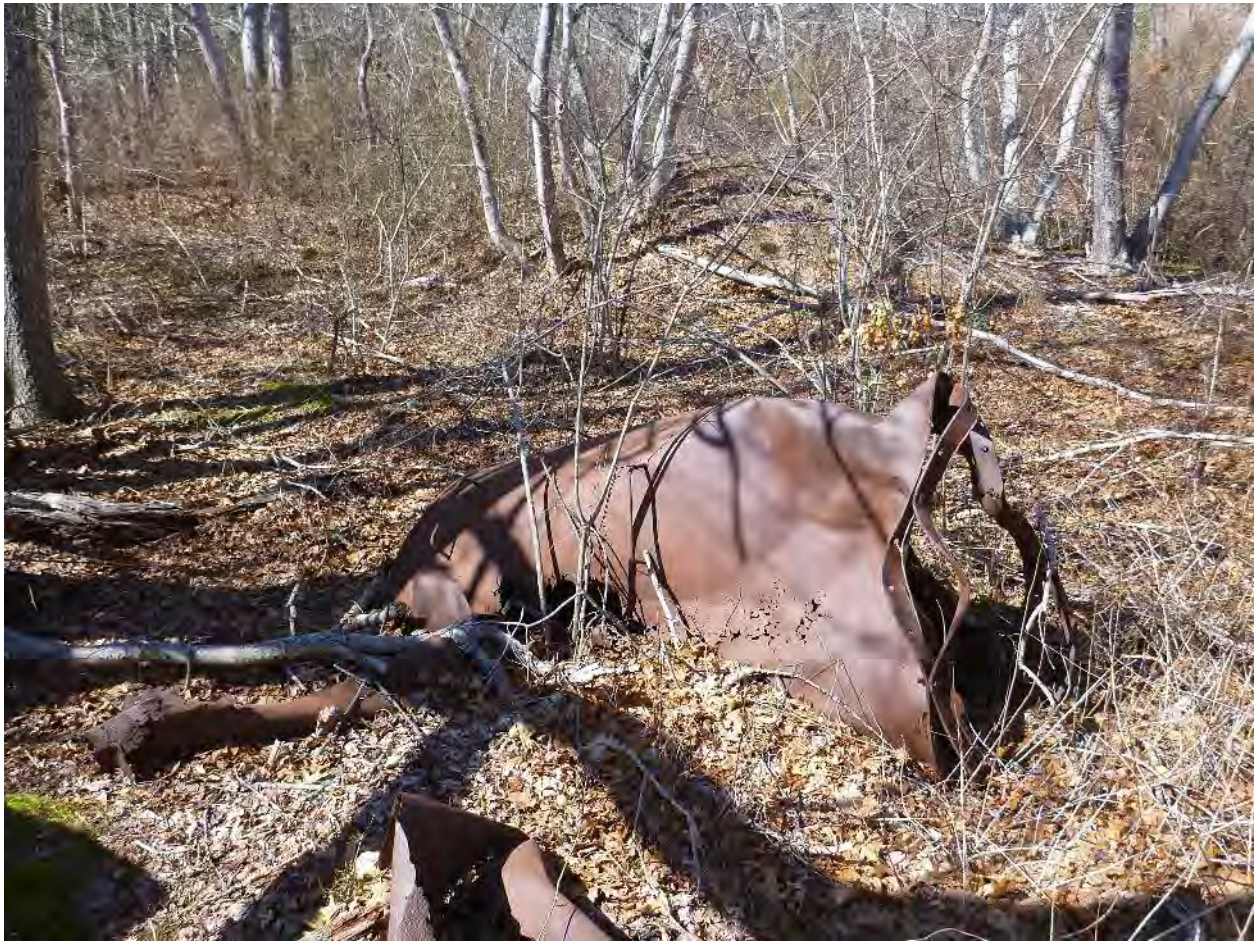
Figure 9. Abandoned farm equipment and mounds from excavating a farm ditch.

To the south, is another abandoned cranberry bog with wetland vegetation growing throughout (Cell 7). Ditches have filled in with sphagnum moss and other vegetation. In the wetter areas, shrubs and herbaceous plants thrive while maple and pitch pine trees grow in the drier areas. Groundwater from the nearby hillslopes flows through the ditches of this abandoned bog and into Mill Pond under the earthen berm and path.

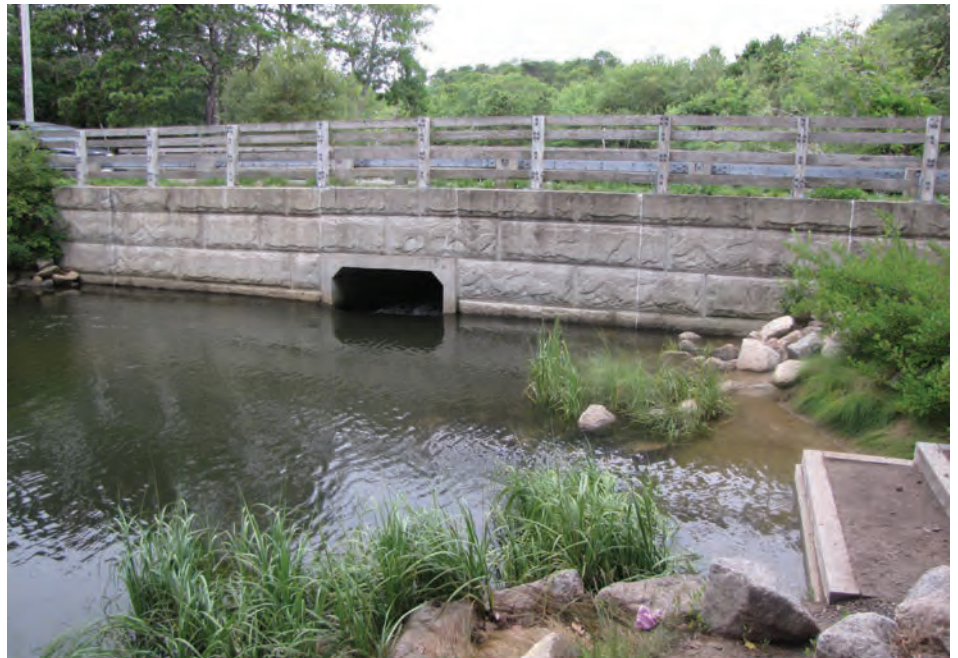
This view of the North Dennis Road bridge over Crab Creek may look bucolic, but the reconstruction of a bridge just south of the Mid-Cape Highway to carry a westward extension of the Cape Cod Rail Trail inadvertently changed the tidal flow of the river, damaging its Crab Creek branch.

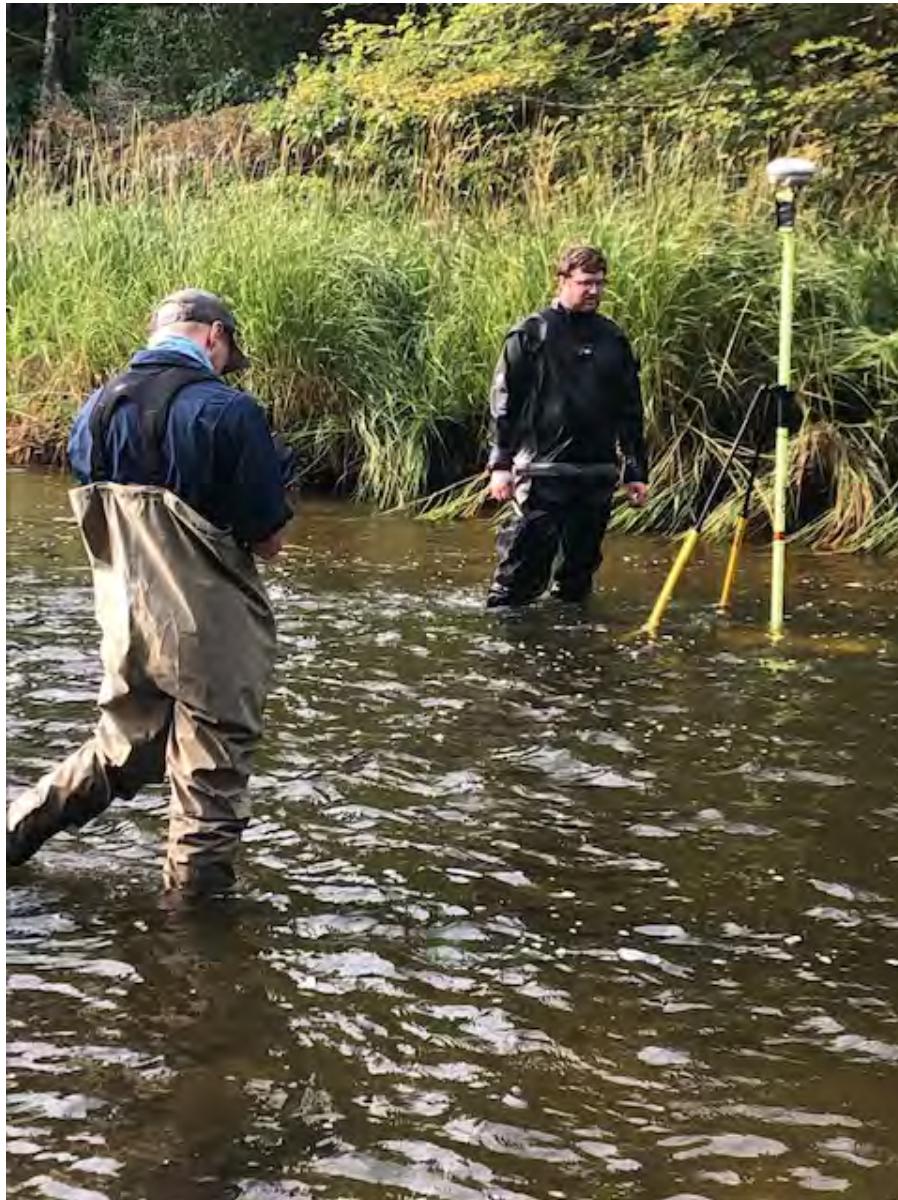
DEPLOYMENT OF THE AQUA-TROLL A200

The Aqua-Troll A-200 is a remote data logger that measures and records water level and

WHG will be on site for the next few weeks making detailed surveys. This data will help the WHG with their summary of current conditions & to make recommendations for improvements to the Culvert at Crab Creek & Weir Road.

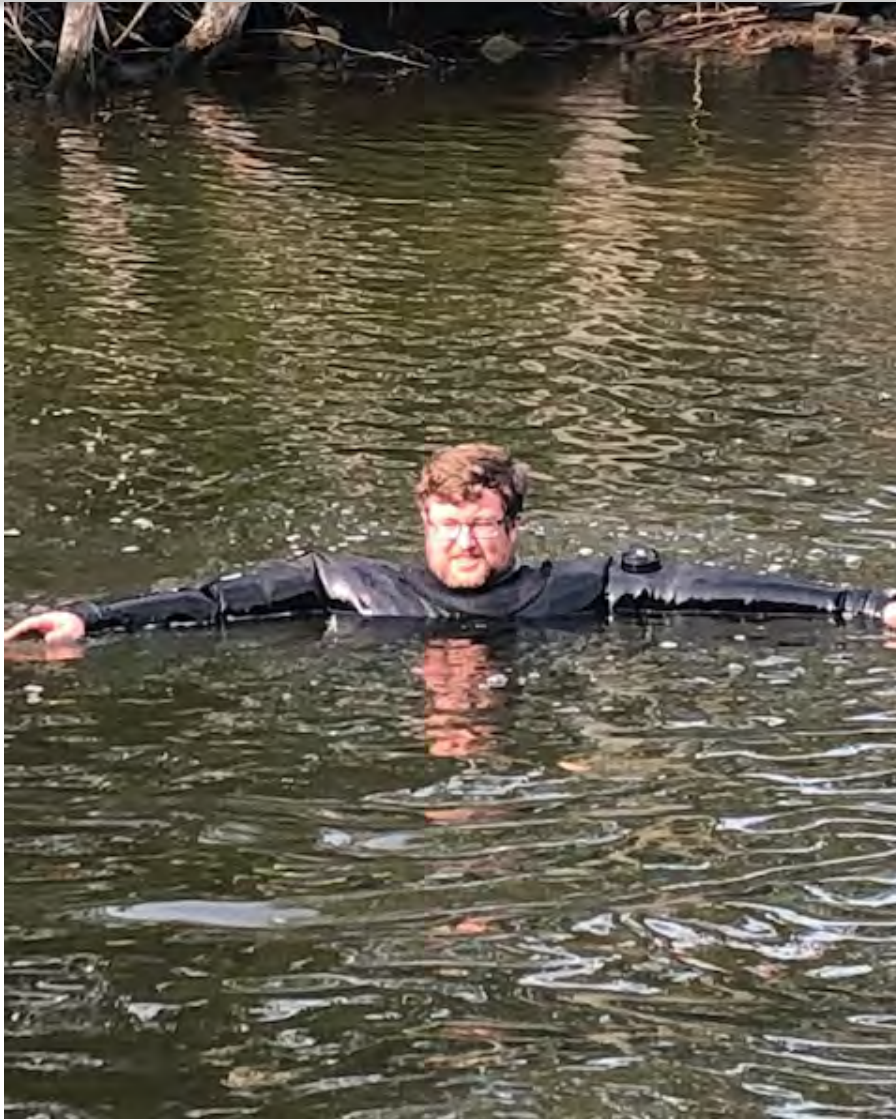
Zach is over 6 feet tall. Here he is working just west of the North Dennis Road overpass. The scouring from increased flow through the narrow culvert has created a over 6' deep!
