Black Brook Stream Crossing Assessment

FINAL REPORT

BLACK BROOK STREAM CROSSING ASSESSMENT

Aquinnah, Massachusetts

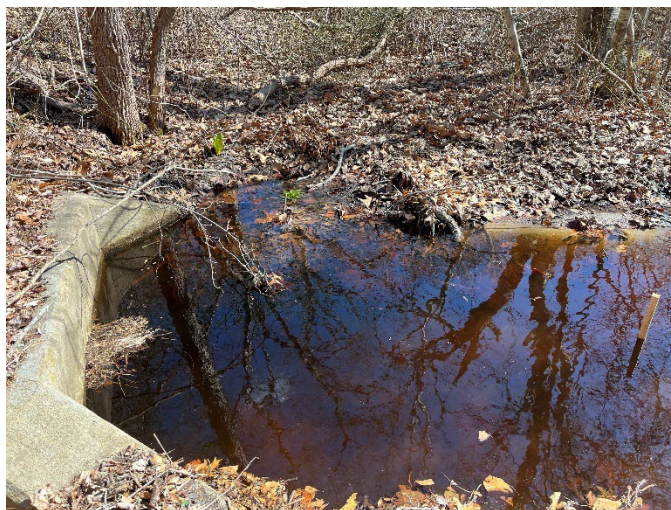
The Moshup Trail Culvert is a 73' long, 3' in diameter reinforced concrete pipe installed with a 3% slope. Horsley Witten Group (HW) conducted an assessment of the town owned culvert including the collection

The water level data showed that during high flow events the culvert creates a considerable flow restriction causing water to back up upstream of the structure. A scour pool has developed downstream of the culvert that had approximately 1' of accumulated sediment at the time of HW's site visit. Sediment samples collected showed that sediment in the Black Brook is essentially free of contaminants.

The Moshup Trail culvert is undersized, not embedded, does not have a natural bottom and does not meet the openness ratio. HW presented two alternative culvert replacements that meet Massachusetts Stream Crossing Standards and improve flow and passage for aquatic animals. To meet the openness ratio two culvert sizes were proposed, both of which would be embedded 2' to provide a natural stream bottom. One alternative is a 10'x8' box culvert (PR M1) and the other is a 16'x6' box culvert (PR M2).

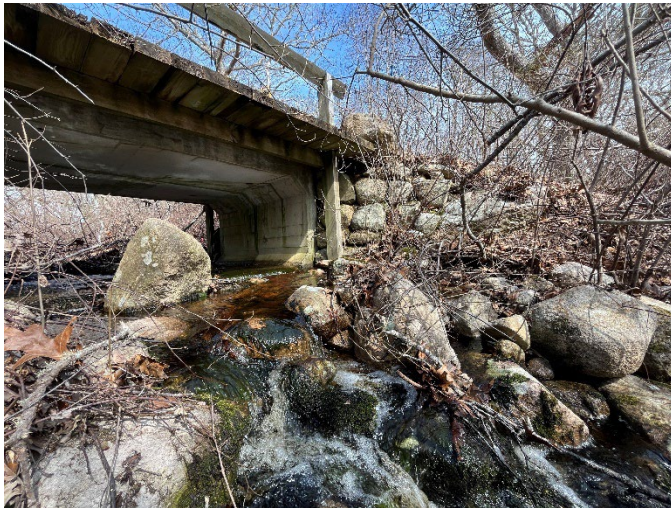
Interior Vehicular Crossing

The interior bridge crossing consists of a 12.5' x 14' x 4' concrete box culvert. HW conducted an assessment of the interior vehicular crossing owned by Sheriff's Meadow Foundation and the Martha's Vineyard Land Bank over which the abutters have an access easement. Data collected included the collection of existing conditions data, a site survey (including a longitudinal profile, stream cross sections and bankfull width), streamflow measurements, water level monitoring, soil boring, sediment sampling and resource area delineations. The water level data collected was used to support hydraulic modeling and to develop alternatives and preliminary replacement design.

The culvert bottom is slightly sloped creating varied elevation and flow depth across the culvert. The culvert is perched and not embedded. Both ends of the culvert are slightly perched 6-9' above the stream bed in the immediate vicinity and 2' above the natural stream bottom. The field stone wingwalls have also partially collapsed into the stream further creating obstacles and supporting the accumulation of debris.

embedment which does not meet Standards but is an improvement over the existing conditions. The second alternative proposed is to replace the existing culvert with a 12x6 concrete box culvert which meets Massachusetts Stream Crossing Standards. The third alternative is to leave the existing box culvert and create a series of rock weirs downstream of the culvert spanning the hydraulic gap and creating fish passage.

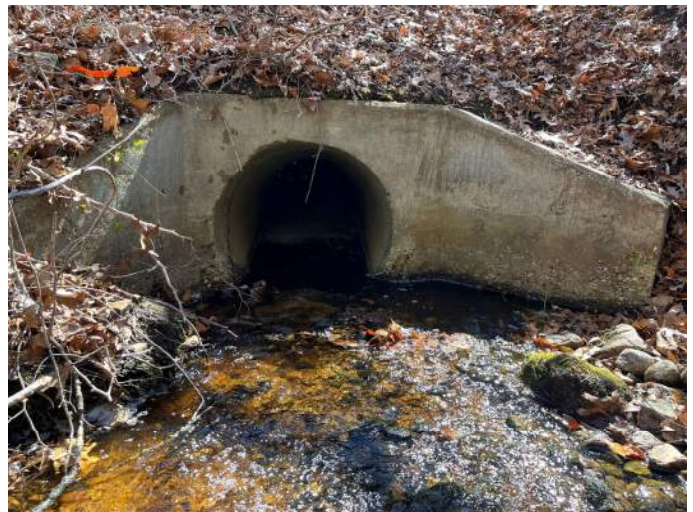
Image 2. Moshup Trail Crossing Upstream Culvert (March 19, 2024)

The culvert crossing beneath the roadway consists of an approximately 73-foot long 3-foot diameter reinforced concrete pipe (RCP) with approximately 12-foot wide and 4-foot tall concrete headwall/wingwall ends. The culvert was observed to be in good physical condition, however, the stream morphology immediately downstream of the culvert outfall transitions to a scour pool before reverting to a more natural condition further downstream, indicating that velocity outflow from the culvert is likely excessive during higher flow conditions. Material removed from scour pool during high flow events was observed accumulated immediately downstream. The upstream and downstream inverts of the culvert pipe are vertically situated at elevations 42.53 feet and 40.33 feet, respectively. The downstream culvert outfall was almost entirely submerged by the water level in the scour pool at the time of HW's site visits, with backwatering extending partially up the culvert pipe and approximately one foot of accumulated sediment present in the culvert pipe outlet.

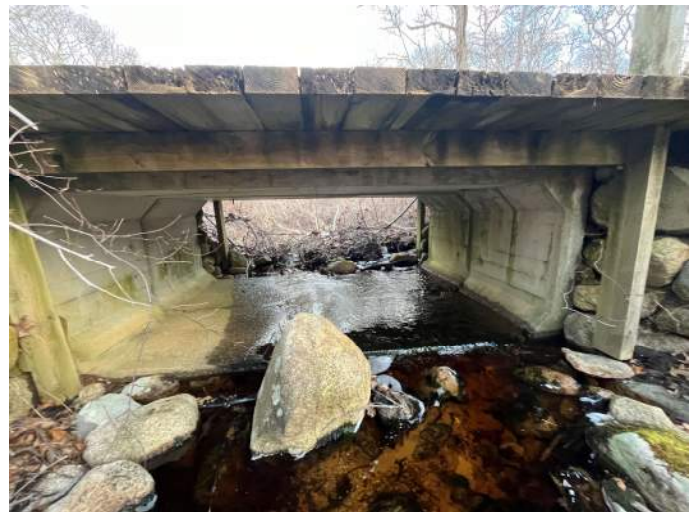
A wooden vehicle crossing over Black Brook is located approximately 1,700 feet downstream of Moshup Trail, on an SMF/MVLB-owned dirt road. The vehicle crossing construction features a 12.5-foot wide by 4-foot tall concrete box culvert set slightly above the stream bed grade, with a wooden timber deck and railing spanning the stream on top of the box culvert structure. At the time of HW's site visits, stream flow was limited to the left side of the box culvert, as depicted in Image 3. Boulders and rocks from the left bank of the crossing have fallen into Black Brook, capturing wooden/organic debris and further restricting flow.

Image 3. Wooden Vehicle Crossing Downstream Culvert (March 19, 2024)

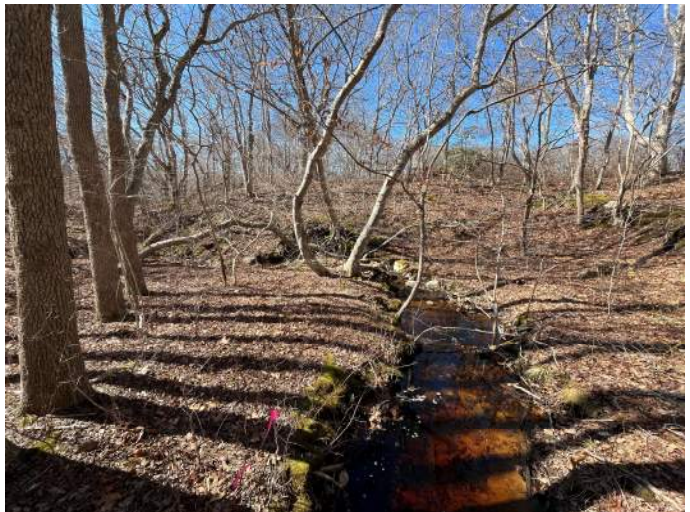
Image 4. Black Brook north of Moshup Trail (March 20, 2024)

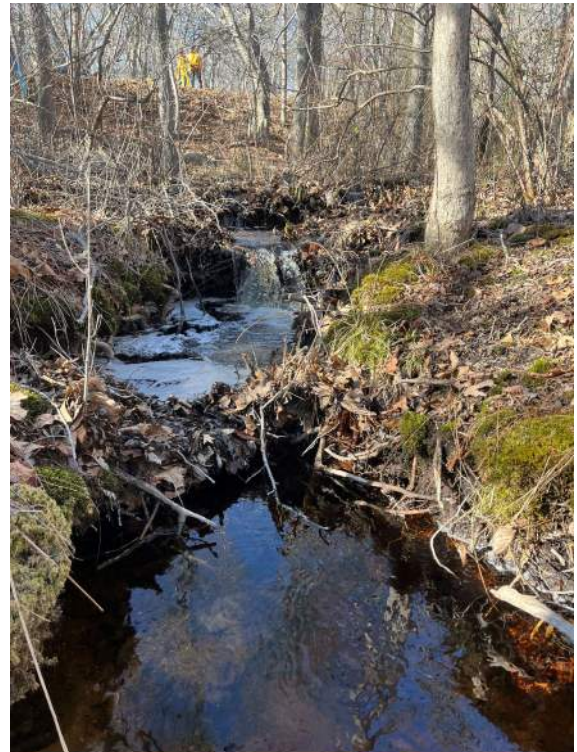
Bankfull width is typically measured both upstream and downstream of hydraulic restrictions within a watershed. HW staff measured natural bankfull widths at three locations in the Project Area, beginning approximately 100 feet upstream of Moshup Trail, and continuing further downstream. Bankfull width estimates are summarized in Table 1 and average 5.25 feet.

Image 5. Typical Bankfull Width Segment Location

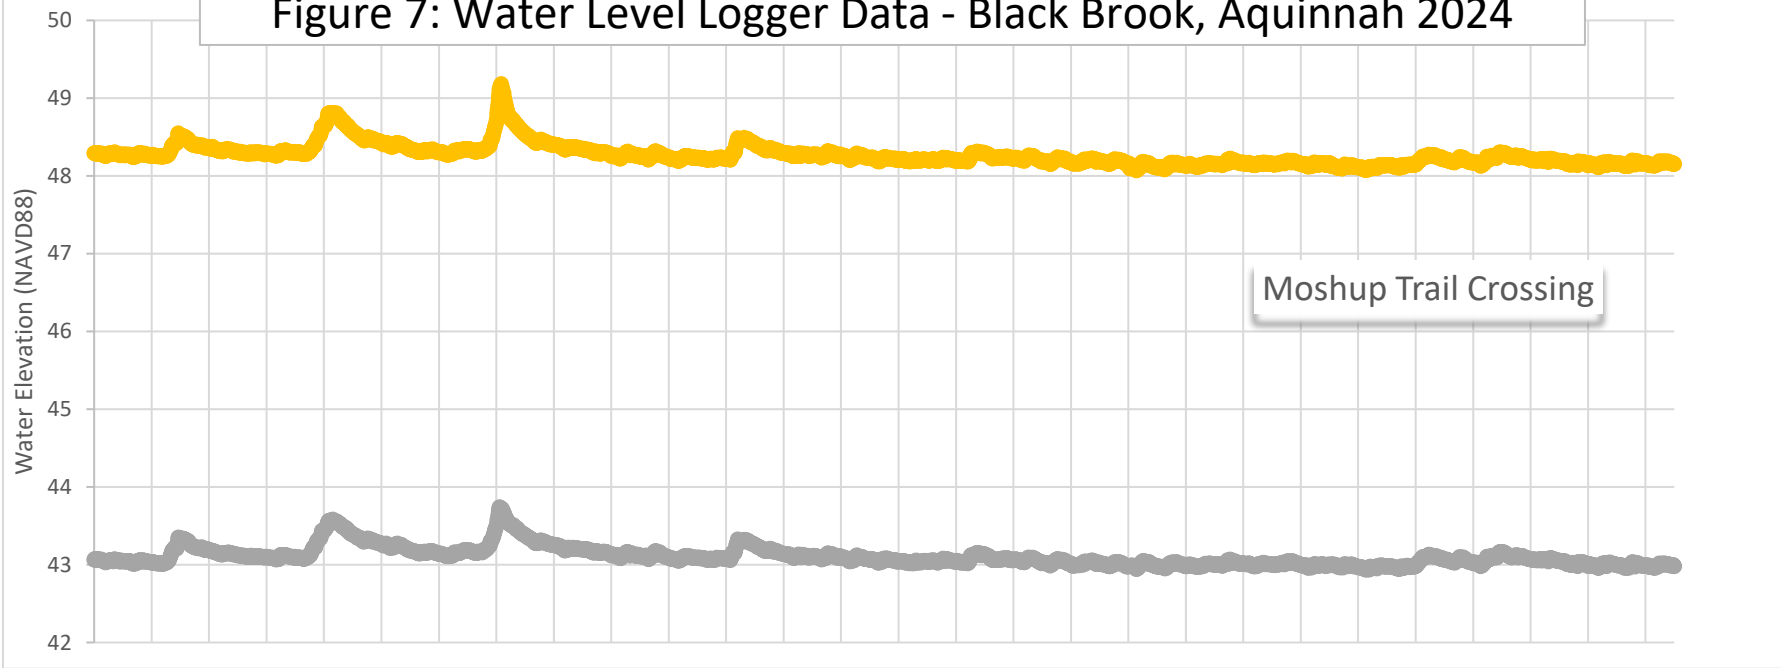
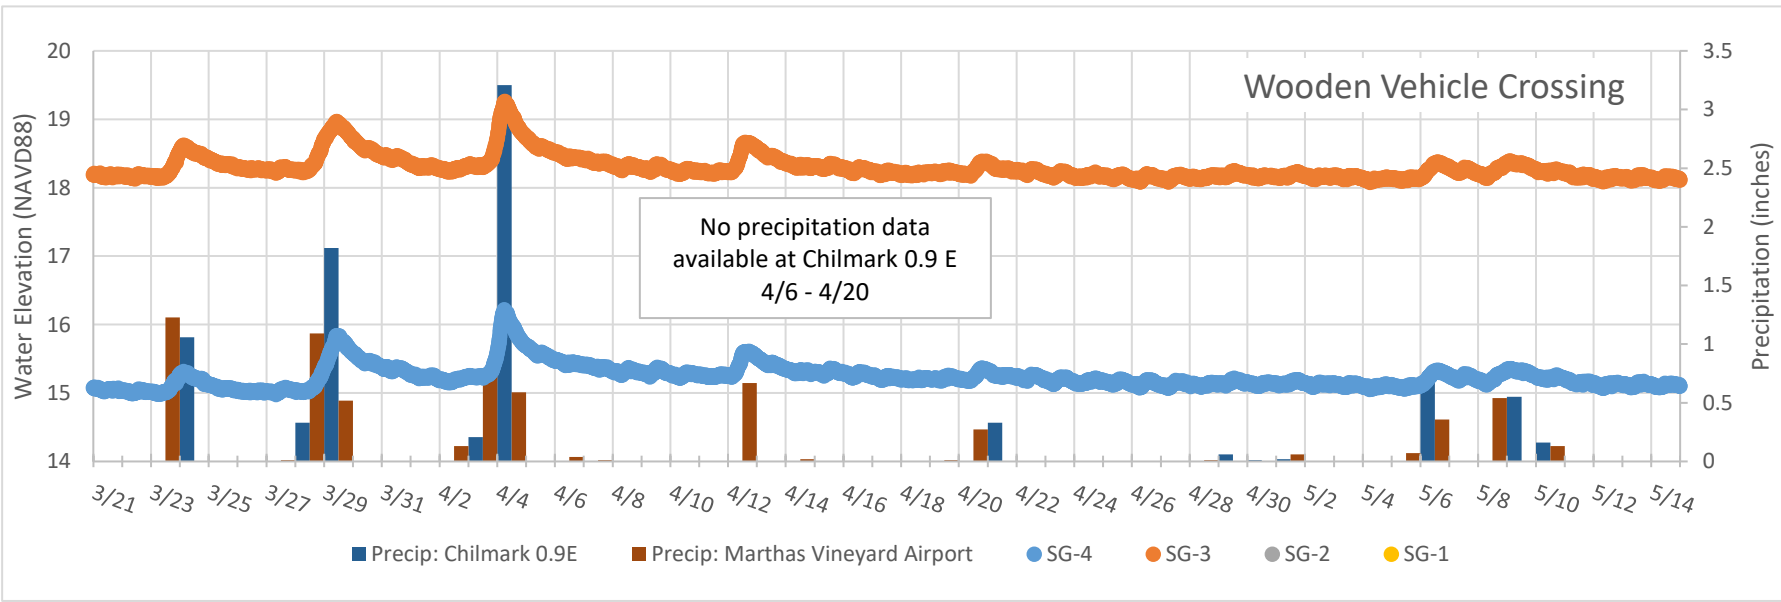
Figure 7: Water Level Logger Data - Black Brook, Aquinnah 2024

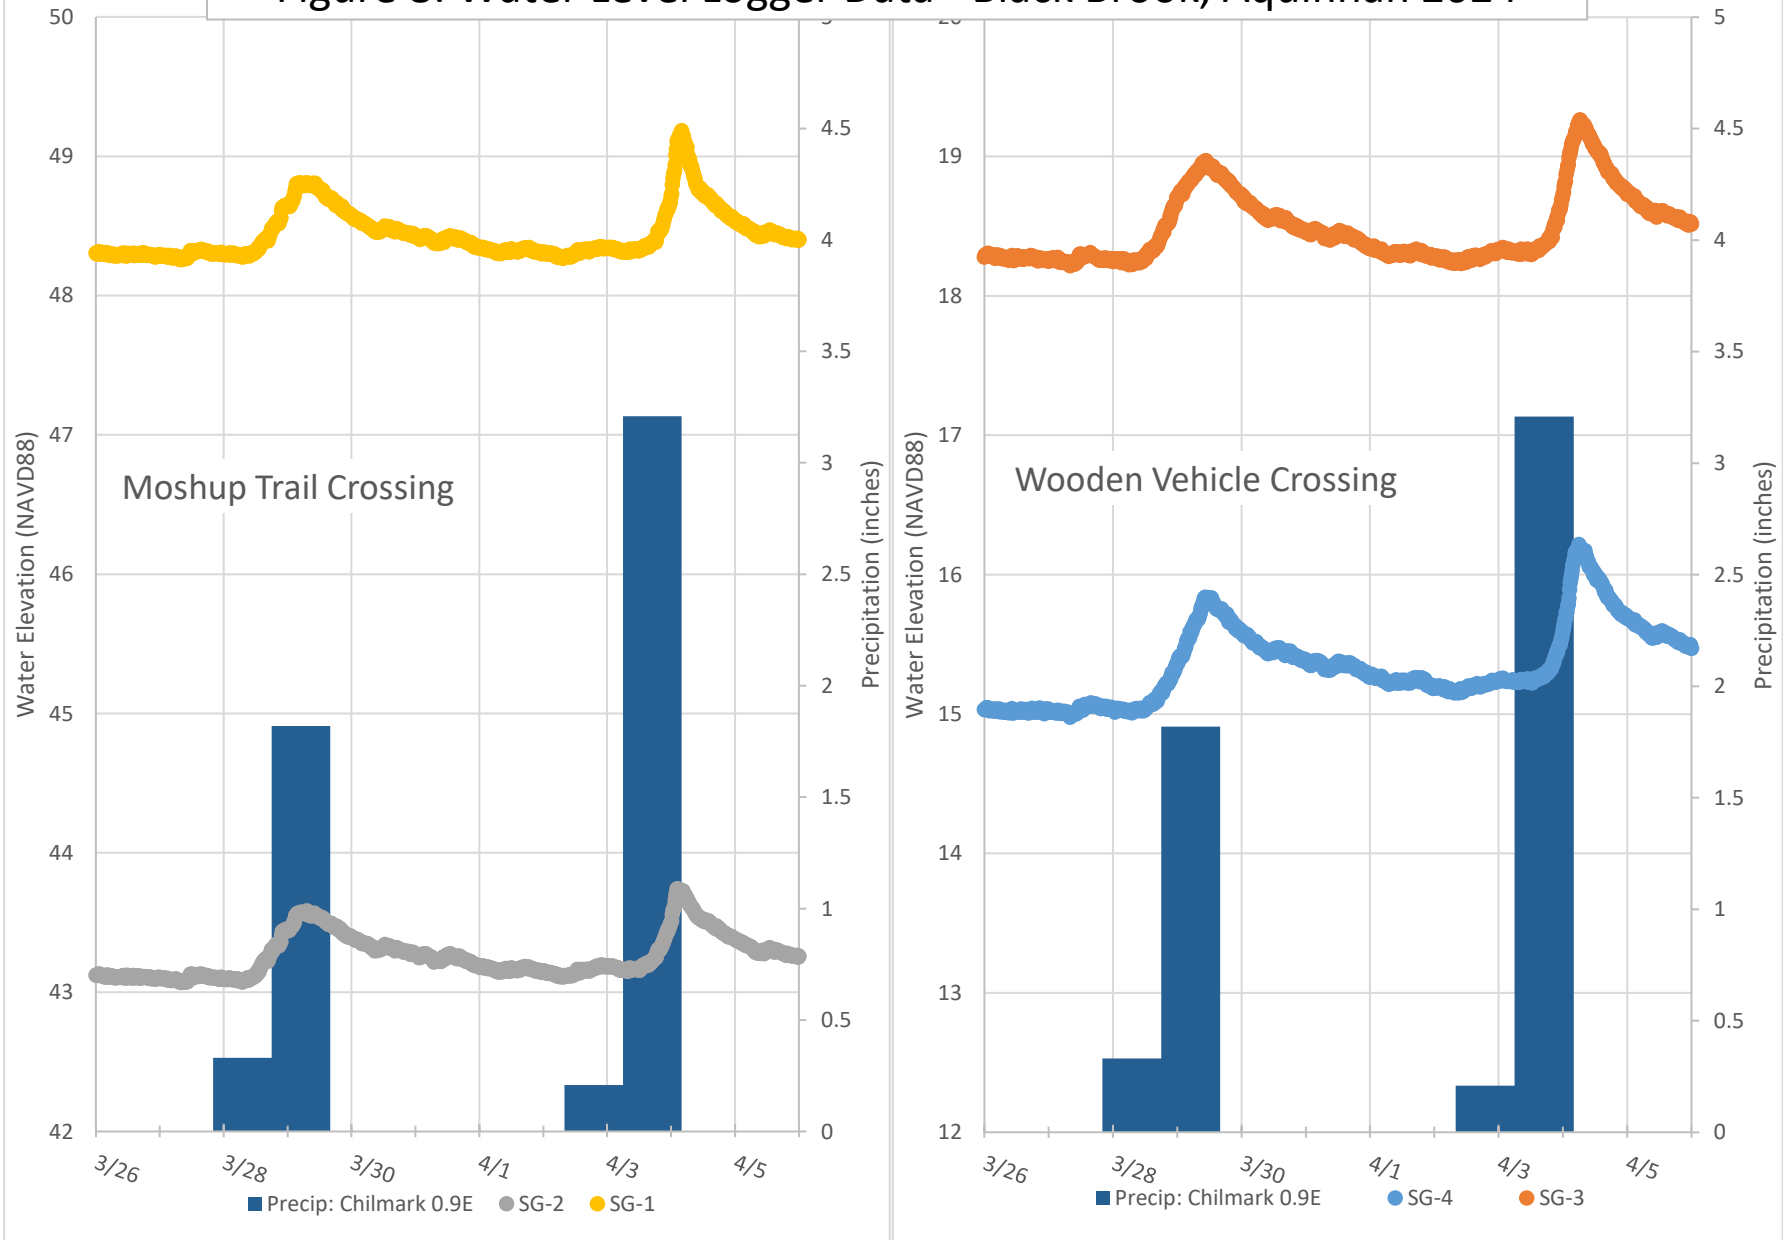
Figure 8: Water Level Logger Data - Black Brook, Aquinnah 2024

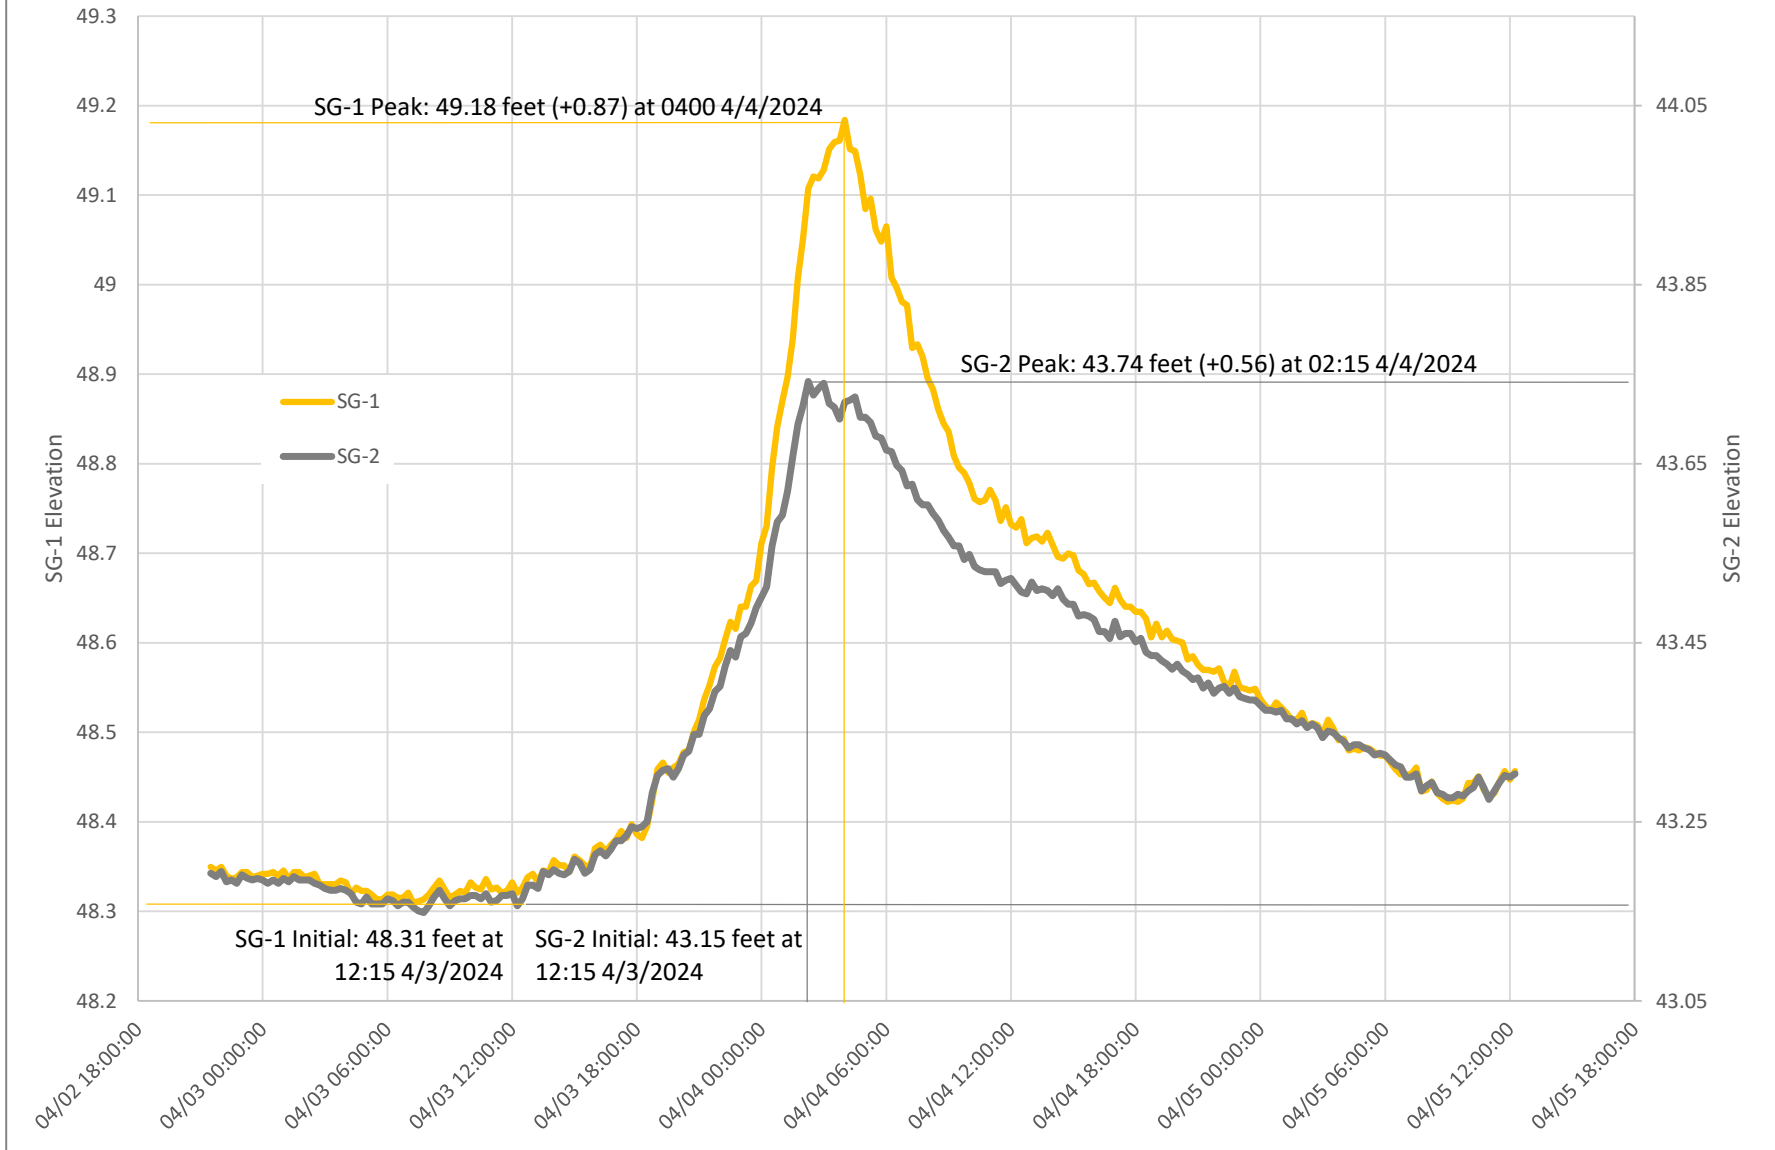
Figure 9: Water Level Response at SG-1 and SG-2
(3.4 inch Rain Event Overnight on April 3-4, 2024)

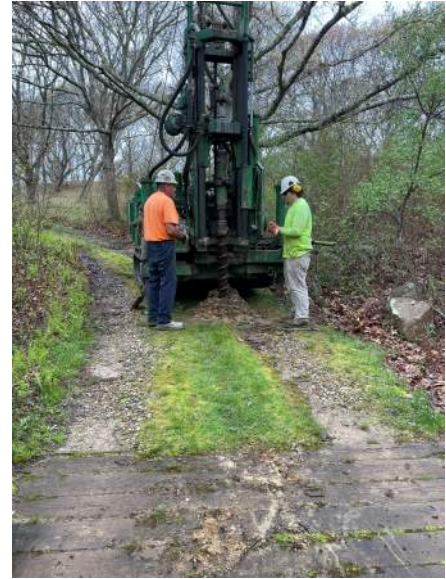
On May 15, 2024, a soil boring was completed in the center of the SMF/MVLB-owned dirt road on the western approach to the wooden vehicle crossing to evaluate subsurface geological conditions. The soil boring was completed by Geosearch of Sterling, Massachusetts, using 4.25" diameter hollow stem auger drilling equipment. Continuous soil samples were collected from the boring with 2 foot long 2-inch inner diameter stainless steel split spoons to a completion depth of 24 feet below ground surface (bgs). Split spoon samples were collected by driving with a hammer with blow counts recorded for each 6 inches of spoon advancement. Subsurface soil materials encountered ranged from very fine/fine to medium/coarse sand down to a depth of 15 feet bgs, with some clayey fine sand observed from 15 to 24 feet bgs. No organic material deposits were encountered. Groundwater was encountered in the soil boring at approximately 7 feet bgs, roughly equal to the observed level of Black Brook in relation to the soil boring location. The observed materials do not appear to pose a limiting factor for design and construction of an appropriately sized replacement structure at the wooden vehicle crossing location. A soil boring log is included as Attachment C.

Image 8. Wooden Vehicle Crossing Soil Boring

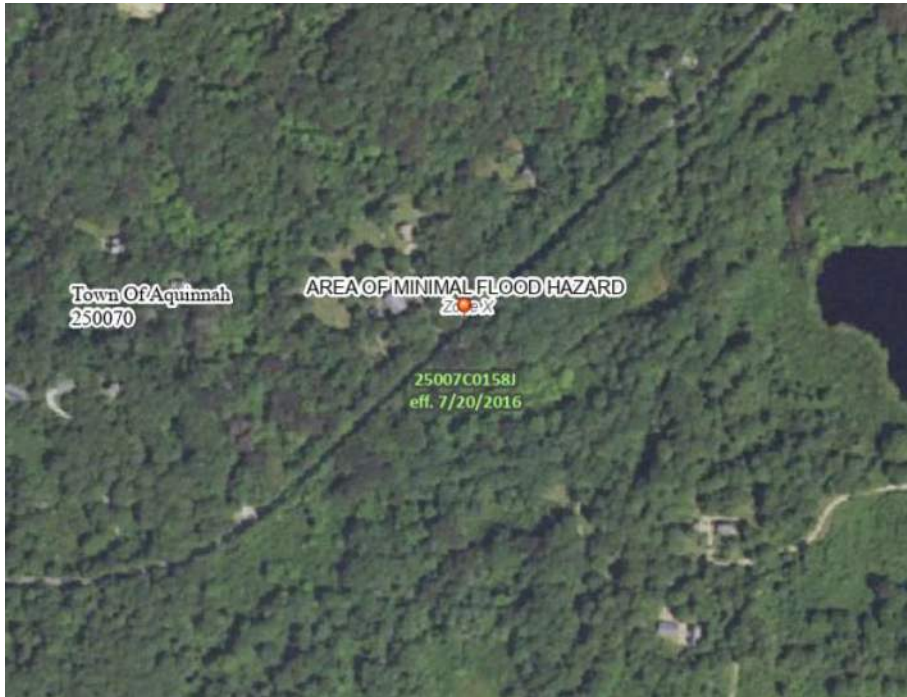
Image 9. Excerpt from the Federal Emergency Management Agency (FEMA) FIRMette for Moshup Trail crossing

According to the Federal Emergency Management Agency (FEMA) National Flood Hazard Map (Community Panel No. 25007C0158J, effective July 20, 2016) the Project Area is located within an Area of Minimal Flood Hazard, Zone X (Image 9-10).

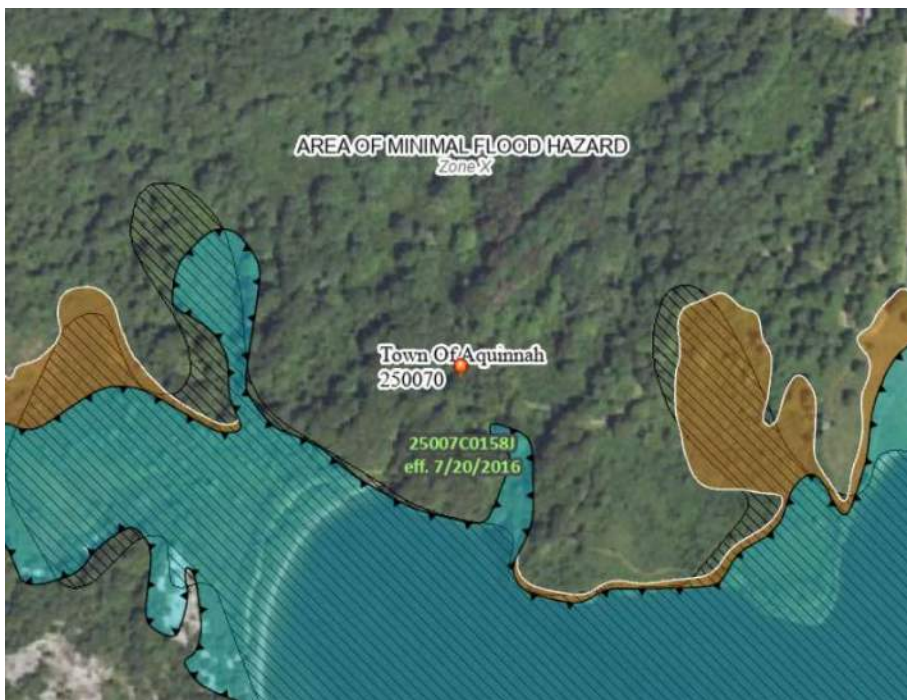
Image 10. Excerpt from the Federal Emergency Management Agency (FEMA) FIRMette for the wooden vehicle crossing

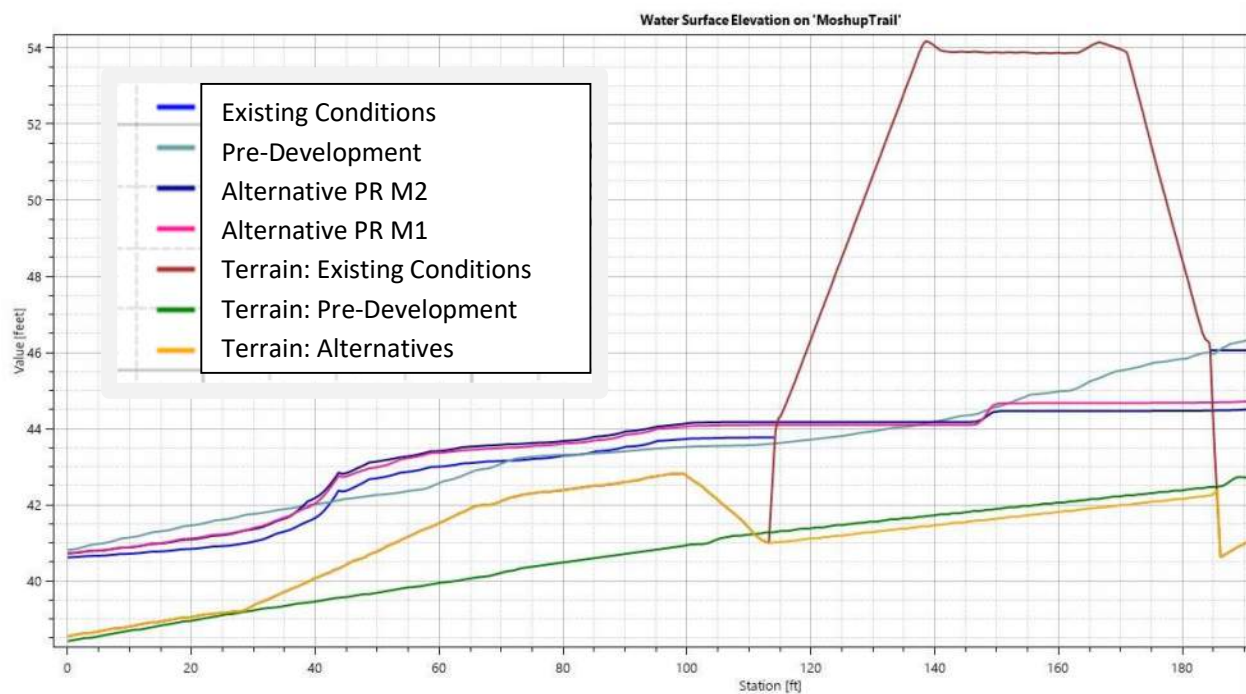
The downstream water surface elevation increases by 0.7 feet for PR M1, while the downstream water surface elevation remains constant between the existing, pre-development and PR M2 scenarios.

Figure 13. HEC-RAS results for Maximum Water Surface Elevation at Moshup Trail

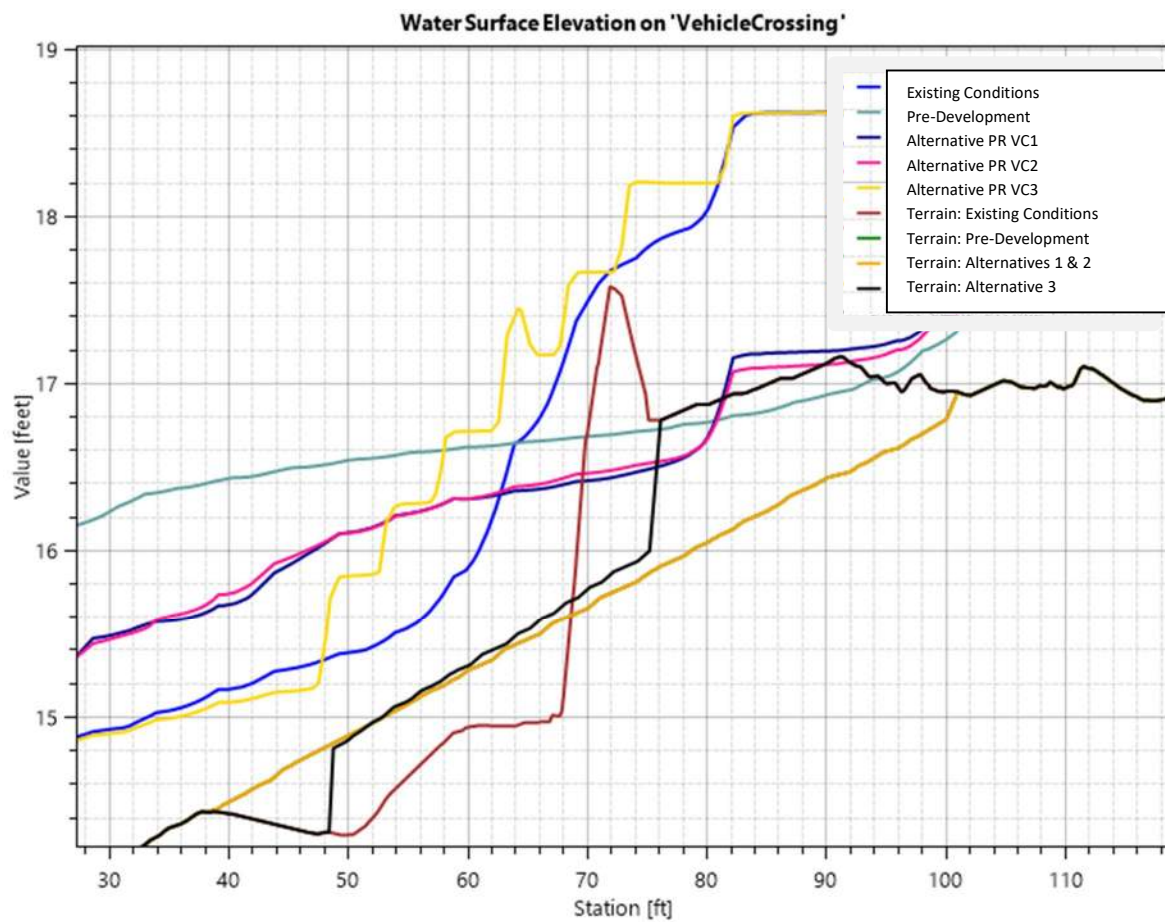
The two alternatives that include lowering the culvert will result in a lower water surface elevation at the crossing. There is a minimal difference between maximum elevation upstream for the reusing of the existing culvert alternative VC1 (12.5 ft wide) and the new culvert alternative VC2 (16 feet wide). PR VC3 fish passage improvement only maintains the water surface elevation directly upstream of the crossing and increases it by 0.4 ft directly below the culvert (approx. STA 75 on the table below). The increase is due to the rock pools created just downstream of the culvert.

Figure 24. HEC-RAS results for Water Surface Elevation at Vehicle Crossing

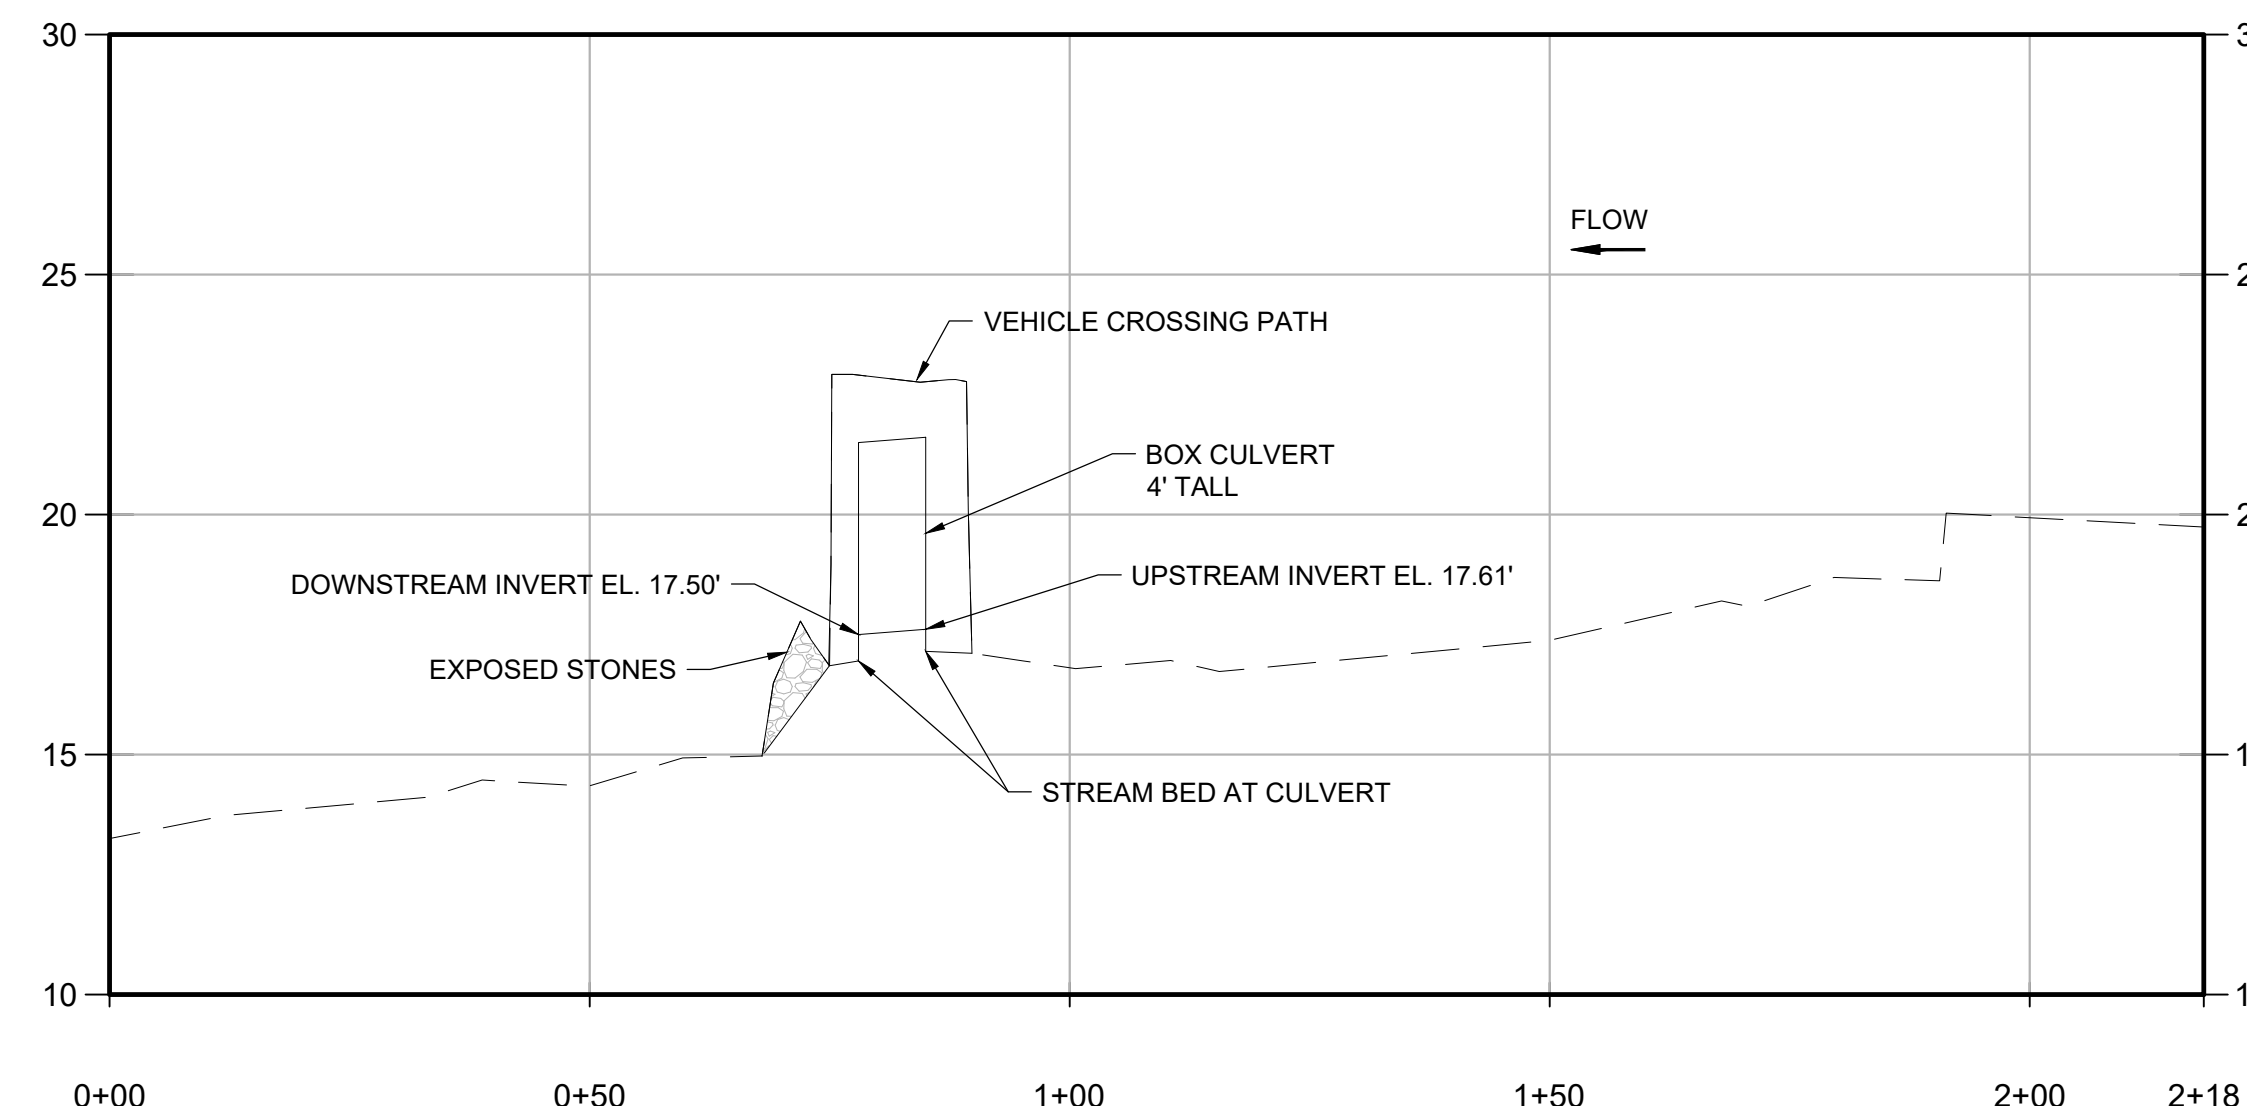
VEHICLE CROSSING LONGITUDINAL PROFILE
HORIZONTAL SCALE: 1" = 10'
VERTICAL SCALE: 1" = 2'

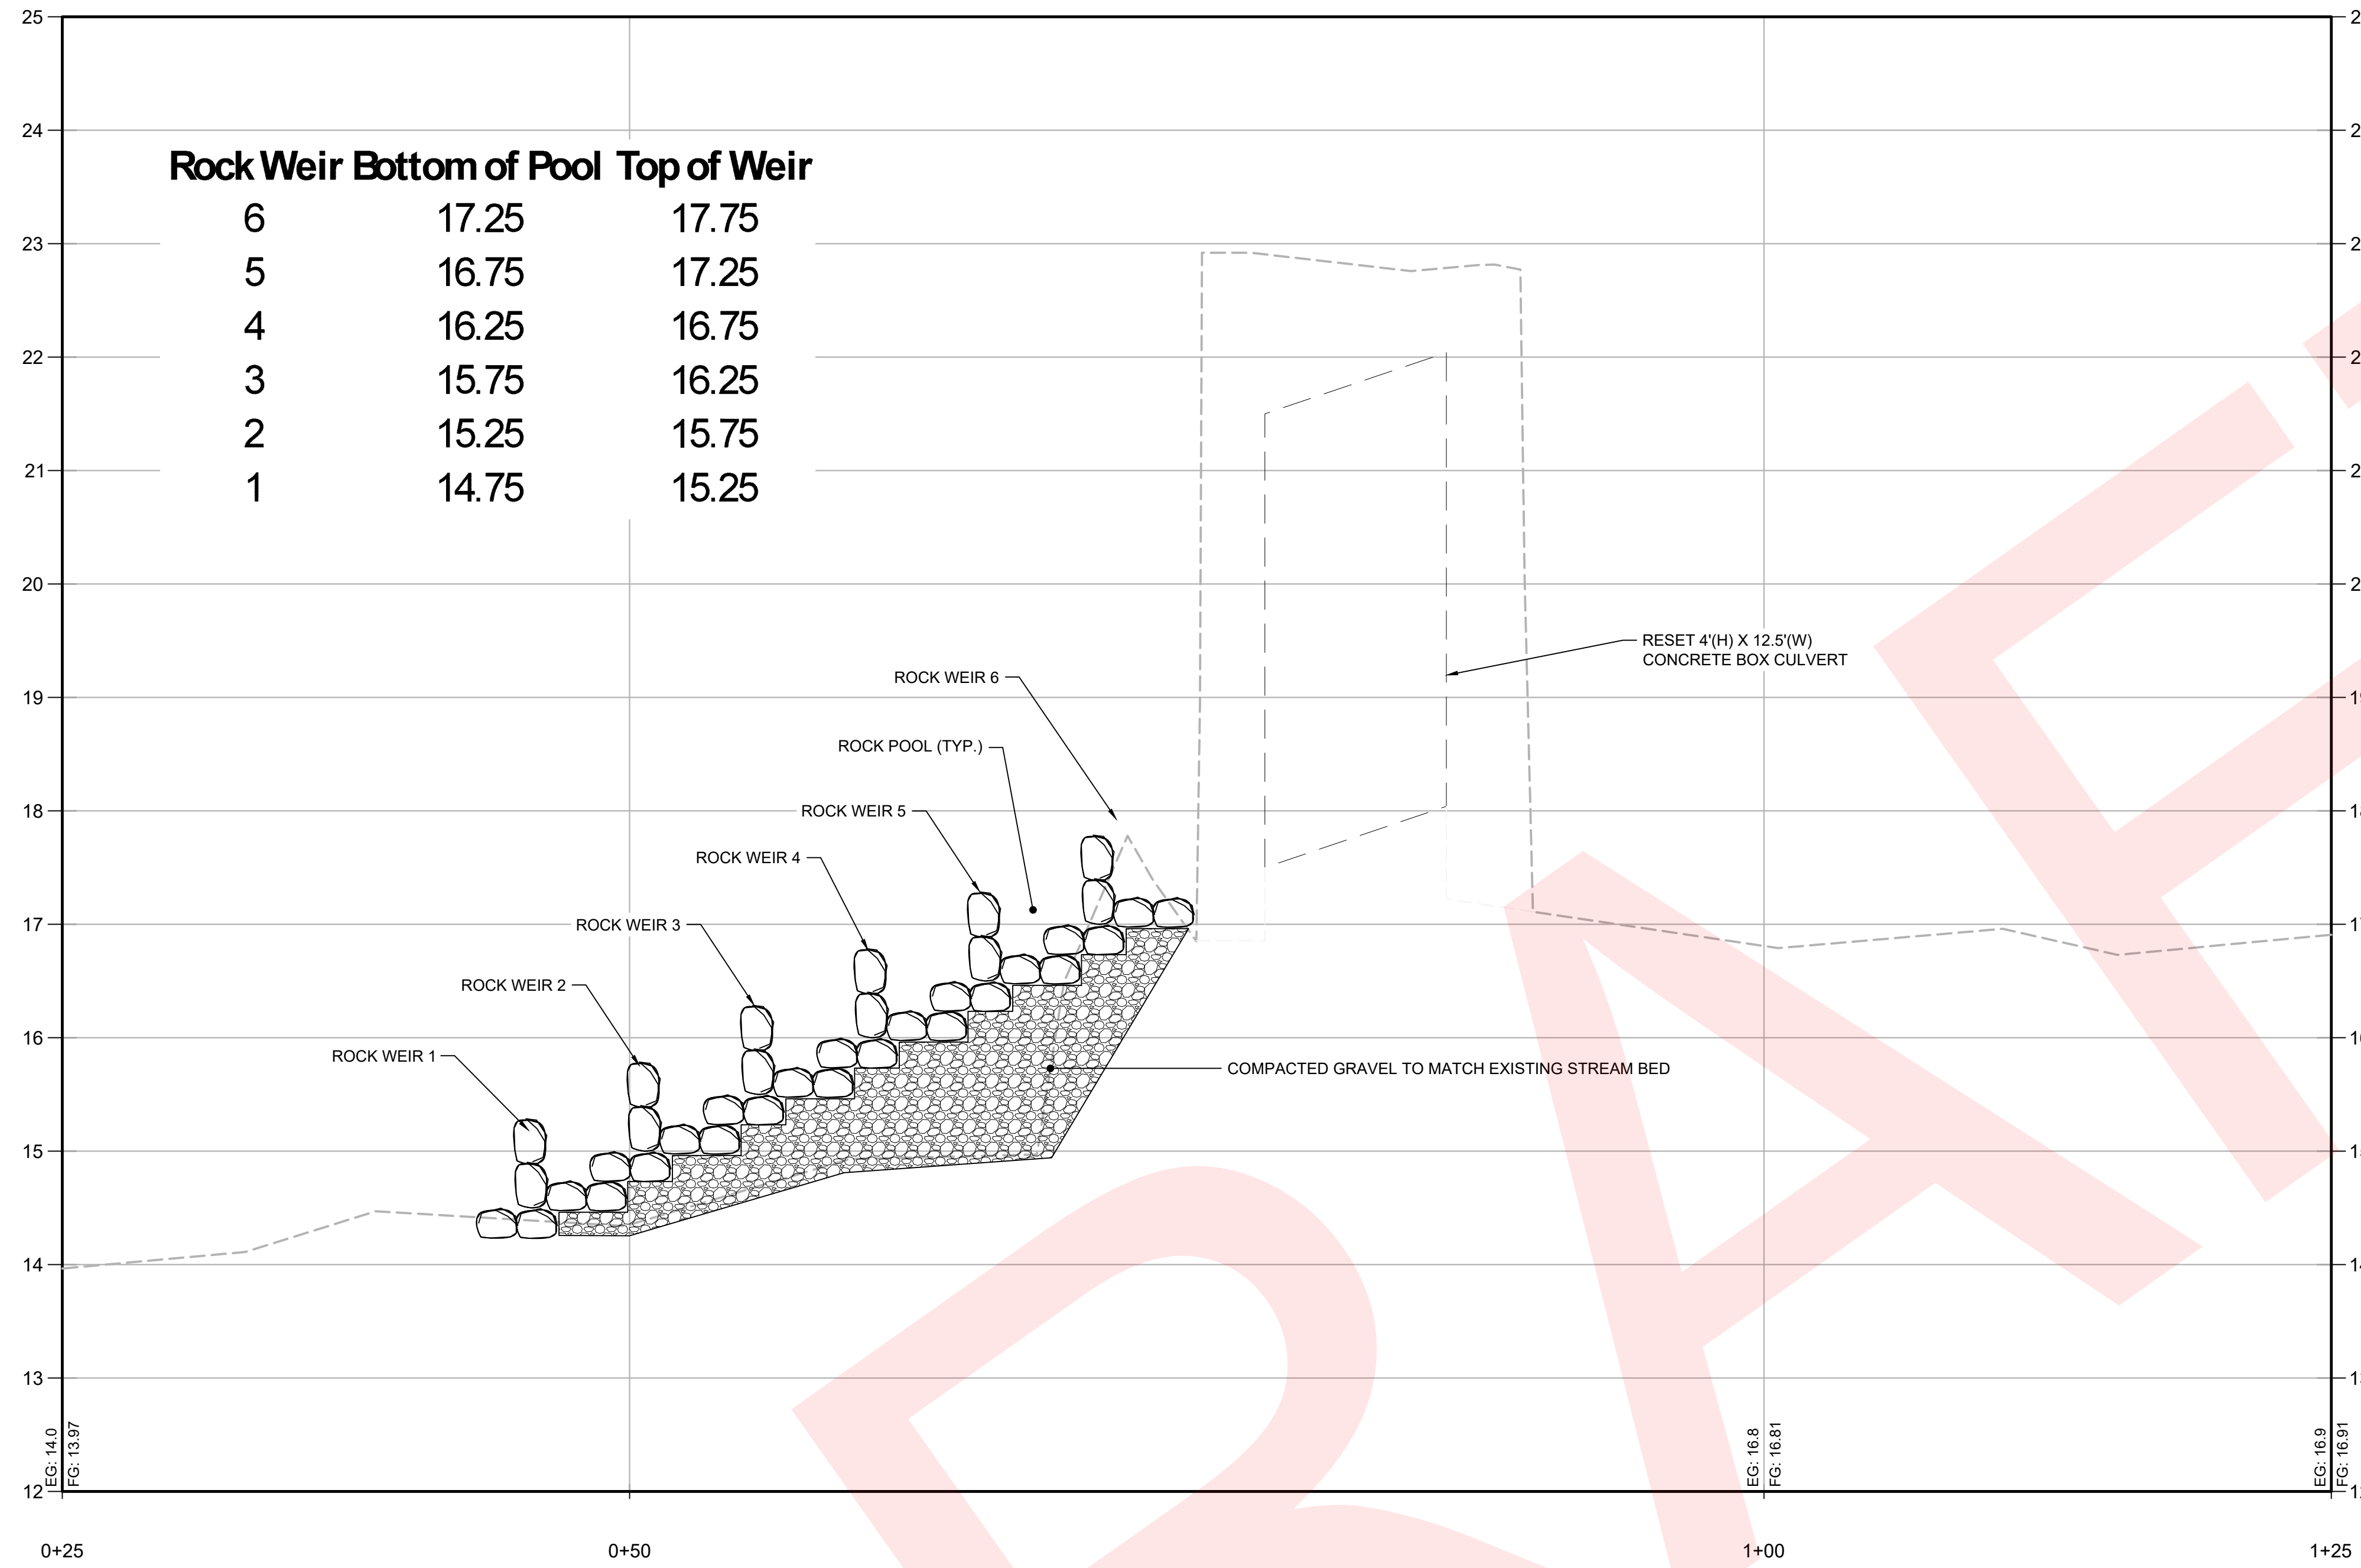
VEHICLE CROSSING ROCK WEIRS PROFILE
 HORIZONTAL SCALE: 1" = 5'
 VERTICAL SCALE: 1" = 1'
