Black Brook Stream Crossing Assessment

FINAL REPORT

BLACK BROOK STREAM CROSSING ASSESSMENT

Aquinnah, Massachusetts

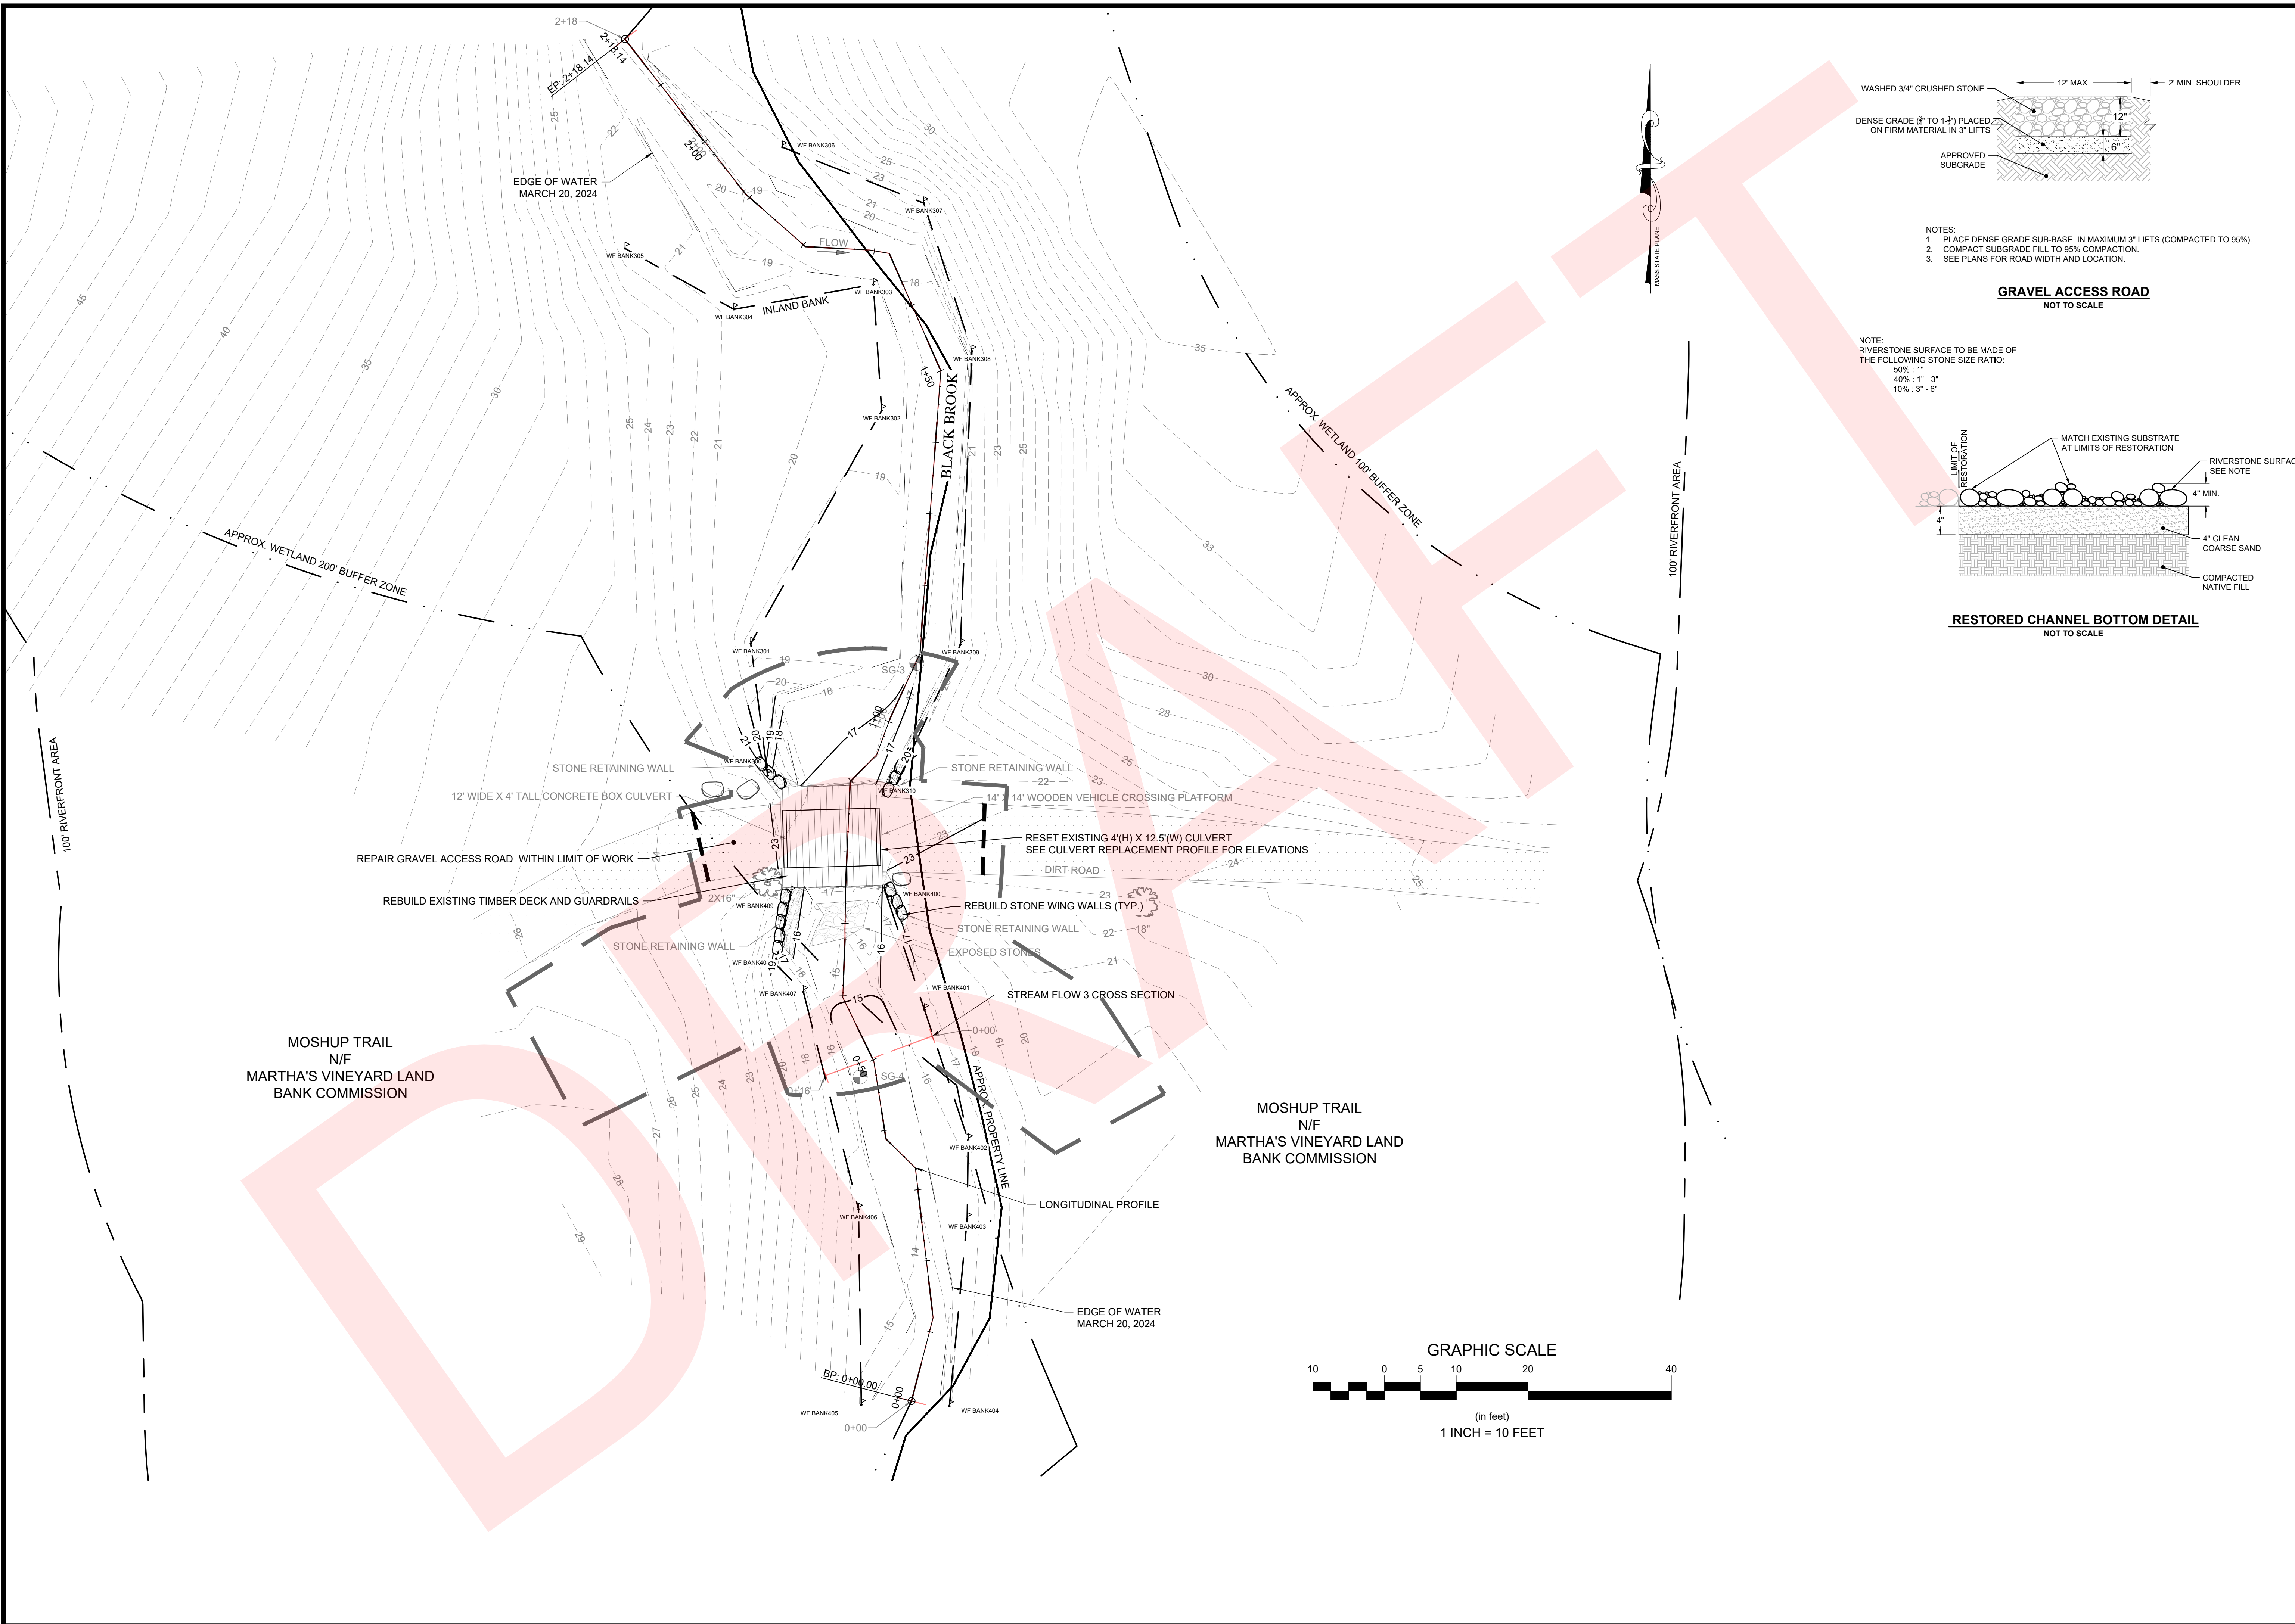
GRAVEL ACCESS ROAD
NOT TO SCALE

- NOTES:
1. PLACE DENSE GRADE SUB-BASE IN MAXIMUM 3" LIFTS (COMPACTED TO 95%).
 2. COMPACT SUBGRADE FILL TO 95% COMPACTION.
 3. SEE PLANS FOR ROAD WIDTH AND LOCATION.

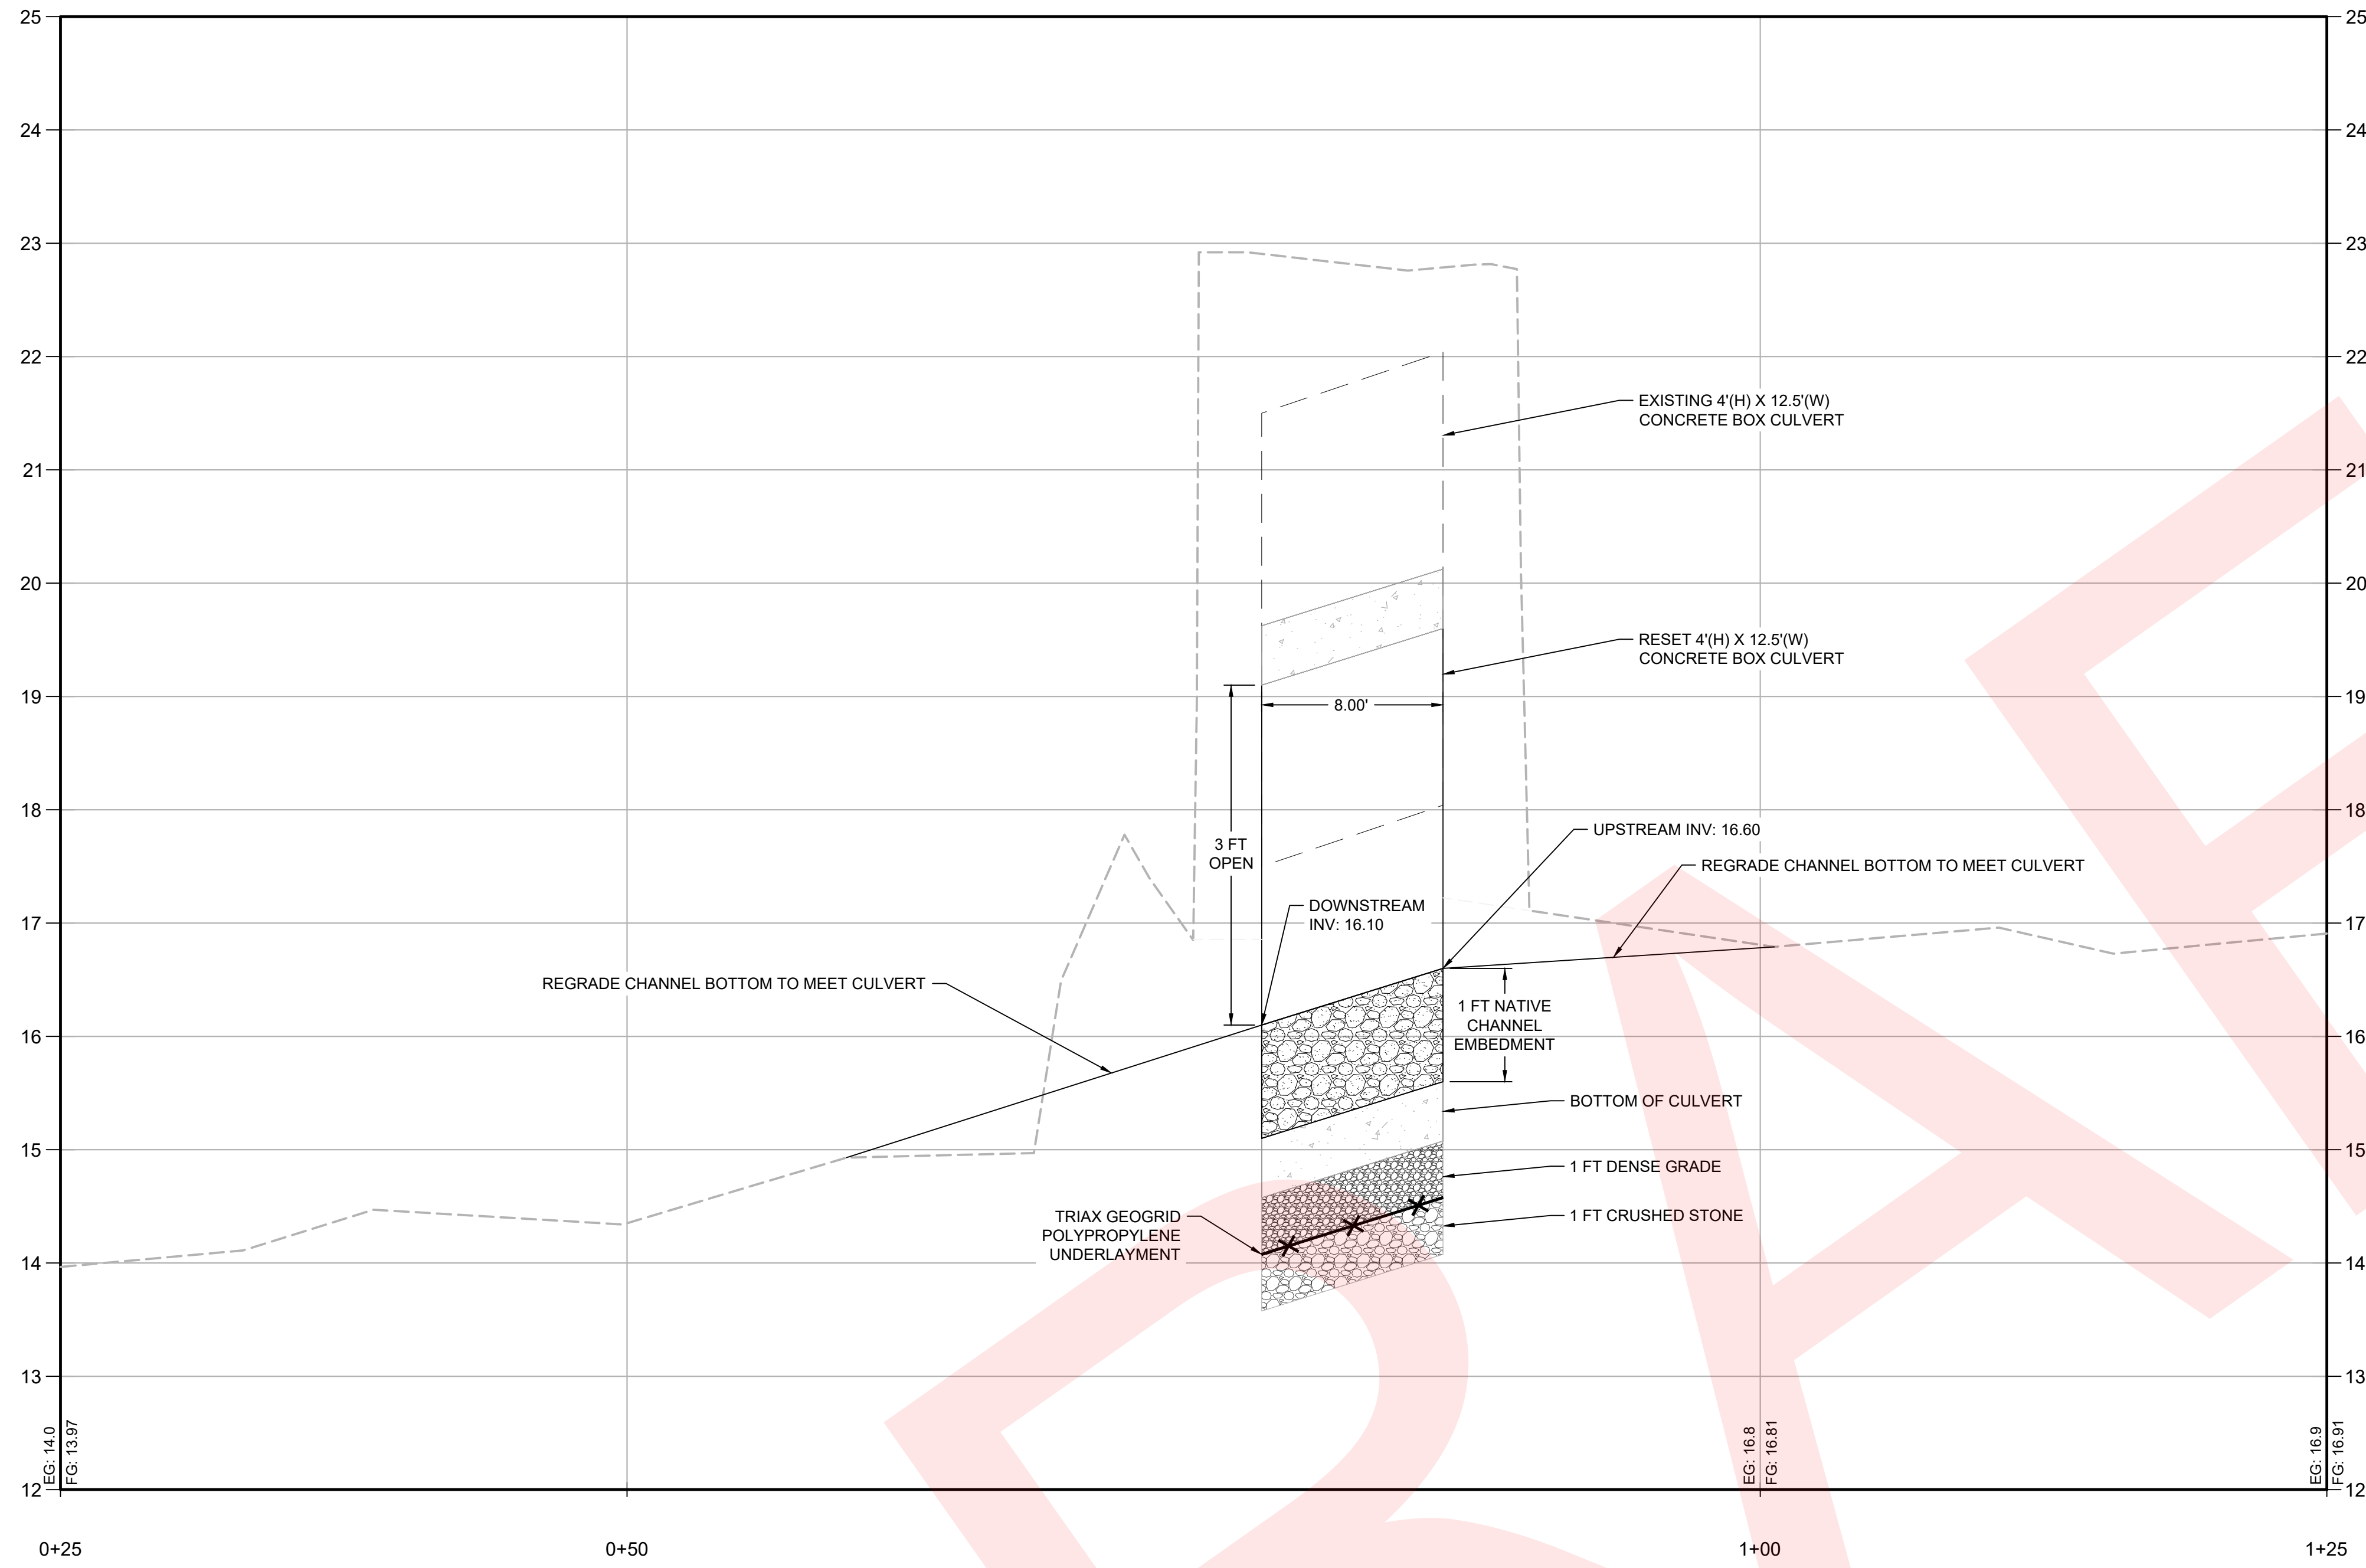
VEHICLE CROSSING CULVERT REPLACEMENT PROFILE
 HORIZONTAL SCALE: 1" = 5'
 VERTICAL SCALE: 1" = 1'
