0. Executive Summary

The Capwell Mill Pond Dam is on the Carr River in the Big River Management Area (BRMA) in West Greenwich, Rhode Island. The dam impounds the Carr River just upstream of its confluence with the Big River. The dam was assessed as a significant hazard potential dam that could impact downstream communities if it were to fail. When the dam was built over 100 years ago, it flooded wetlands and created an impassable barrier to aquatic organisms. Currently the dam is creating reverberating impacts throughout the interconnected waterways on biological resources and water quality as well as from an ecosystem and community resiliency perspective.

Capwell Mill Pond Dam

The alternative evaluated in this EDR is removal of the Capwell Mill Pond Dam and removal of a Legacy Dam located approximately 120 feet (ft) upstream of the Capwell Mill Pond Dam. The evaluation consisted of creating a hydrologic and hydraulic model to assess the existing and proposed hydraulic conditions at the project site. EA used available U.S. Geological Survey (USGS) stream gage data to determine operating flows and peak flows at the Capwell Mill Pond Dam. Survey data and flow data were then incorp

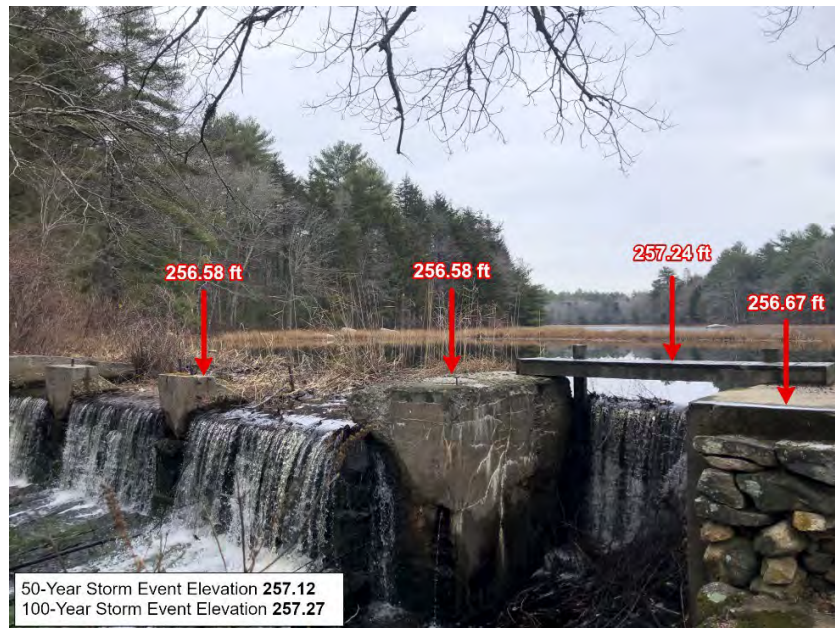
Photo 1. Peak Flow Water Surface Elevation Comparison

EA developed a Hydrologic Engineering Center River Analysis System (HEC-RAS) model of the Carr River at the Capwell Mill Pond Dam to evaluate existing and proposed water levels and velocities in the river over the range of aquatic passage flows and flood event flows. Results of the existing condition HEC-RAS model are presented in **Table 6-3** and **Table 6-4**, and results of the proposed condition HEC-RAS models are presented in **Table 6-5**, **Table 6-6**, and **Table 6-7**. Full HEC-RAS results are included in Appendix C.

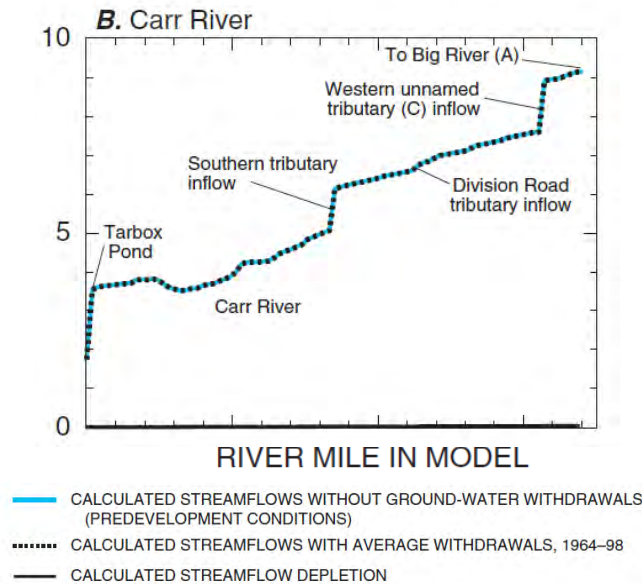
The two wells that were used in the model are located approximately 1.4 miles from Capwell Mill Pond. The combined average annual rate of withdrawal from these two wells was 1.4 million gallons per day (Mgal/d) (2.15 cubic feet per second [ft³/s]) during the 1964–1998 simulation period. The simulation results showed that this caused a streamflow depletion of 0.01 ft³/s in the Carr River; however, the report mentions that this “is about 0.1 percent of the average annual streamflow and probably is attributable to numerical-simulation error. Therefore, the Carr River and its tributaries are not affected by withdrawals at the Kent County wells” (USGS 2003). **Figure 2-2** shows the reach of the Carr River that was modeled (river mile 0 being the most upstream point) and the calculated streamflow depletion; the project site is located just downstream of the western unnamed tributary.

Figure 2-2. Carr River Calculated Streamflow Depletion from Groundwater Withdrawal

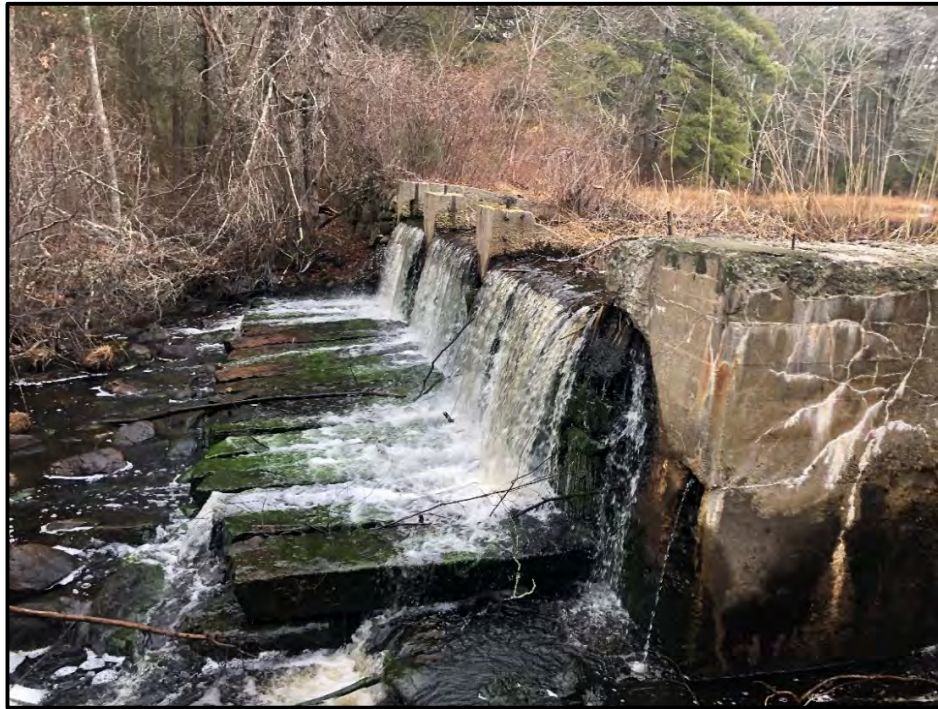
- The upstream portion of the left sidewall is eroded away and has exposed supporting rebar. Bolts and steel supports are exposed on the concrete structures and right sidewall.
- The concrete mortar has eroded to reveal the aggregate underneath at all concrete structures interfacing with flowing water.
- Two steel pipe outlets were observed in the downstream face of the left concrete training wall:
 - The upper pipe was approximately 2 inches (in.) in diameter with a steady stream of water flowing out of the pipe.
 - The lower pipe was approximately 3 inches (in.) in diameter with no water observed flowing out of the pipe.
- Thick phragmite vegetation and woody beaver debris are present along the entire upstream face, partially blocking the spillway.

Photograph 2-1. Capwell Mill Pond Dam concrete and masonry spillway. Deterioration of concrete structures and vegetation on right bank of dam evident. Looking north.

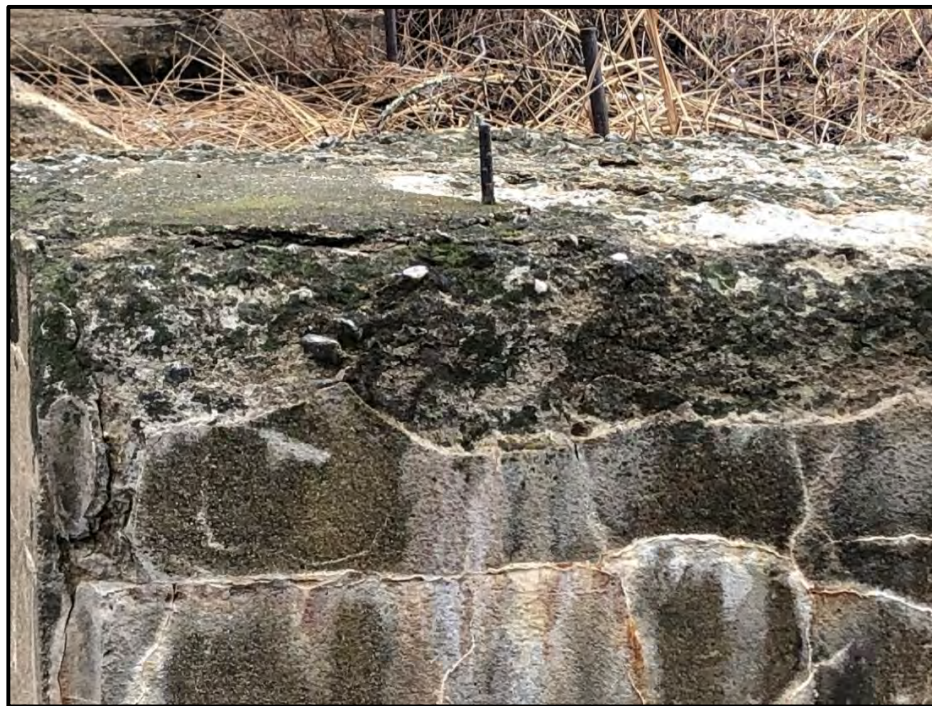
Photograph 2-2. Spalling at top of left concrete sidewall and exposed rebar protruding from concrete. Looking north.

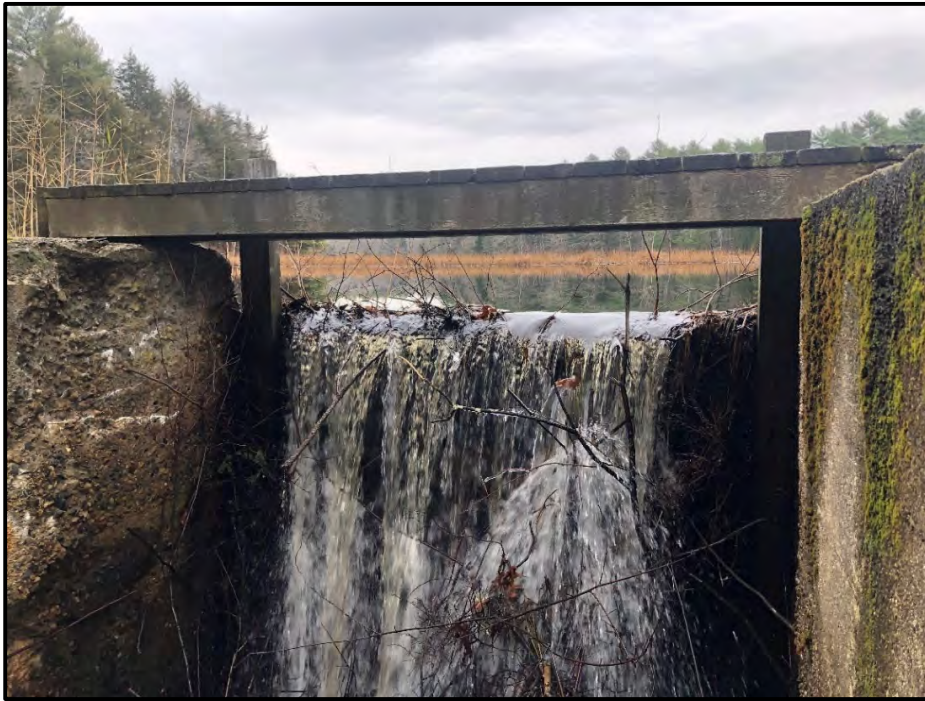
Water flow and vegetation prevented a complete examination of the low-level outlet, but the outlet appeared to be composed of timber, which has been secured with bolts into two vertical timber posts. These two timber posts also support the timber pedestrian bridge providing access to the left spillway sidewall from the left embankment. The low-level outlet condition could not be examined in detail due to debris and water volume on the day of inspection. The pedestrian bridge timber decking and supporting timber posts appear to be in good condition. Thick and woody vegetation and loose vegetation are present along the upstream face of the low-level outlet, partially blocking the spillway. It has been observed that during the summer months the low-level outlet structure does not flow, resulting in the Capwell Mill Pond Dam completely cutting off hydraulic flow downstream.

Photograph 2-3. Downstream side of timber low-level outlet at spillway. Flow overtopping timber planks which are secured to vertical timber posts. Pedestrian bridge, spalling of concrete, and accumulation of beaver debris within outlet are shown. Looking east.

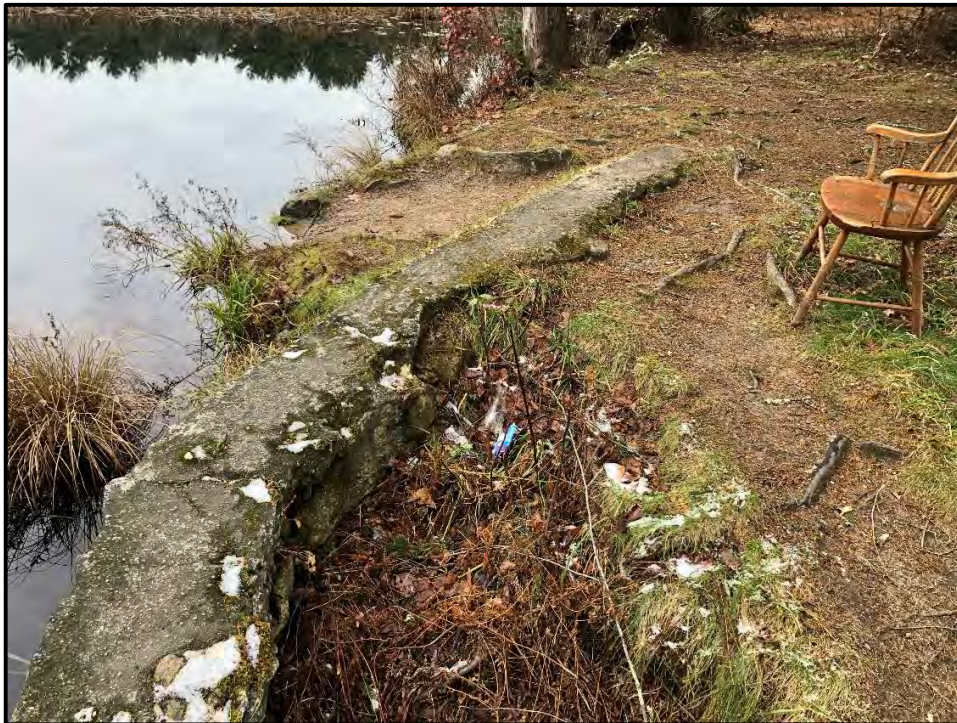
- A large and deep scour hole is present at the end of the retaining wall on the left bank.
- The river left downstream retaining wall appears to be bulging outward toward the stream channel just downstream of the location of the scour hole. Several trees are present just behind the retaining wall at this location.

Photograph 2-4. Horizontal cracking across top of concrete portion of left embankment wall at the impoundment and large scour hole in bottom center of photograph. Looking southeast.

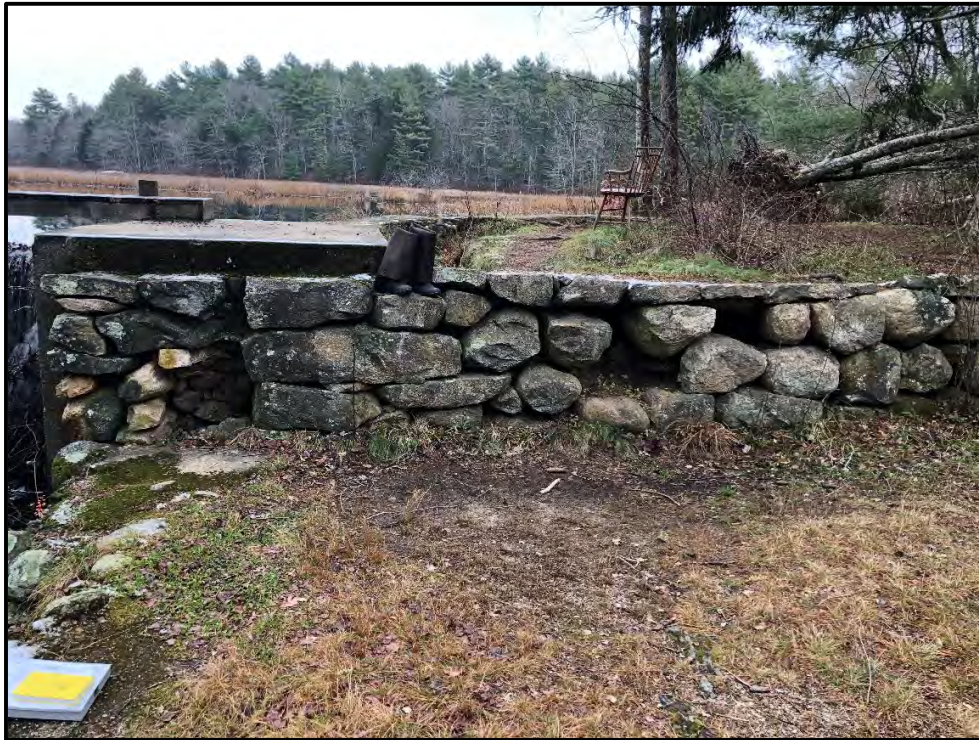
Photograph 2-5. Missing stones/gaps in downstream side of masonry left embankment wall near spillway. Looking east.

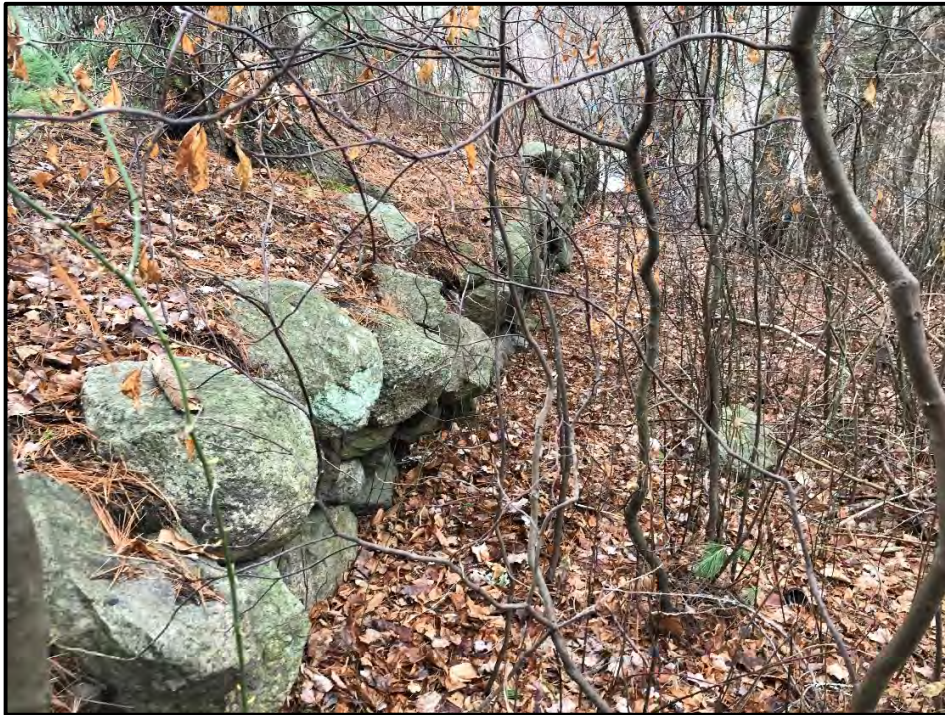
- A bulge was observed toward the downstream direction. Multiple large trees were observed to be growing on the earth upstream of the wall.
- Portions of the footpath along the upstream face of the impoundment are experiencing erosion, likely resulting from recreational foot traffic. Standing water was observed at two points along the footpath.
- Muddy tire rutting was observed at the northernmost side of the right embankment abutting Burnt Sawmill Road.

Photograph 2-6. Outward bulge of downstream side of right embankment wall. Large tree in top left corner of photograph. Looking south.

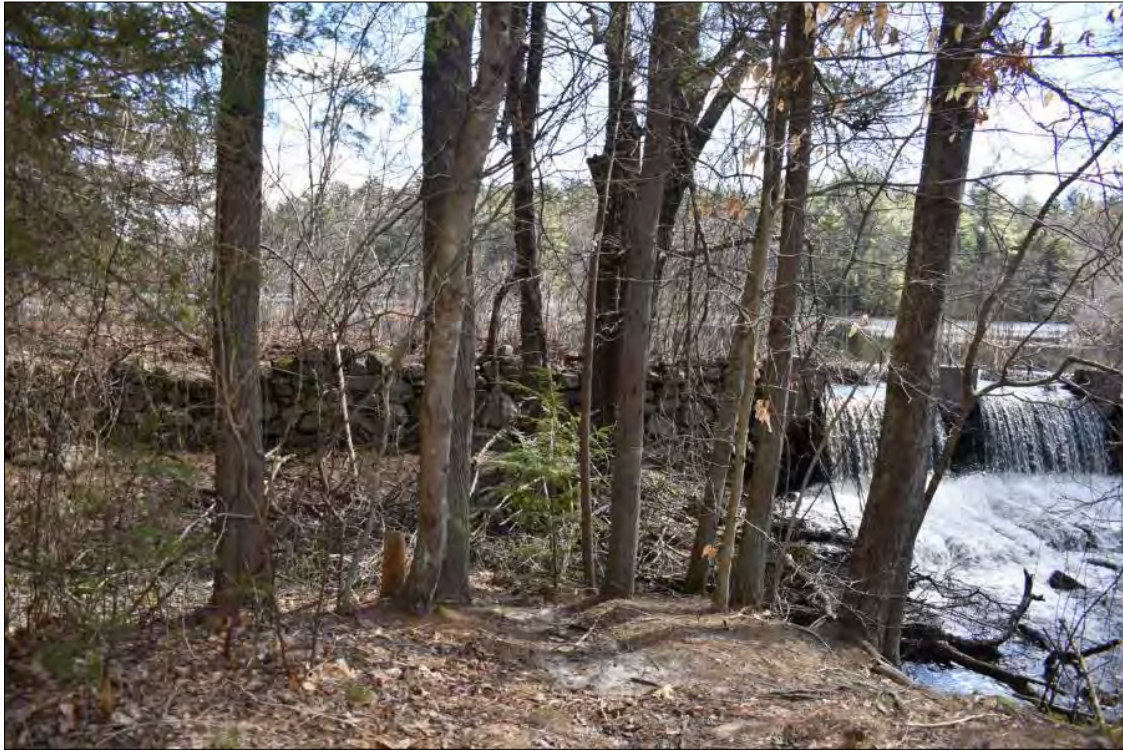
Photo 3. Downstream (west) face of the Capwell Mill Pond Dam, view east.

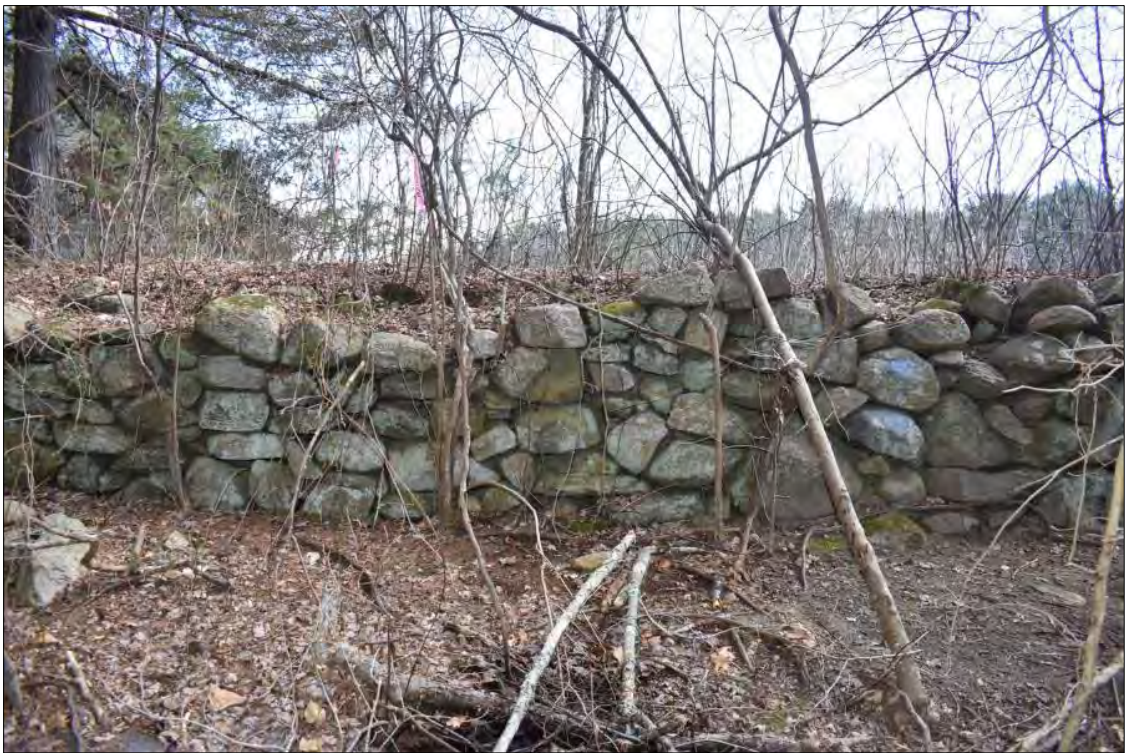
Photo 4. Dry-laid stone masonry on the downstream face of the Capwell Mill Pond Dam, view east.

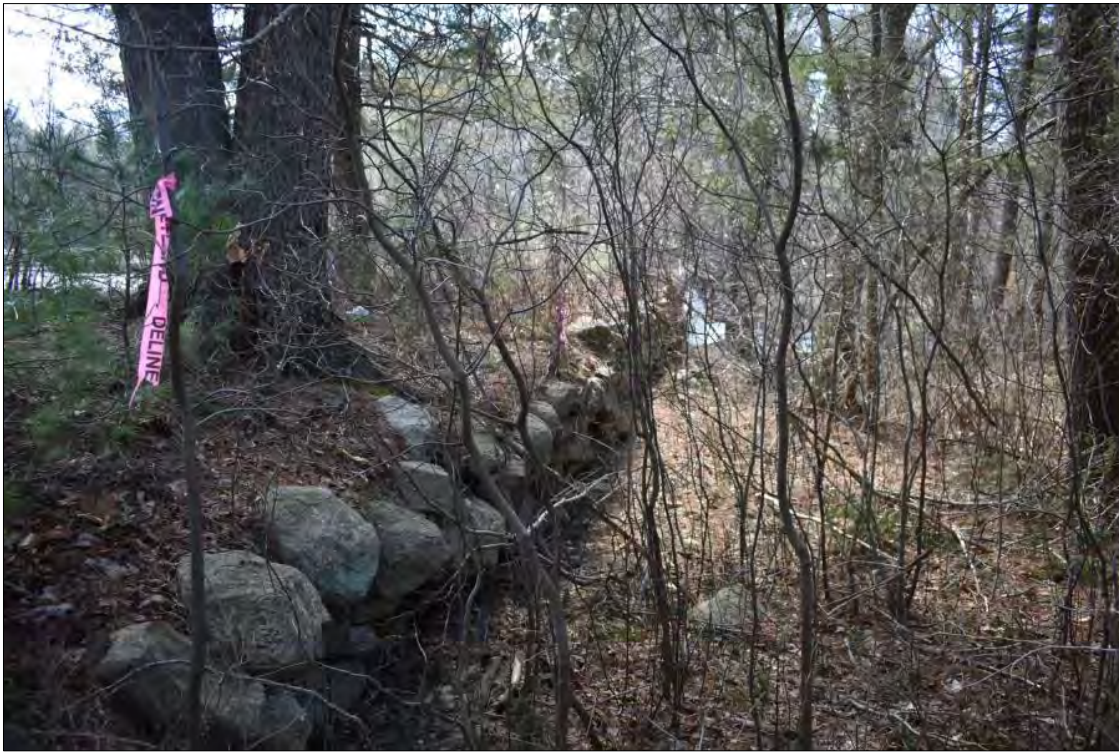
Photo 5. Dry-laid stone masonry on the downstream face of the Capwell Mill Pond Dam, view south.

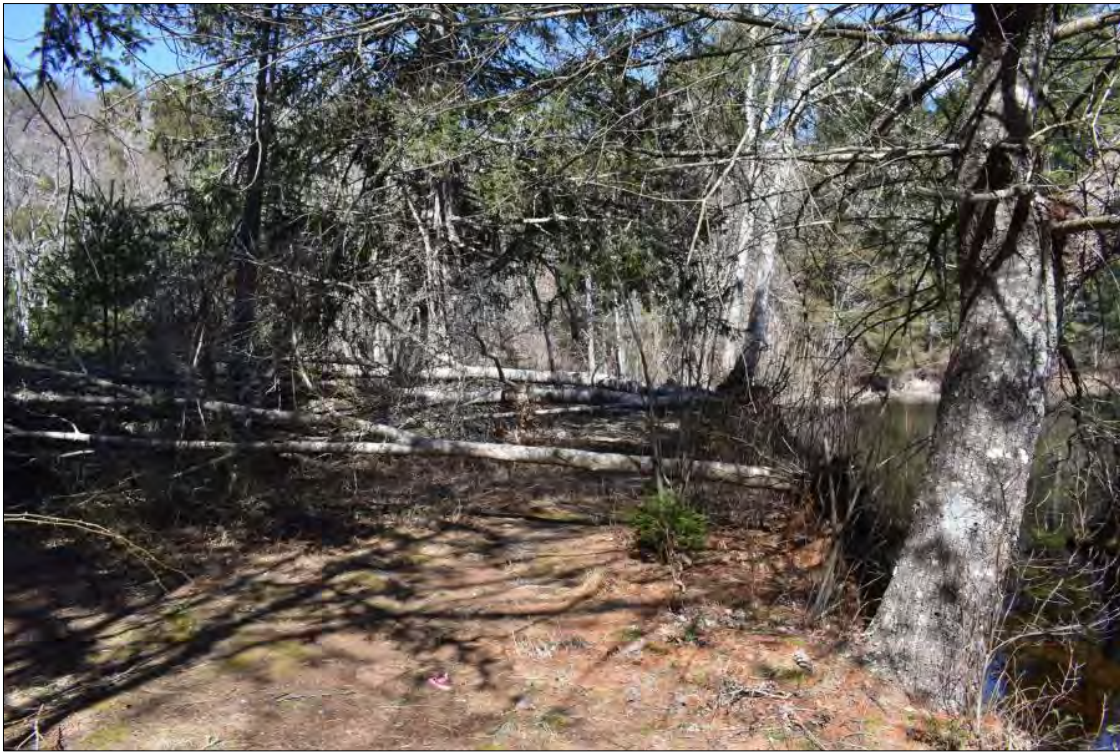
Photo 7. Overgrown earthen crest of the Capwell Mill Pond Dam, view north.

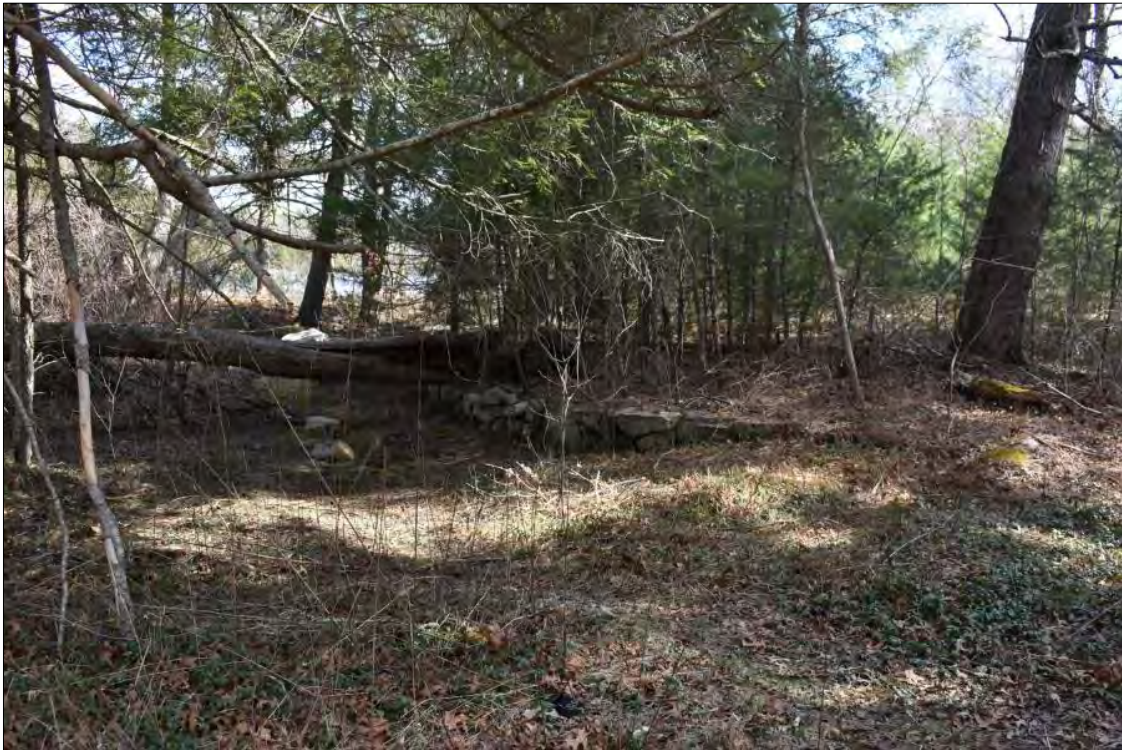
Photo 9. Low retaining wall at Capwell Mill Pond Dam's southern abutment, view southeast.

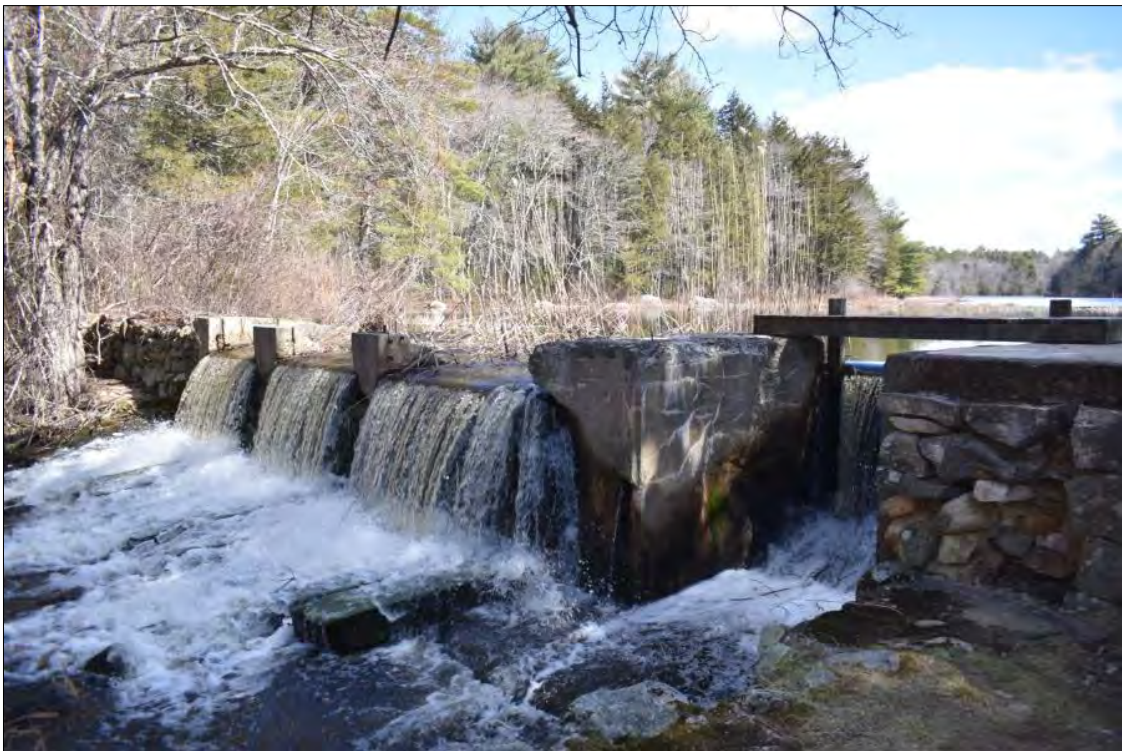
Photo 10. Capwell Mill Pond Dam spillway and sluice, view northeast.

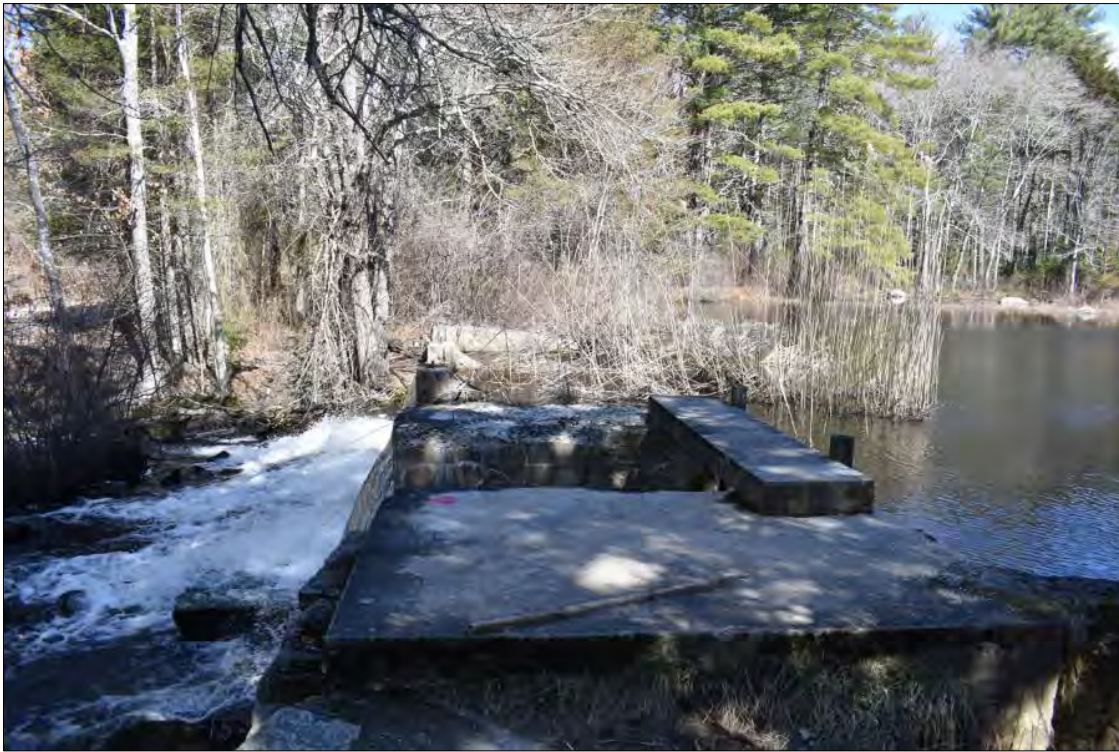
Photo 11. Capwell Mill Pond Dam spillway and sluice with a small wooden footbridge.

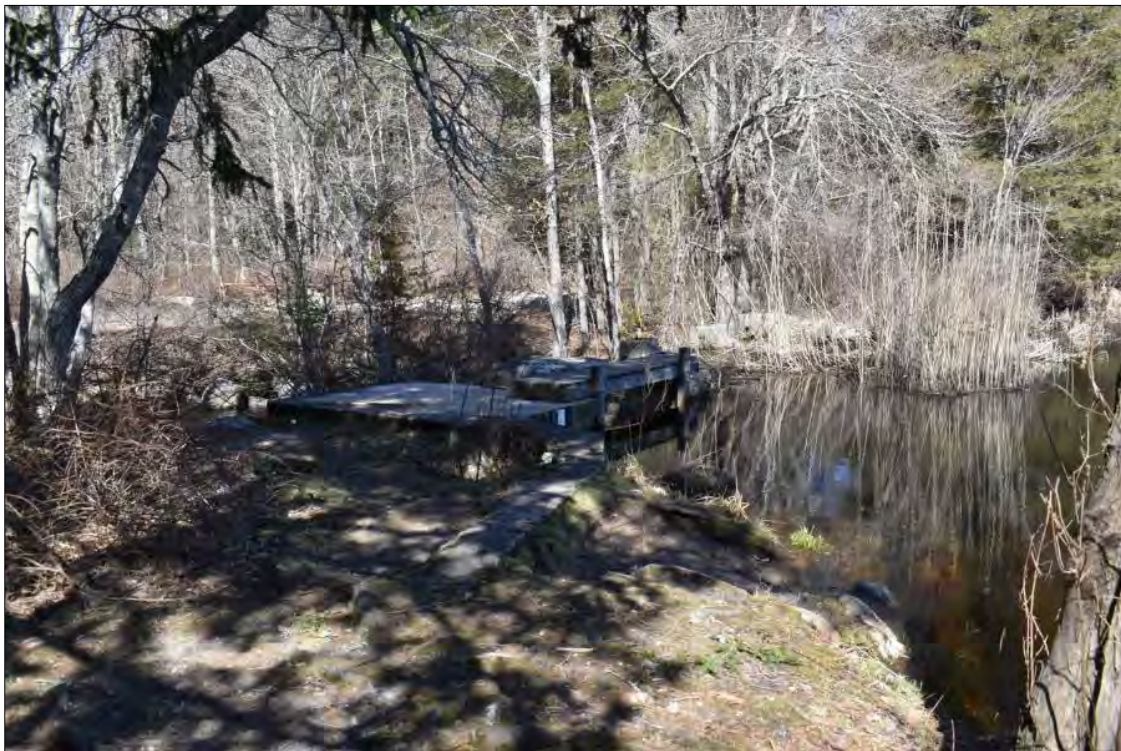
Photo 12. Capwell Mill Pond Dam spillway and sluice with a water level meter on the upstream (east) face, view southwest.

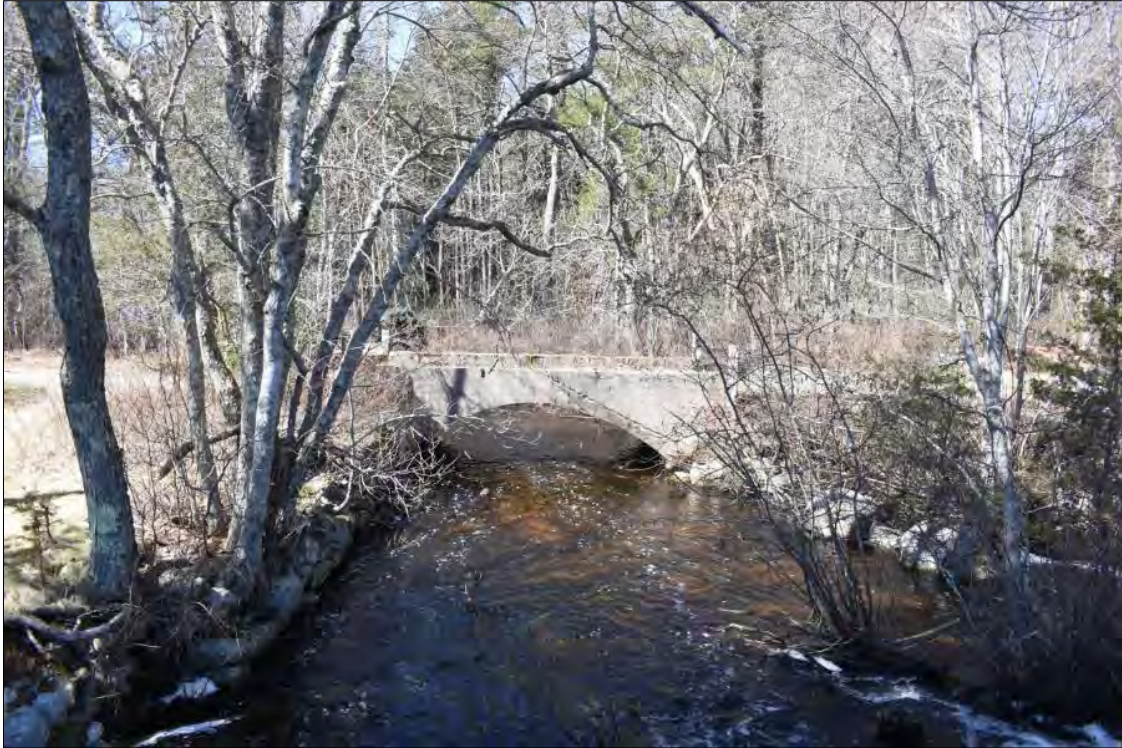
Photo 14. Concrete arch bridge immediately downstream of the Capwell Mill Pond Dam on Burnt Sawmill Road, view west.

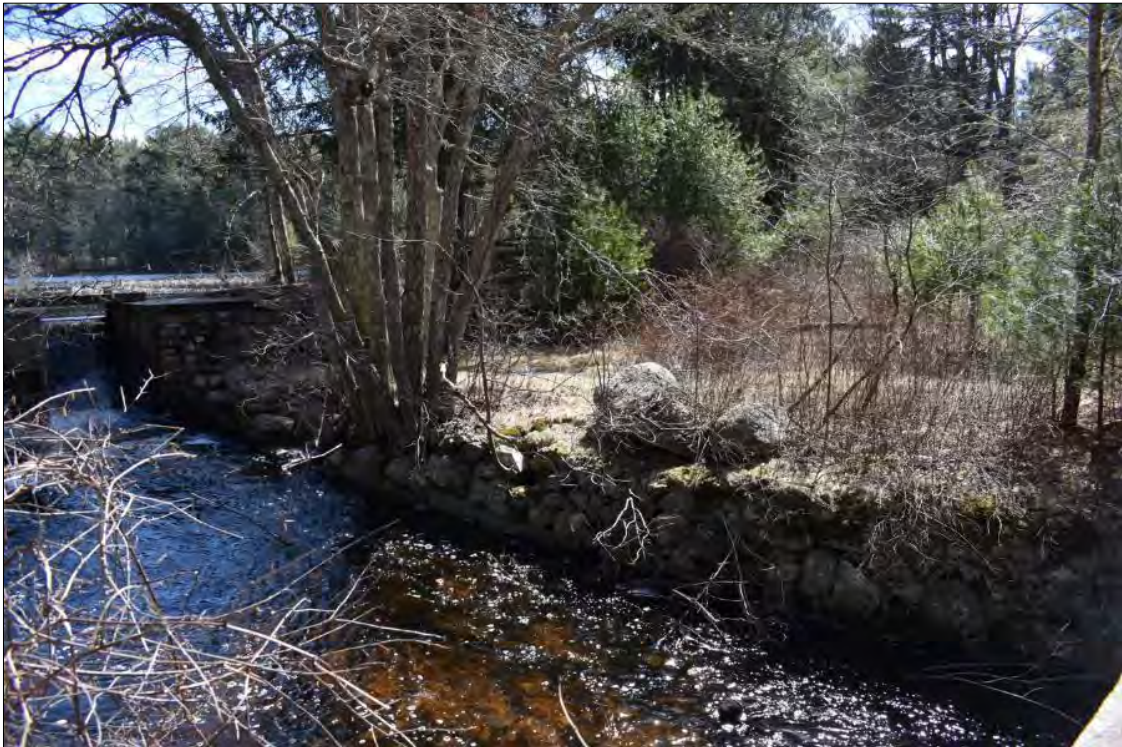
Photo 15. Stone-lined river wall on the south bank of the Carr River downstream from the Capwell Mill Pond Dam, view southeast.

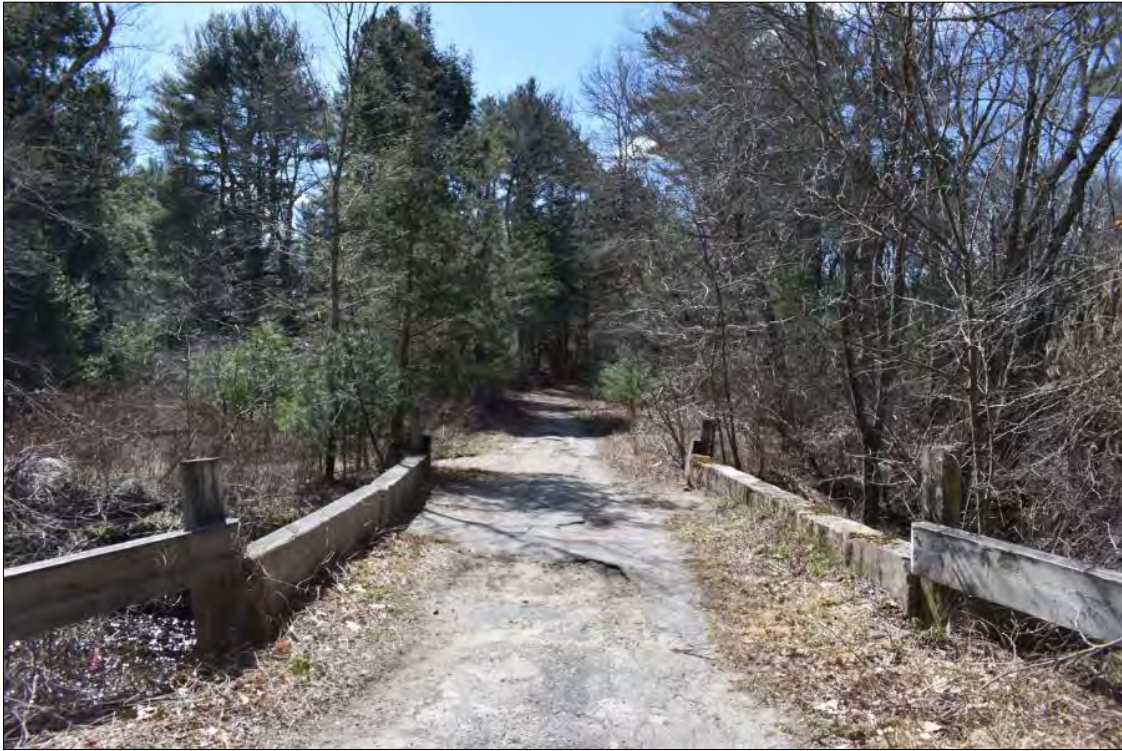
Photo 16. Concrete arch bridge deck on Burnt Sawmill Road, view south.

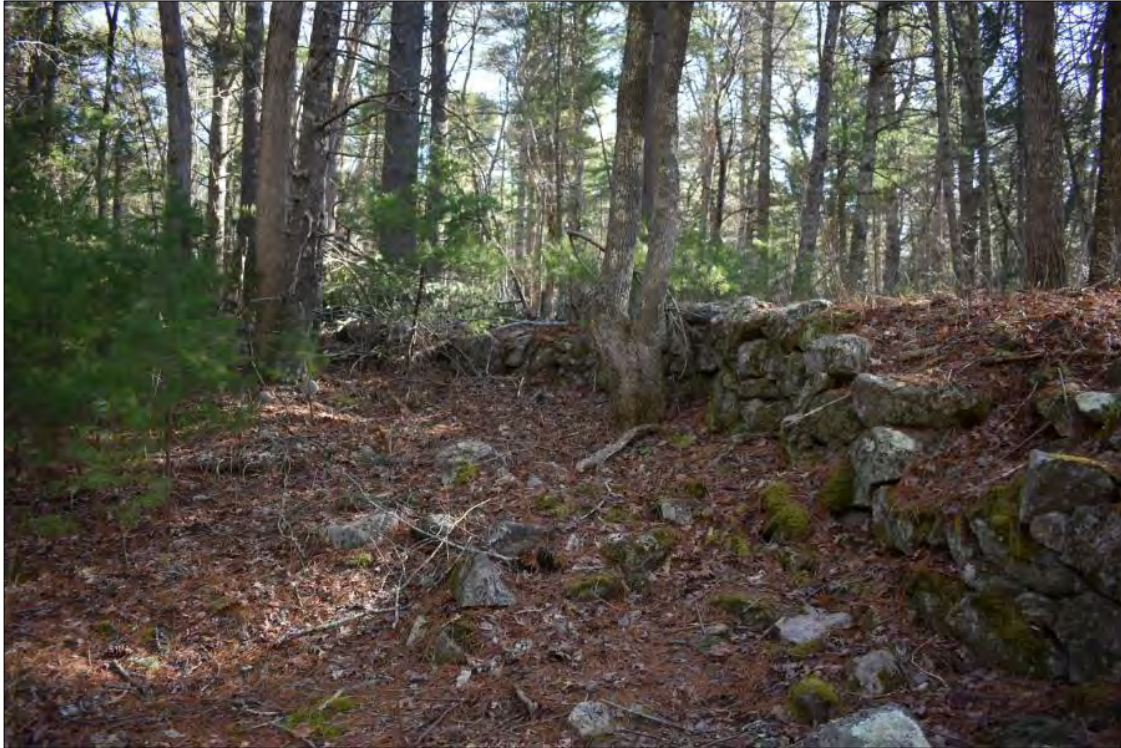
Photo 37. Sweet Pond Dam northeast abutment wall, view east.
