# CHILDS RIVER RESTORATION REPORT

## EXECUTIVE SUMMARY - JULY 2023

# Upper Childs River Restoration

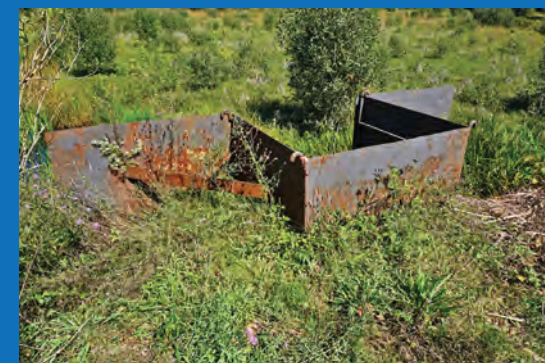
September 2018 – Bog Water Control Device Blocking Fish Passage

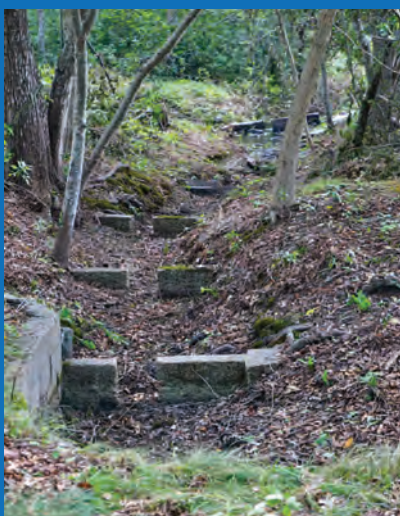
August 2020  
Non-functional Fish Ladder

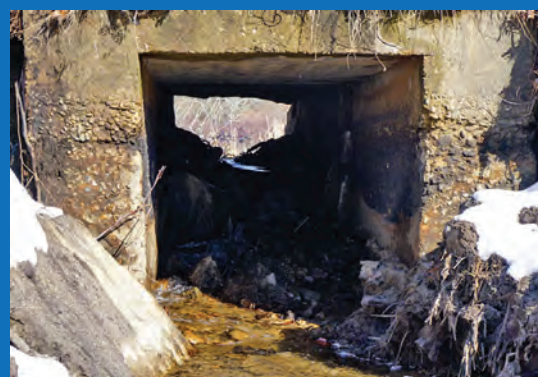
February 2021 – Deteriorated, Blocked Culvert

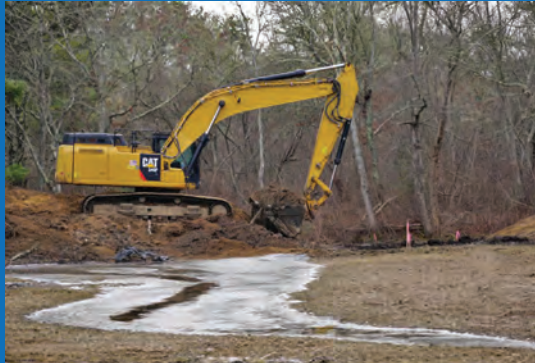
January 2021 – Dam Removal

With an earthen dam at the south end of the pond, water was blocked from freely exiting the Upper Childs. This inhibited fish passage and created an unhealthy environment for aquatic life. The pond area water was temporarily diverted to enable sediment removal and channel construction. The dam and old spillway were removed, the fish ladder buried, and the winding river was channeled along the western tree line to mitigate late afternoon heat and to provide a coldwater habitat for brook trout.

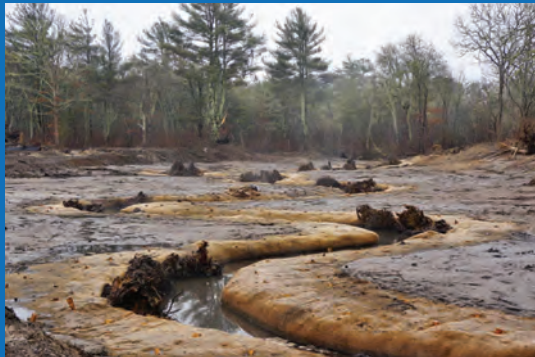
March 2021 – New River Channel Created

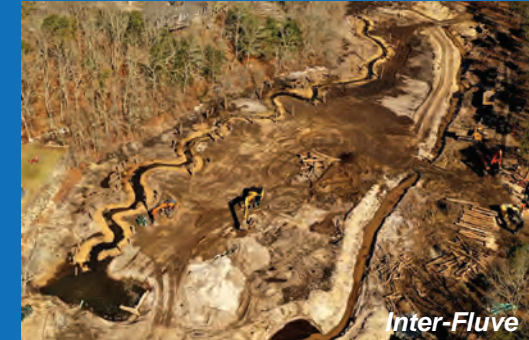
Early April 2021 – Things are Drying Out

A diversionary channel was dug to drain the impounded water and direct water away from where the new river channel was to go. In addition to the diversion, water had to be pumped to a distant drainage basin so that sediment could be removed and the new river constructed.

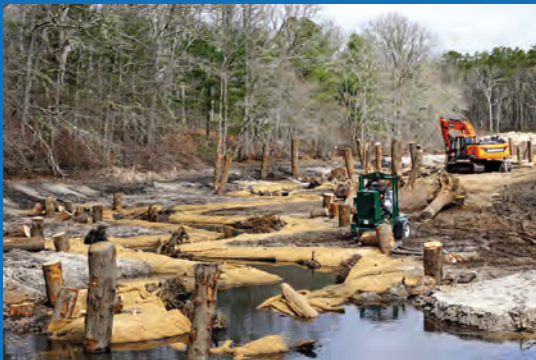
April 2021 – New River Channel & Floodplain

Like the south pond area, the river was positioned along the tree line on the western side to protect the water from the summer afternoon sun as much as possible. Aided by plantings, it did not take long for the vegetation to take hold and the area to green up.

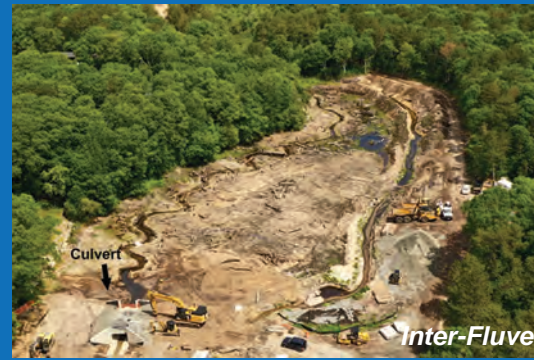
June 2021 – Culvert in Place

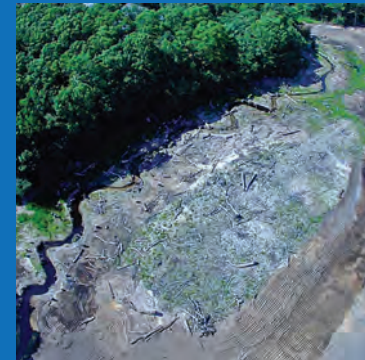
July 2021 – River Turned On

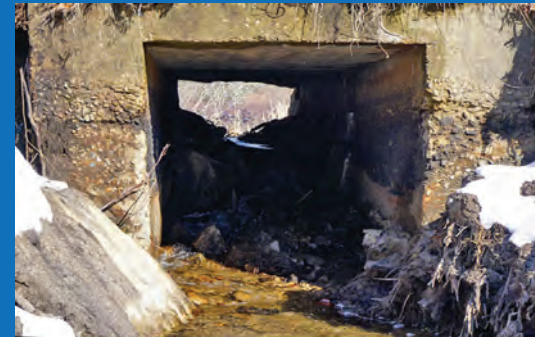
Early February 2021 – Deteriorated Culvert

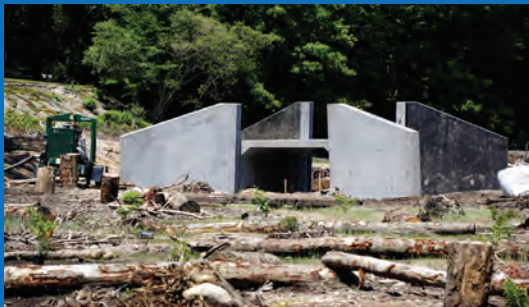
June 2021 – New Culvert in Place

With the former ponds north and south of Carriage Shop Road eliminated, construction complete and the river now free-flowing, average water temperatures in July have dropped from 70 degrees to 58 degrees. This dramatic change will create a thriving habitat for the return of brook trout and other aquatic life.

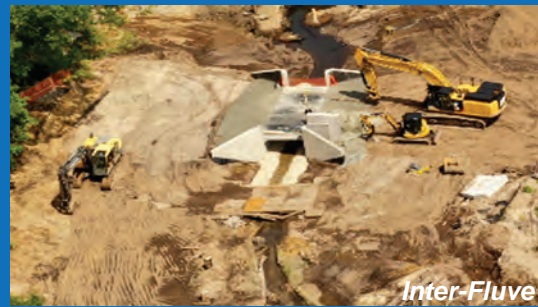
June 2021 – Construction of New Road

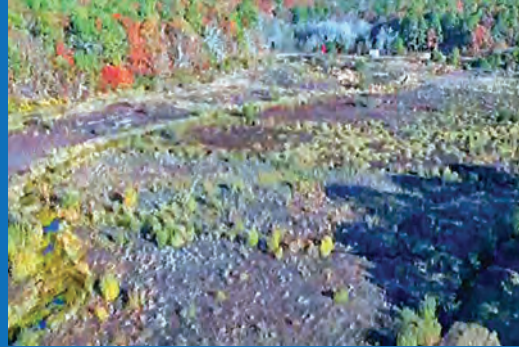
November 2018 – Bog Overgrowth

With abandonment of the bogs in 2014, invasive plants, shrubs and small trees began to overgrow the area where cranberries once thrived. At the beginning of the restoration, a diversion channel was dug to direct water away from targeted construction areas.

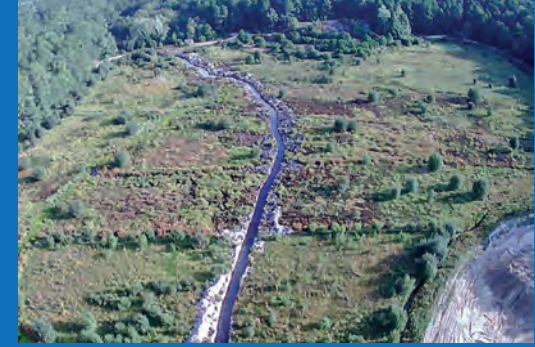
September 2020 – Diversion Channel

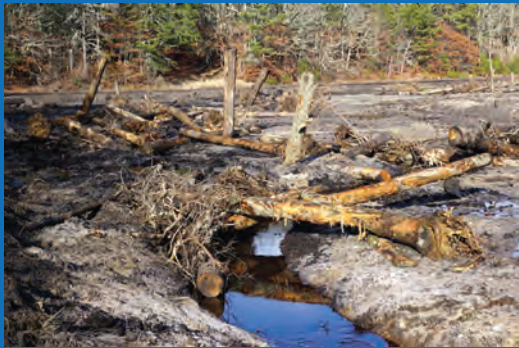
January 2021 – Logs & Root Wads Protect the River and Aquatic Life

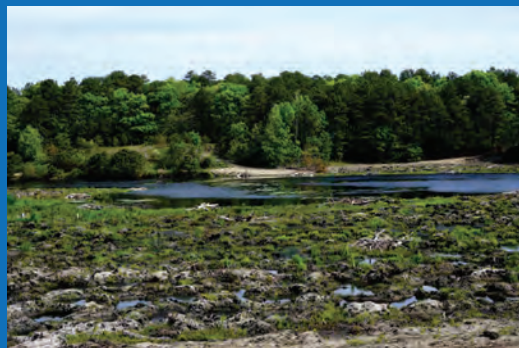
June 2021 – Microtopography – Plant Life

Excess sand from farming was removed. The bog holding pond was expanded to provide diving and dabbling duck habitat. Microtopography work was done to turn over the bog surface allowing dormant wetland seedlings to sprout. Ditches were filled and a new river channel created.

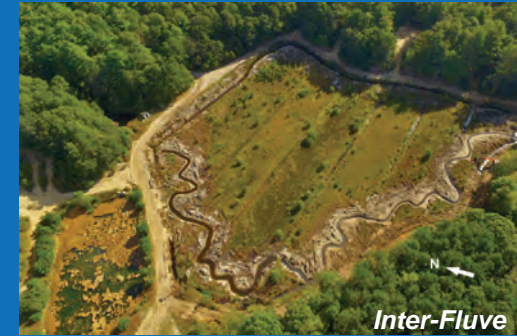
October 2020 – Eastern Bog, River Channel

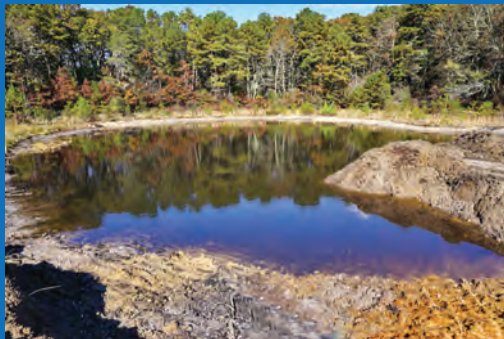
October 2020 – Diving Duck Pond
